SUBJECT: LER 91-005-00: on 910309, unplanned engineered safety actuation occurred when 'A' standby gas treatment fan started unexpectedly. Caused by actuation of filter train outlet sensor. Technical review performed. W/910408 ltr.

SUSQUEHANNA STEAM ELECTRIC STATION  
LICENSEE EVENT REPORT 91-005-00  
FILE R41-2  
PLAS -478

TITLE (4)  
**Standby Gas Treatment Fan - Unexpected Start**

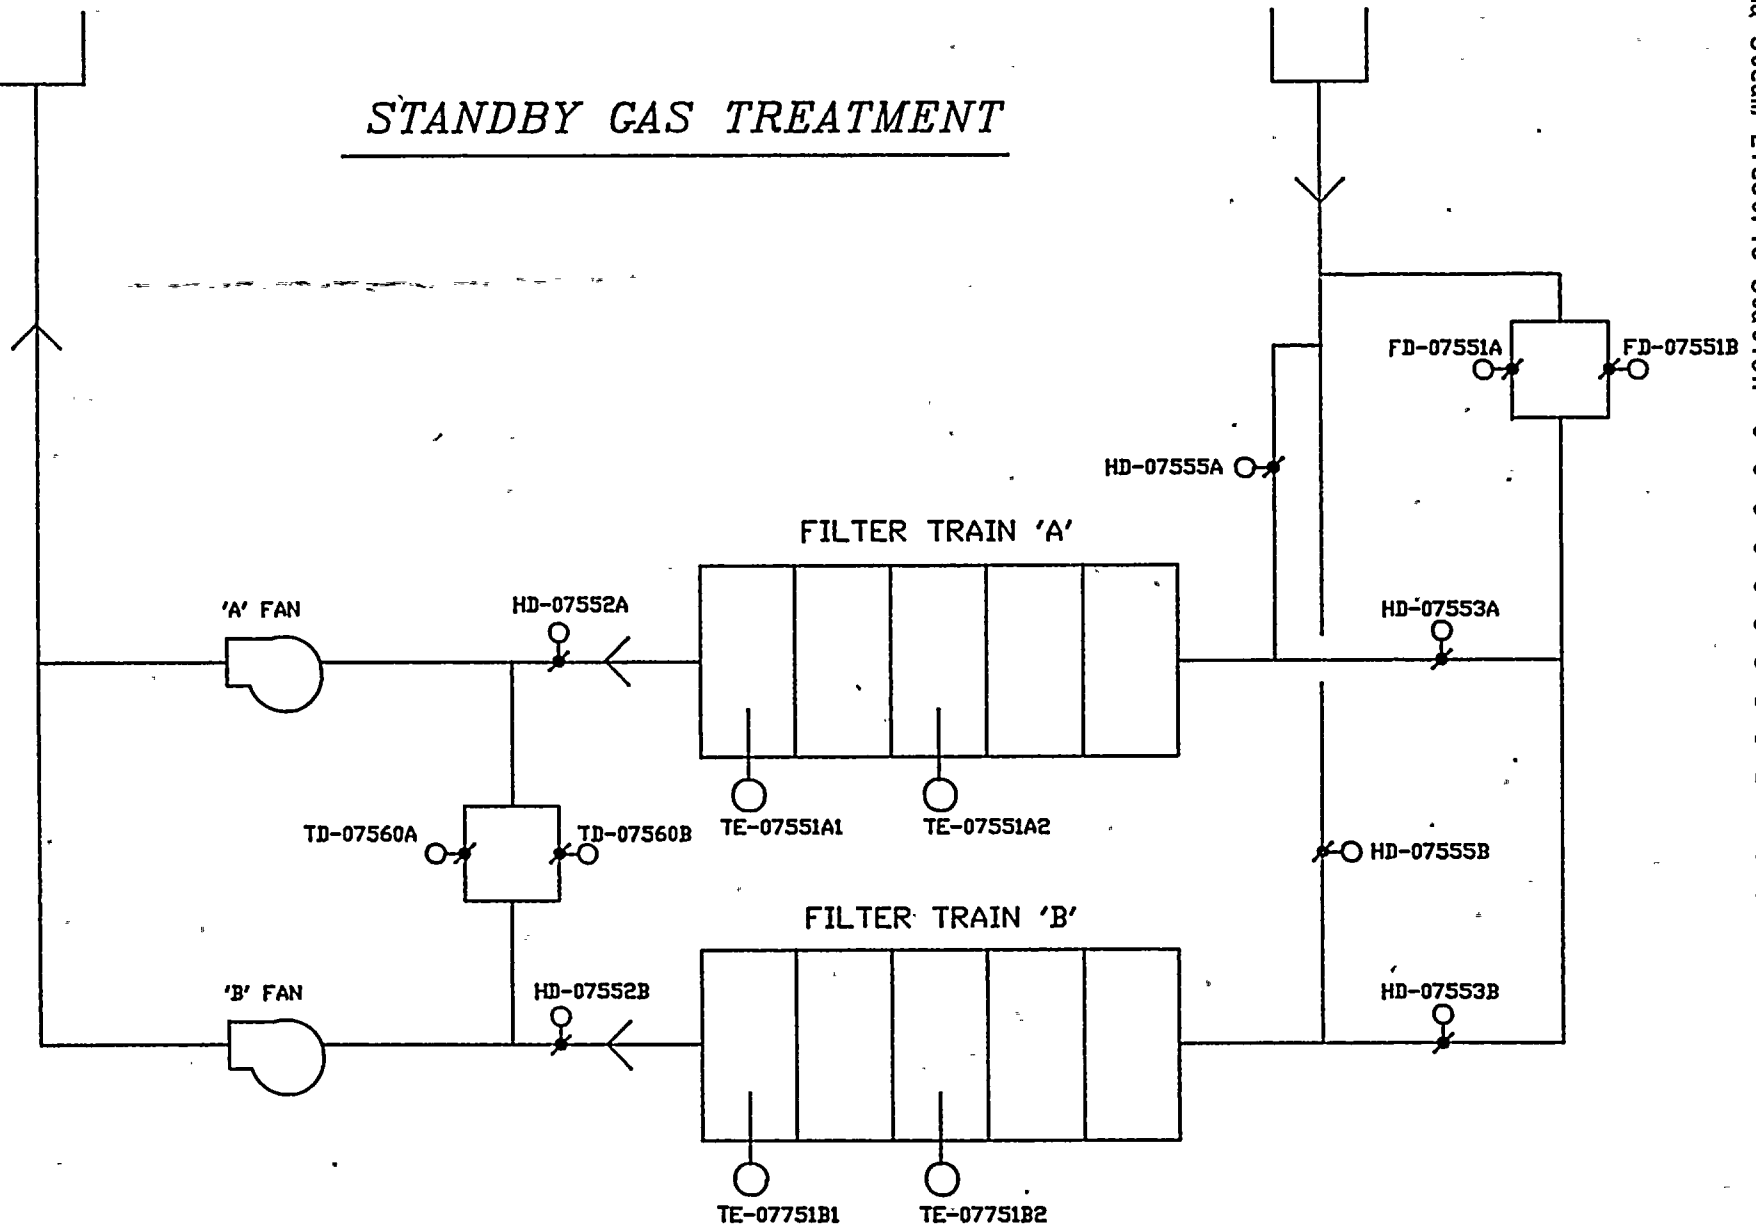
STANDBY GAS TREATMENT

This event involved the SGTS Cooling Mode logic. The cooling mode is designed for post-accident cooling of the charcoal beds to remove heat that may be generated as a result of radioactive decay of gases which have been absorbed by the charcoal. The attached sketch is provided to assist in understanding the normal sequence of events for the cooling mode function. This description assumes the 'A' filter train is idle (fan not running) and has become "loaded" with radioactive gases post accident. As the temperature increases, actuation of the charcoal inlet temperature switch (TSH-07551-A2) causes the cross-tie damper (TD-07560A) and the outside cooling air damper (HD-07555A) to open thus providing a cooling path since the 'B' fan would already be running to maintain secondary containment. Actuation of TSH-07551A2 also annunciates a control room alarm. If the charcoal temperature continues to rise, actuation of the outlet temperature switch (TSH-07551A1) causes the 'A' fan to start, the normal outside makeup air damper (FD-07551A) to open, and the outside cooling air and cross-tie dampers to close. Further temperature increase to a much higher temperature (indicating possible ignition) will actuate the charcoal deluge system.

During the described event, only TSH-07551A1 actuated thus causing the auto start of the 'A' Fan. Since TSH-07551A2 had not actuated, dampers TD-07560A and HD-07555A had not opened so no flow path was available. As a result the, 'A' fan subsequently tripped on low flow. This was proper response of the system to the actuation of TSH-07551A1.
