REGULATORY INFORMATION DISTRIBUTION SYSTEM (RIDS)

SUBJECT: LER 91-007-01: on 910619, C EDG failed to reach Tech Spec
 required speed, frequency & voltage within required time.
 Caused by air entrapment in fuel supply header. C EDG being
 tested once every seven days. W/910719 ltr..

SUSQUEHANNA STEAM ELECTRIC STATION
LICENSEE EVENT REPORT 91-007-00
FILE R41-2
PLAS - 491

TITLE (4)
'C' Emergency Diesel Start Time Exceeded Technical Specification Requirements

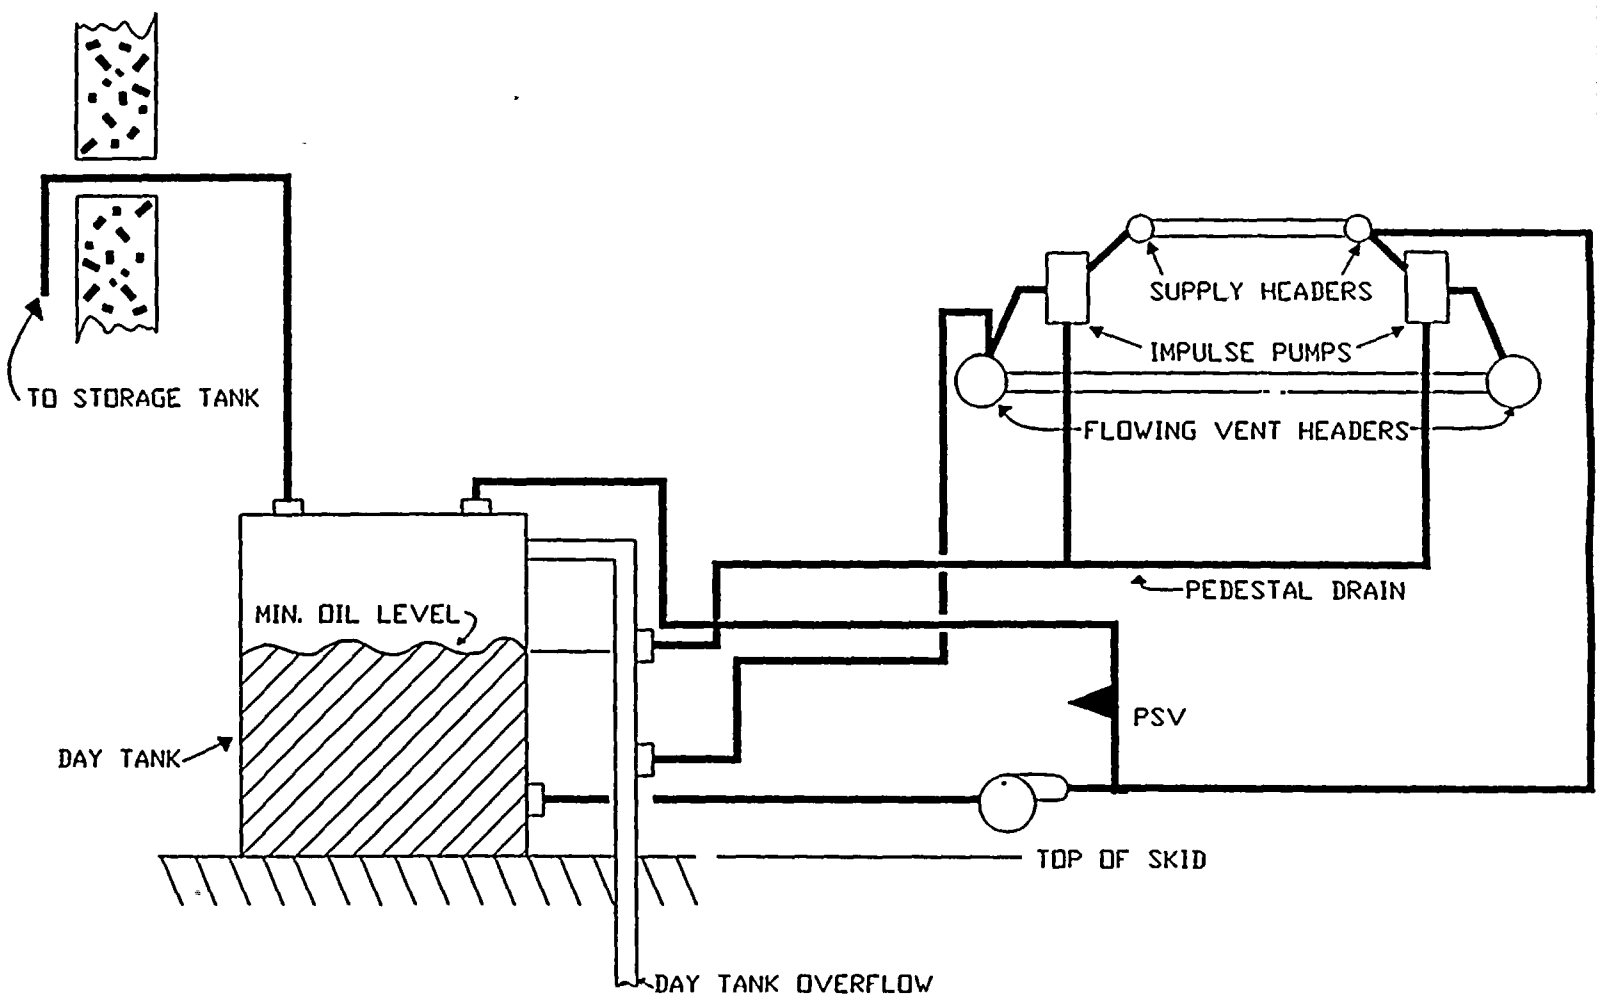
INITIAL FLOWING VENT MOD.

Based on the investigation, the most probable cause of the 'C' EDG slow start has been concluded to be excessive air trapped in the fuel supply header existing prior to the initial surveillance run on 6/19/91. The cause of air entrapment within the fuel supply header is believed to be due to an injection pump flowing vent modification which had been implemented on the 'C' EDG in August 1990. The flowing vent modification had been installed to alleviate an injection pump overheating problem at idle or low power engine operation by draining excess fuel oil back to the main fuel oil storage tanks. The new flowing vents have been found ineffective in venting air from the fuel header during startup. This modification had been installed on EDGs 'A' through 'D' between August and October 1990. It should be noted that EDG 'E', which is a fifth and spare EDG at Susquehanna, is of a different design and did not require this modification. Warmer outside temperatures experienced recently have made the problem more evident as decreased fuel oil viscosity results in faster draining, thus increasing the rate at which air enters the fuel header.

An injection pump flowing vent modification was implemented on the 'A' through 'D' EDGs between August and October 1990. The flowing vent modification was installed to alleviate an injection pump overheating problem at idle or low power engine operation (The 'E' EDG (spare EDG) is a different design and did not require this modification). Prior to the 6/19/91 'C' EDG slow start, a concern for potential fuel supply header voiding had only been identified relative to the 'D' EDG, which had experienced a slow start on March 25, 1991 during a troubleshooting run. Although the root cause investigation did not identify a definitive cause for the 03/25/91 slow start, voiding in the fuel supply header as a result of the flowing vent modification was identified as a potential contributor. As a precautionary measure, the flowing vent design was re-modified to eliminate the potential for fuel header voiding. Similar re-modifications were scheduled for the 'A', 'B' and 'C' EDGs at that time, to be implemented as a precautionary measure during their next inspection outages.
