SUBJECT: LER 92-010-00: on 920613, offgas sys guard bed B experienced elevated temps. Caused by less than adequate procedural guidance for guard bed purging. Procedural guidance developed for operation of offgas beds. W/920717 ltr. r.

SUSQUEHANNA STEAM ELECTRIC STATION
LICENSEE EVENT REPORT 92-010-00
FILE R41-2
PLAS -531

TITLE (4) **Offgas System Guard Bed "B" Experienced Elevated Temperatures**

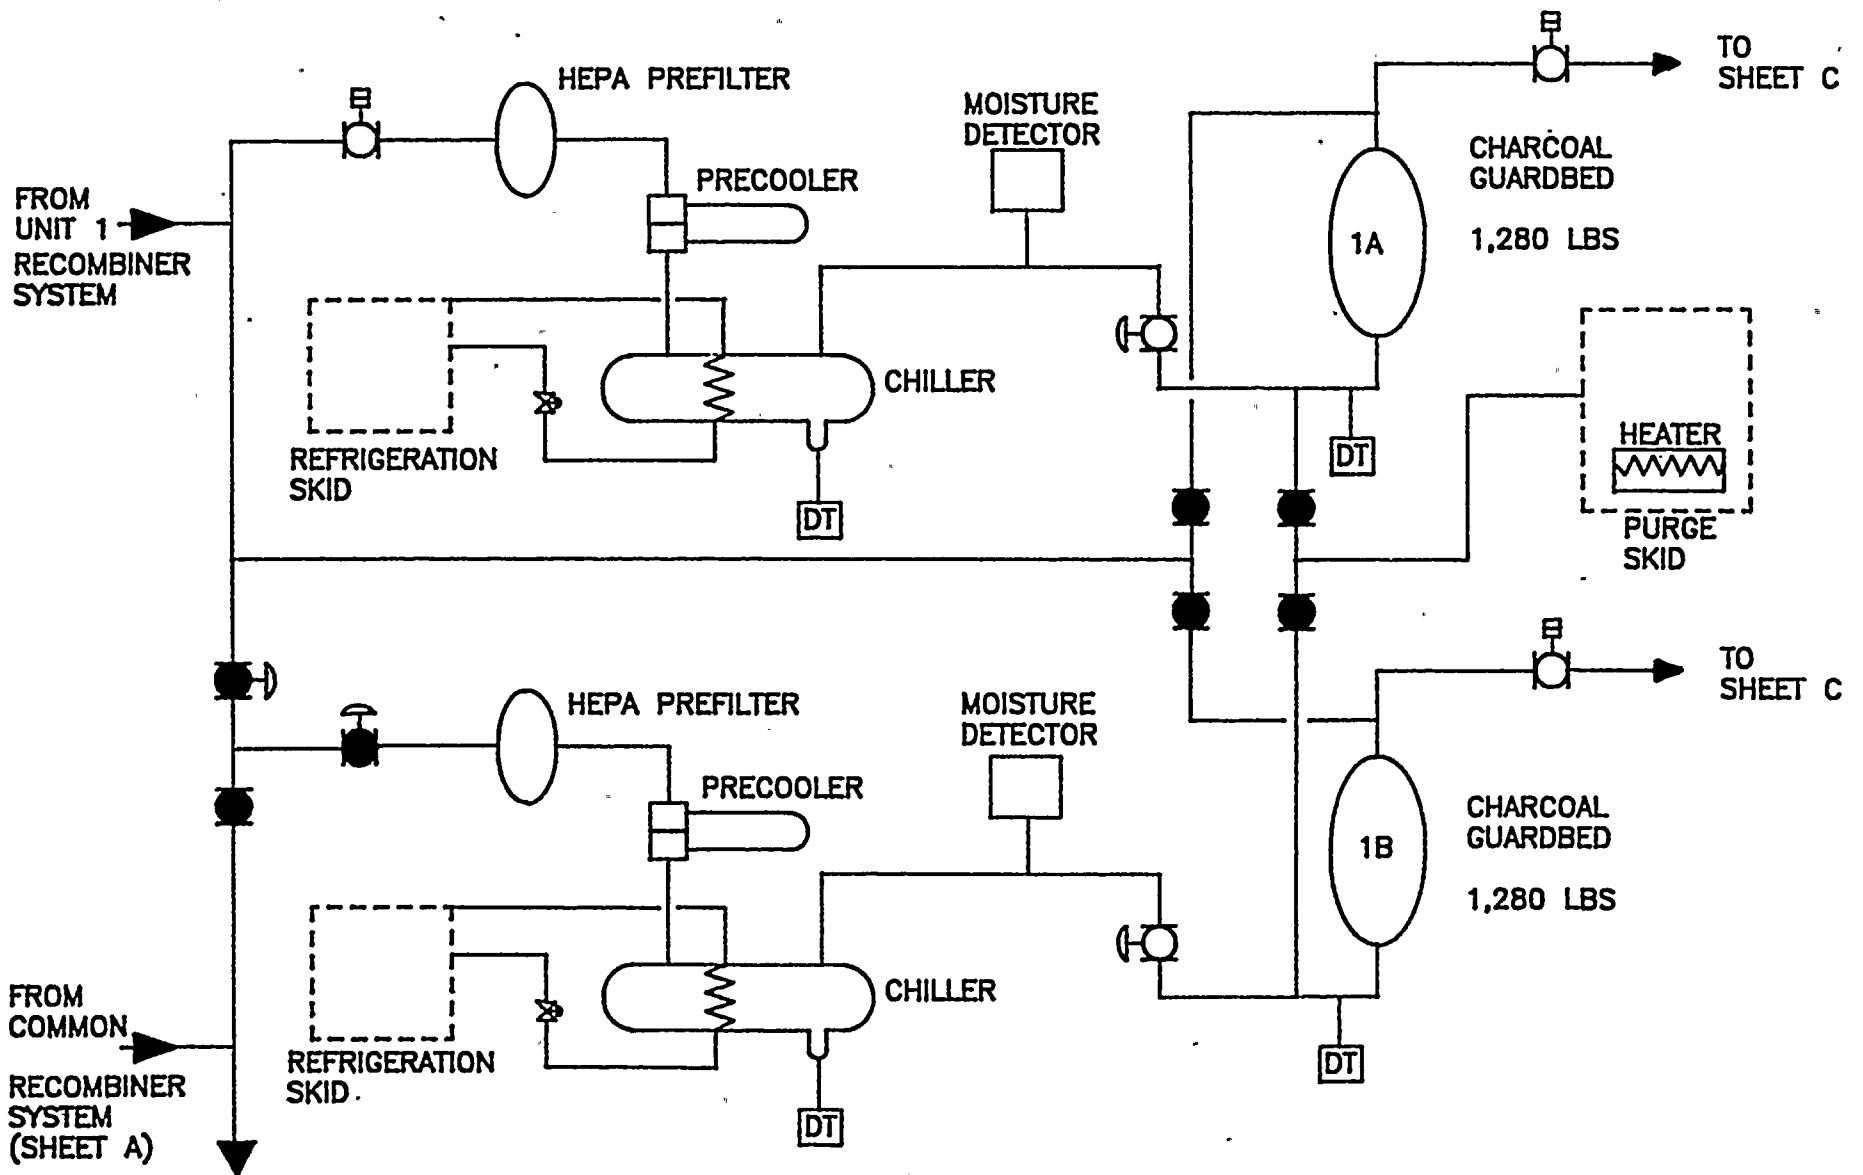
FIGURE 2

The off-gas system consists of three recombiner trains, one for Unit 1, one for Unit 2, and one common. There are two off-gas treatment systems, one for Unit 1 and one for Unit 2. Each one of these off-gas treatments systems consists of two water removal and temperature reduction subtrains with a guard bed which then enter a common charcoal adsorber assembly. (See Figures 2 & 4).

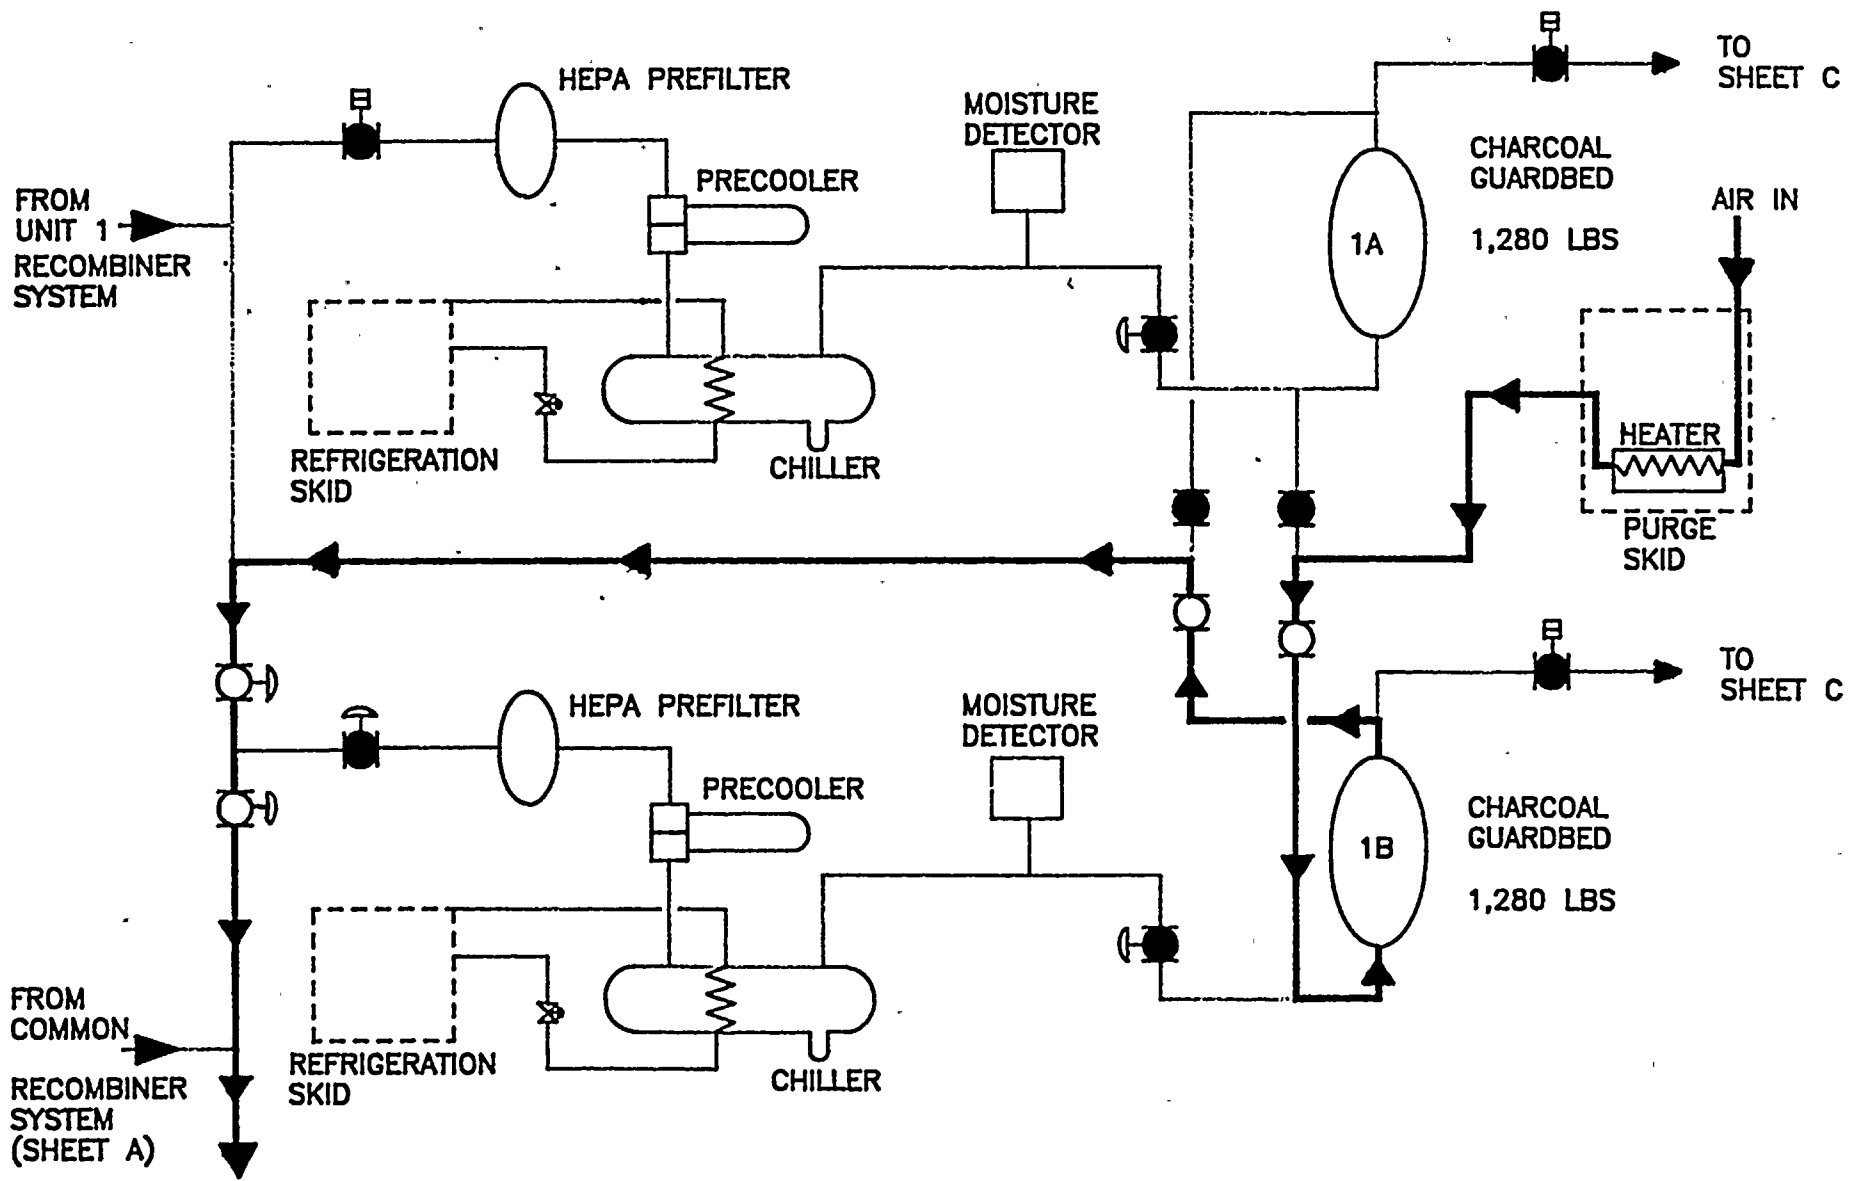
FIGURE 3

On 6/12/92 at 2215 hours a final purge of the "1B" guard bed (250° F air) was being performed (see figure 3) because conditions indicated that the "1B" was still slightly moist. At 0515 hours on 6/13/92, the heater for the purge was turned off when the guard bed internal temperature was 135° F. Air flow was continued until 0545 hours at which time the internal temperature indicated 120° F.

PURGE OF "1B" GUARDBED
