# Pennsylvania Power & Light Company

SUSQUEHANNA STEAM ELECTRIC STATION  
RESPONSE TO 6/15/95 NOTICE OF DEVIATION  
PLA-4351 FILE NOS. A17-2/R41-2

Docket Nos. 50-387  
and 50-388

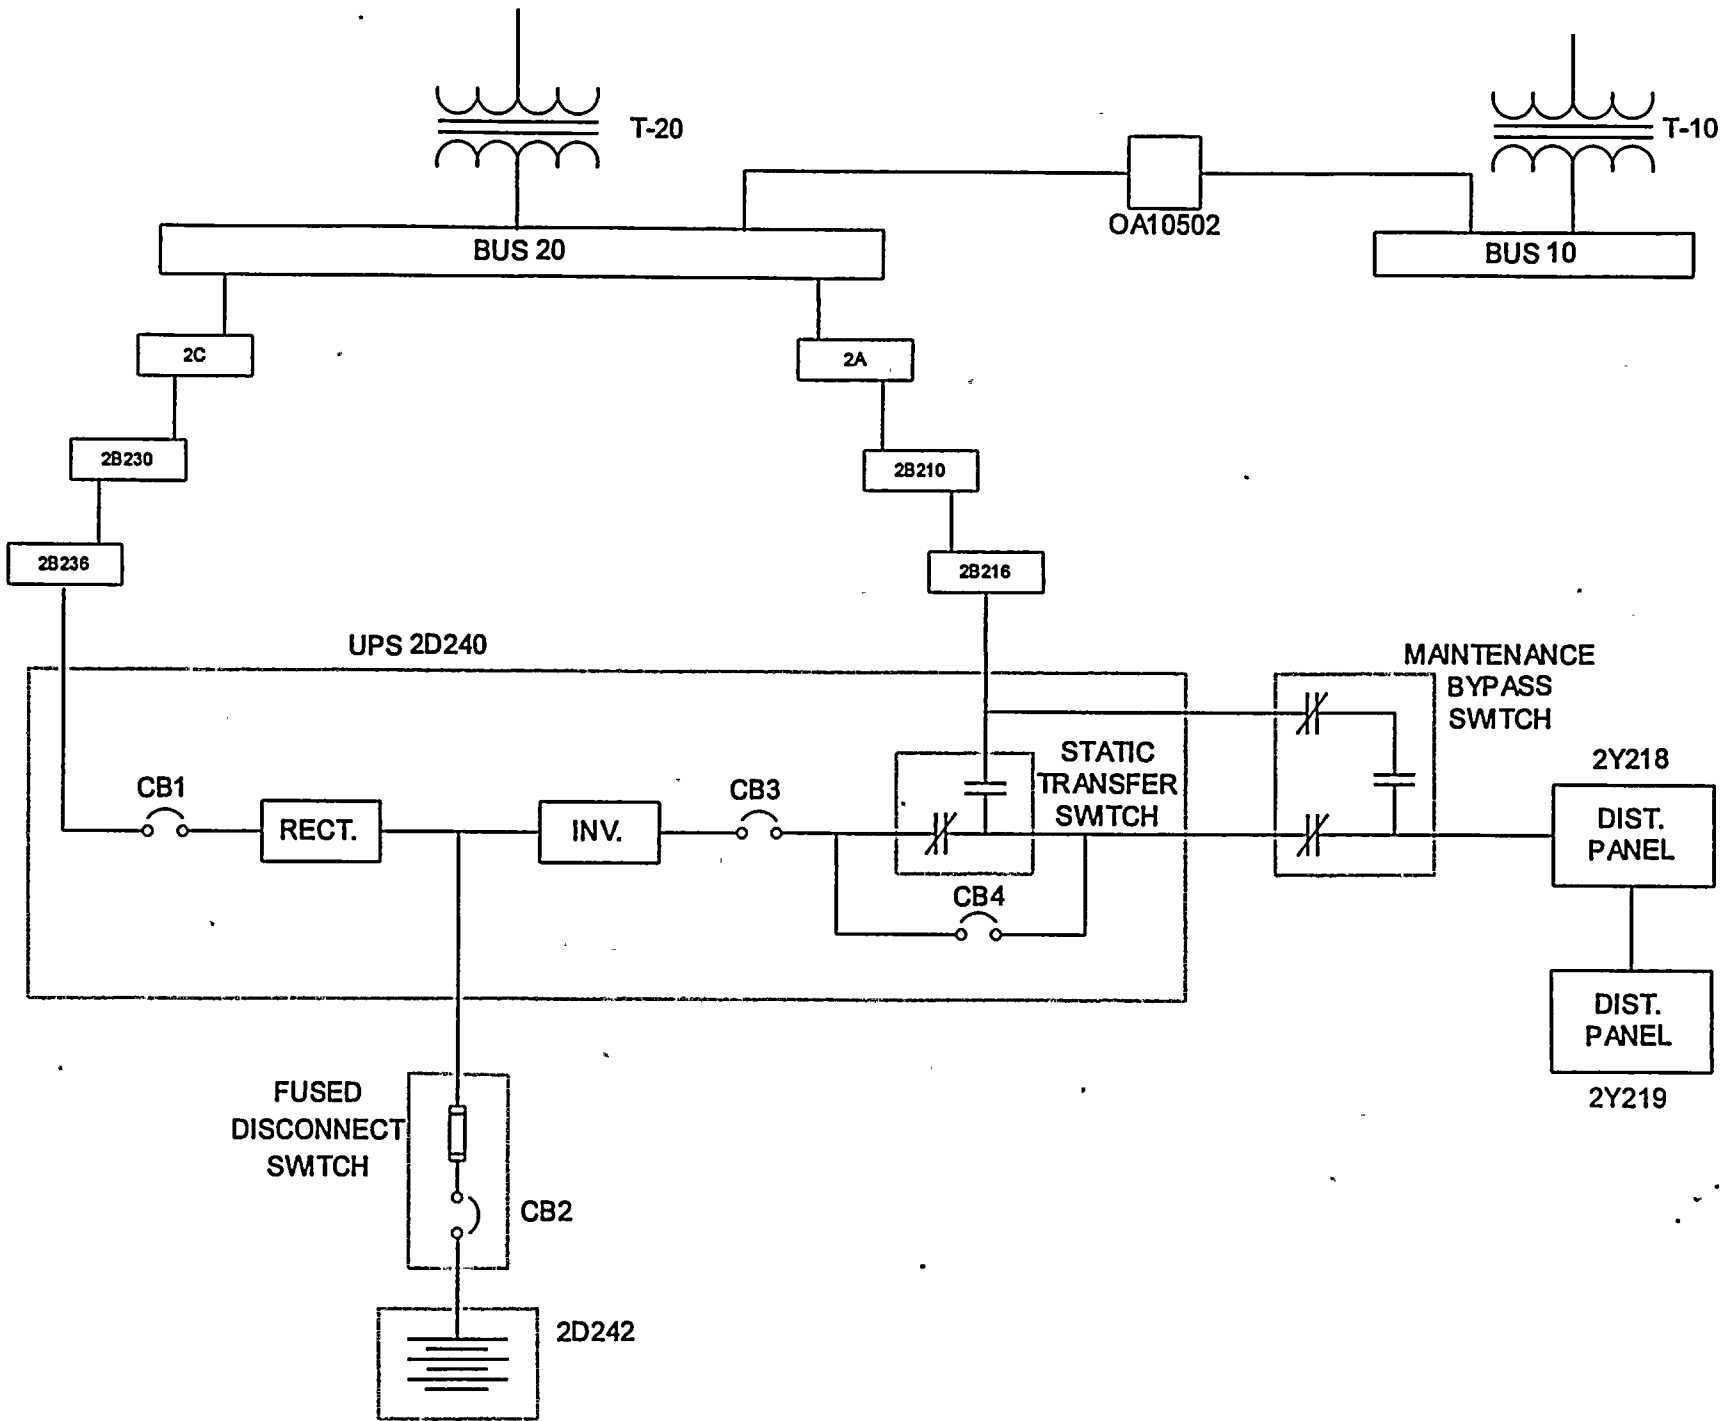
# UPS 2D240 POWER SUPPLY SIMPLIFIED DRAWING

Contrary to the above, after UPS 2D240 failed a post-maintenance test on January 30, 1995, the external maintenance bypass switch was not positioned to bypass the UPS and supply the distribution panel directly from the alternate supply. The UPS was in its normal service

alignment until April 15, 1995, when it failed to provide backup battery power or a transfer (to) its alternate supply in response to an electrical perturbation.”

The event which occurred on April 15, 1995 resulted in a degraded voltage condition on both the primary and alternate supplies. This condition, coupled with the degraded battery, prevented power from being supplied to the non-vital instrument buses. If the external maintenance bypass switch had been placed in its bypass position (i.e., power aligned from the alternate source), power to the instrument buses would have been maintained, since the alternate source was only degraded momentarily, and was never completely lost.

- a. Revising the FSAR to clarify the purpose of the maintenance bypass switch, and that its position will be controlled by plant procedures.
- b. Ensuring that this commitment is properly controlled through Operations procedures. This action will also ensure that the basis for any proposed future changes to this commitment are properly documented.
- c. Training of appropriate personnel on the new procedural requirements and their basis.

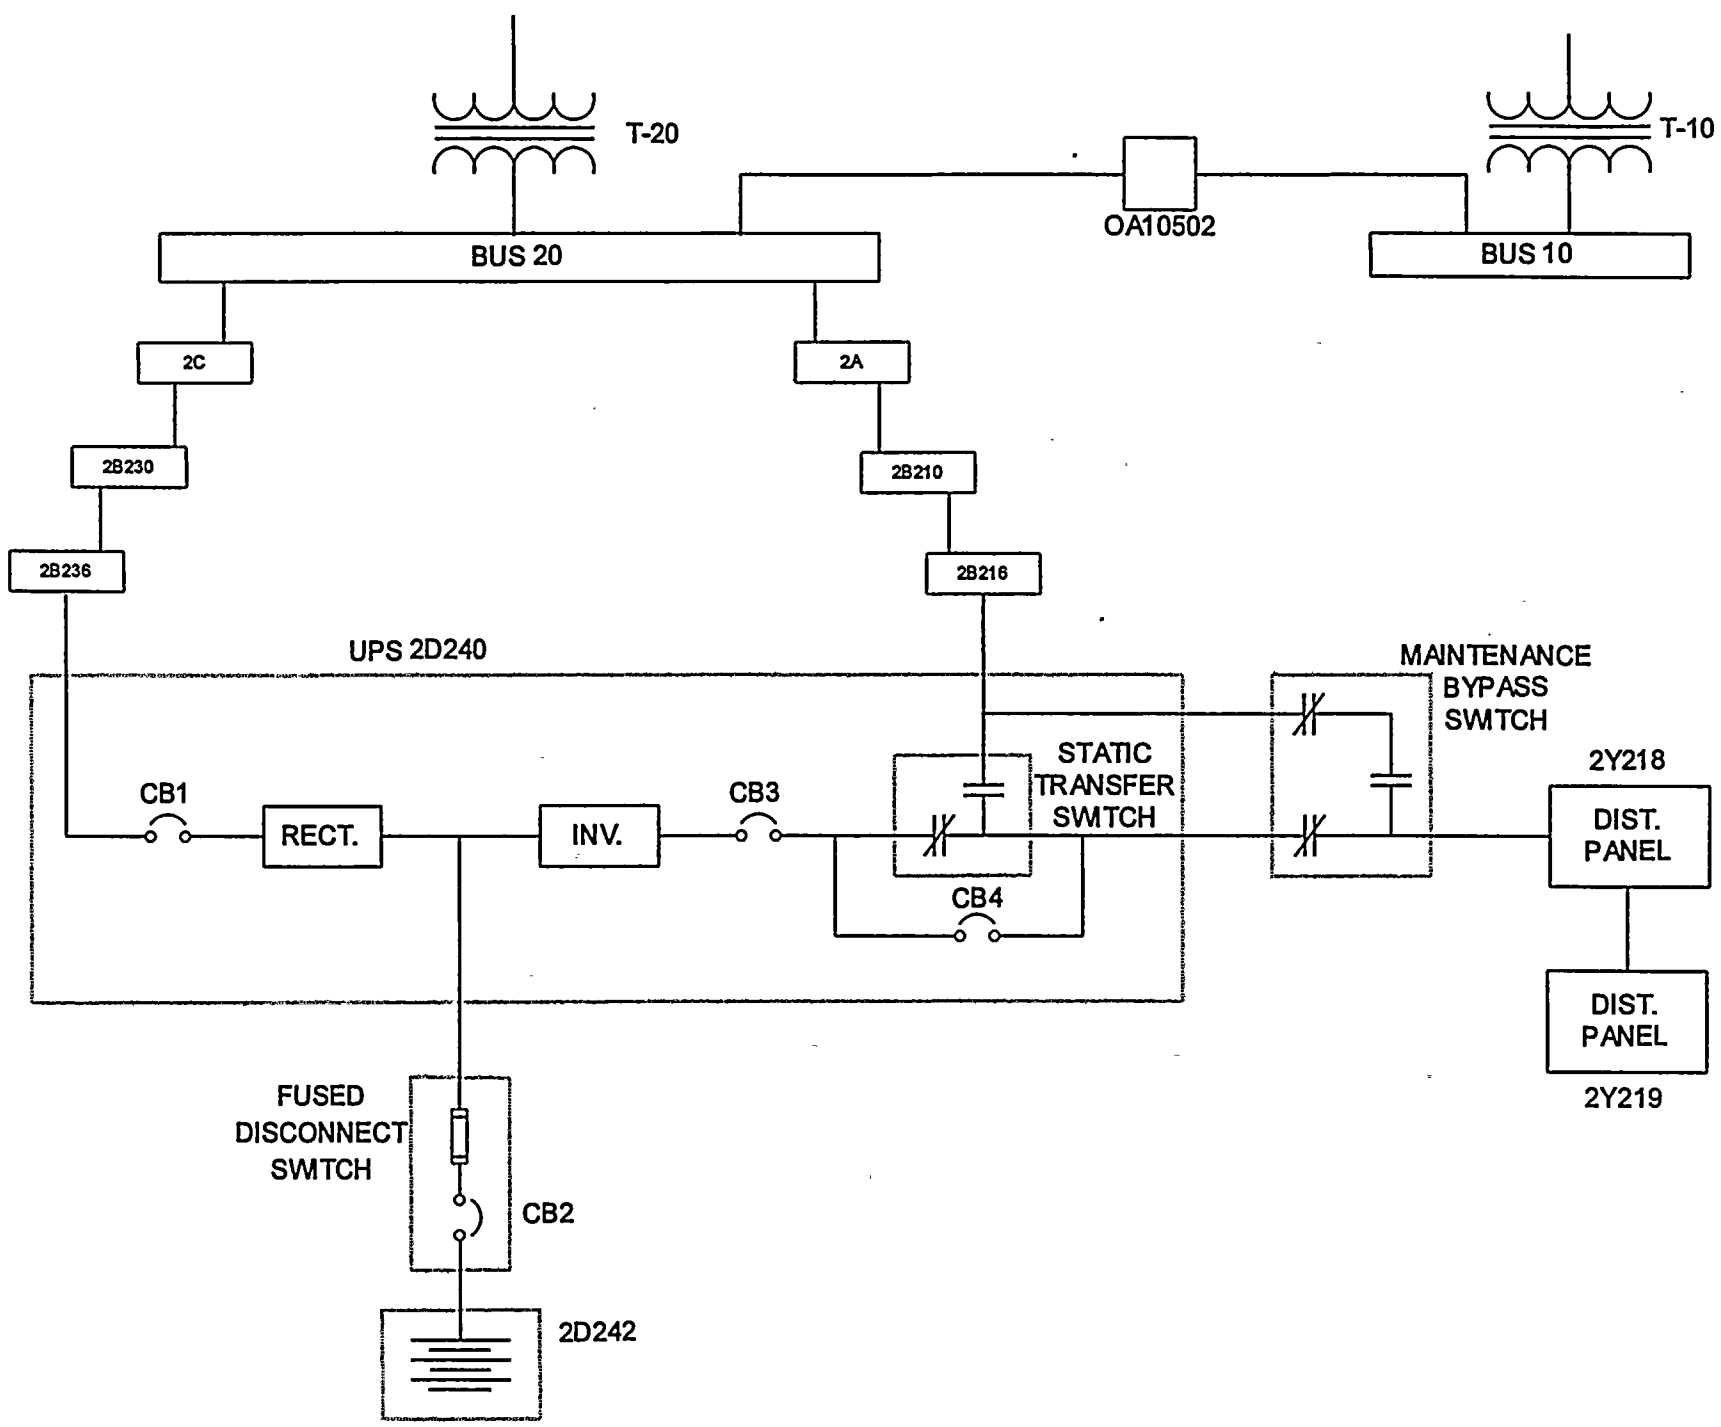
# UPS 2D240 POWER SUPPLY SIMPLIFIED DRAWING

Contrary to the above, after UPS 2D240 failed a post-maintenance test on January 30, 1995, the external maintenance bypass switch was not positioned to bypass the UPS and supply the distribution panel directly from the alternate supply. The UPS was in its normal service

alignment until April 15, 1995, when it failed to provide backup battery power or a transfer (to) its alternate supply in response to an electrical perturbation."

The event which occurred on April 15, 1995 resulted in a degraded voltage condition on both the primary and alternate supplies. This condition, coupled with the degraded battery, prevented power from being supplied to the non-vital instrument buses. If the external maintenance bypass switch had been placed in its bypass position (i.e., power aligned from the alternate source), power to the instrument buses would have been maintained, since the alternate source was only degraded momentarily, and was never completely lost.

- a. Revising the FSAR to clarify the purpose of the maintenance bypass switch, and that its position will be controlled by plant procedures.
- b. Ensuring that this commitment is properly controlled through Operations procedures. This action will also ensure that the basis for any proposed future changes to this commitment are properly documented.
- c. Training of appropriate personnel on the new procedural requirements and their basis.
