SUSQUEHANNA STEAM ELECTRIC STATION  
RESPONSE TO 6/15/95 NOTICE OF DEVIATION  
PLA-4351 FILE NOS. A17-2/R41-2

Docket Nos. 50-387  
and 50-388

## Statement of Deviation

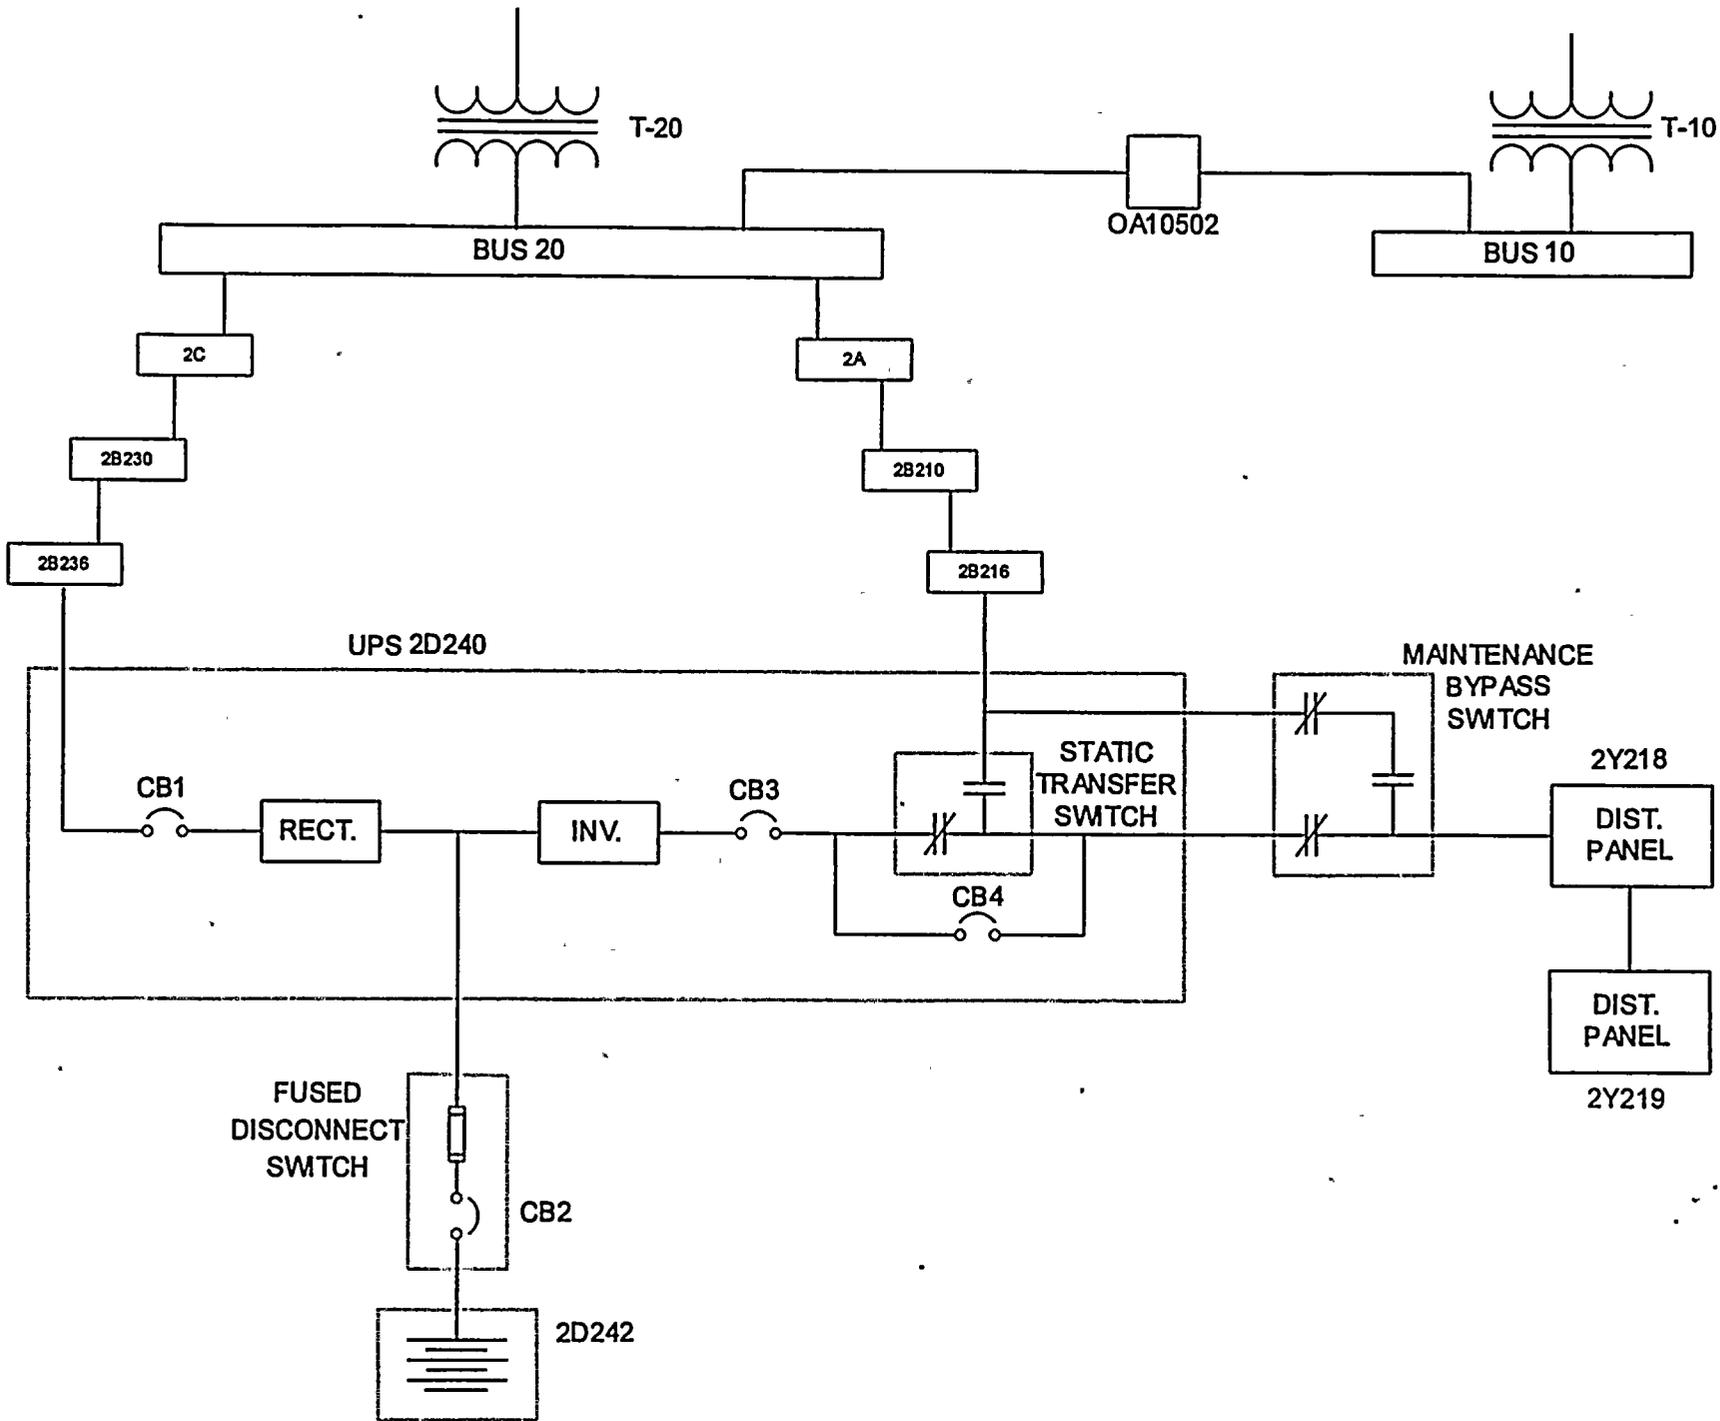
# UPS 2D240 POWER SUPPLY SIMPLIFIED DRAWING

Contrary to the above, after UPS 2D240 failed a post-maintenance test on January 30, 1995, the external maintenance bypass switch was not positioned to bypass the UPS and supply the distribution panel directly from the alternate supply. The UPS was in its normal service

alignment until April 15, 1995, when it failed to provide backup battery power or a transfer (to) its alternate supply in response to an electrical perturbation.”

The event which occurred on April 15, 1995 resulted in a degraded voltage condition on both the primary and alternate supplies. This condition, coupled with the degraded battery, prevented power from being supplied to the non-vital instrument buses. If the external maintenance bypass switch had been placed in its bypass position (i.e., power aligned from the alternate source), power to the instrument buses would have been maintained, since the alternate source was only degraded momentarily, and was never completely lost.

- a. Revising the FSAR to clarify the purpose of the maintenance bypass switch, and that its position will be controlled by plant procedures.
- b. Ensuring that this commitment is properly controlled through Operations procedures. This action will also ensure that the basis for any proposed future changes to this commitment are properly documented.
- c. Training of appropriate personnel on the new procedural requirements and their basis.

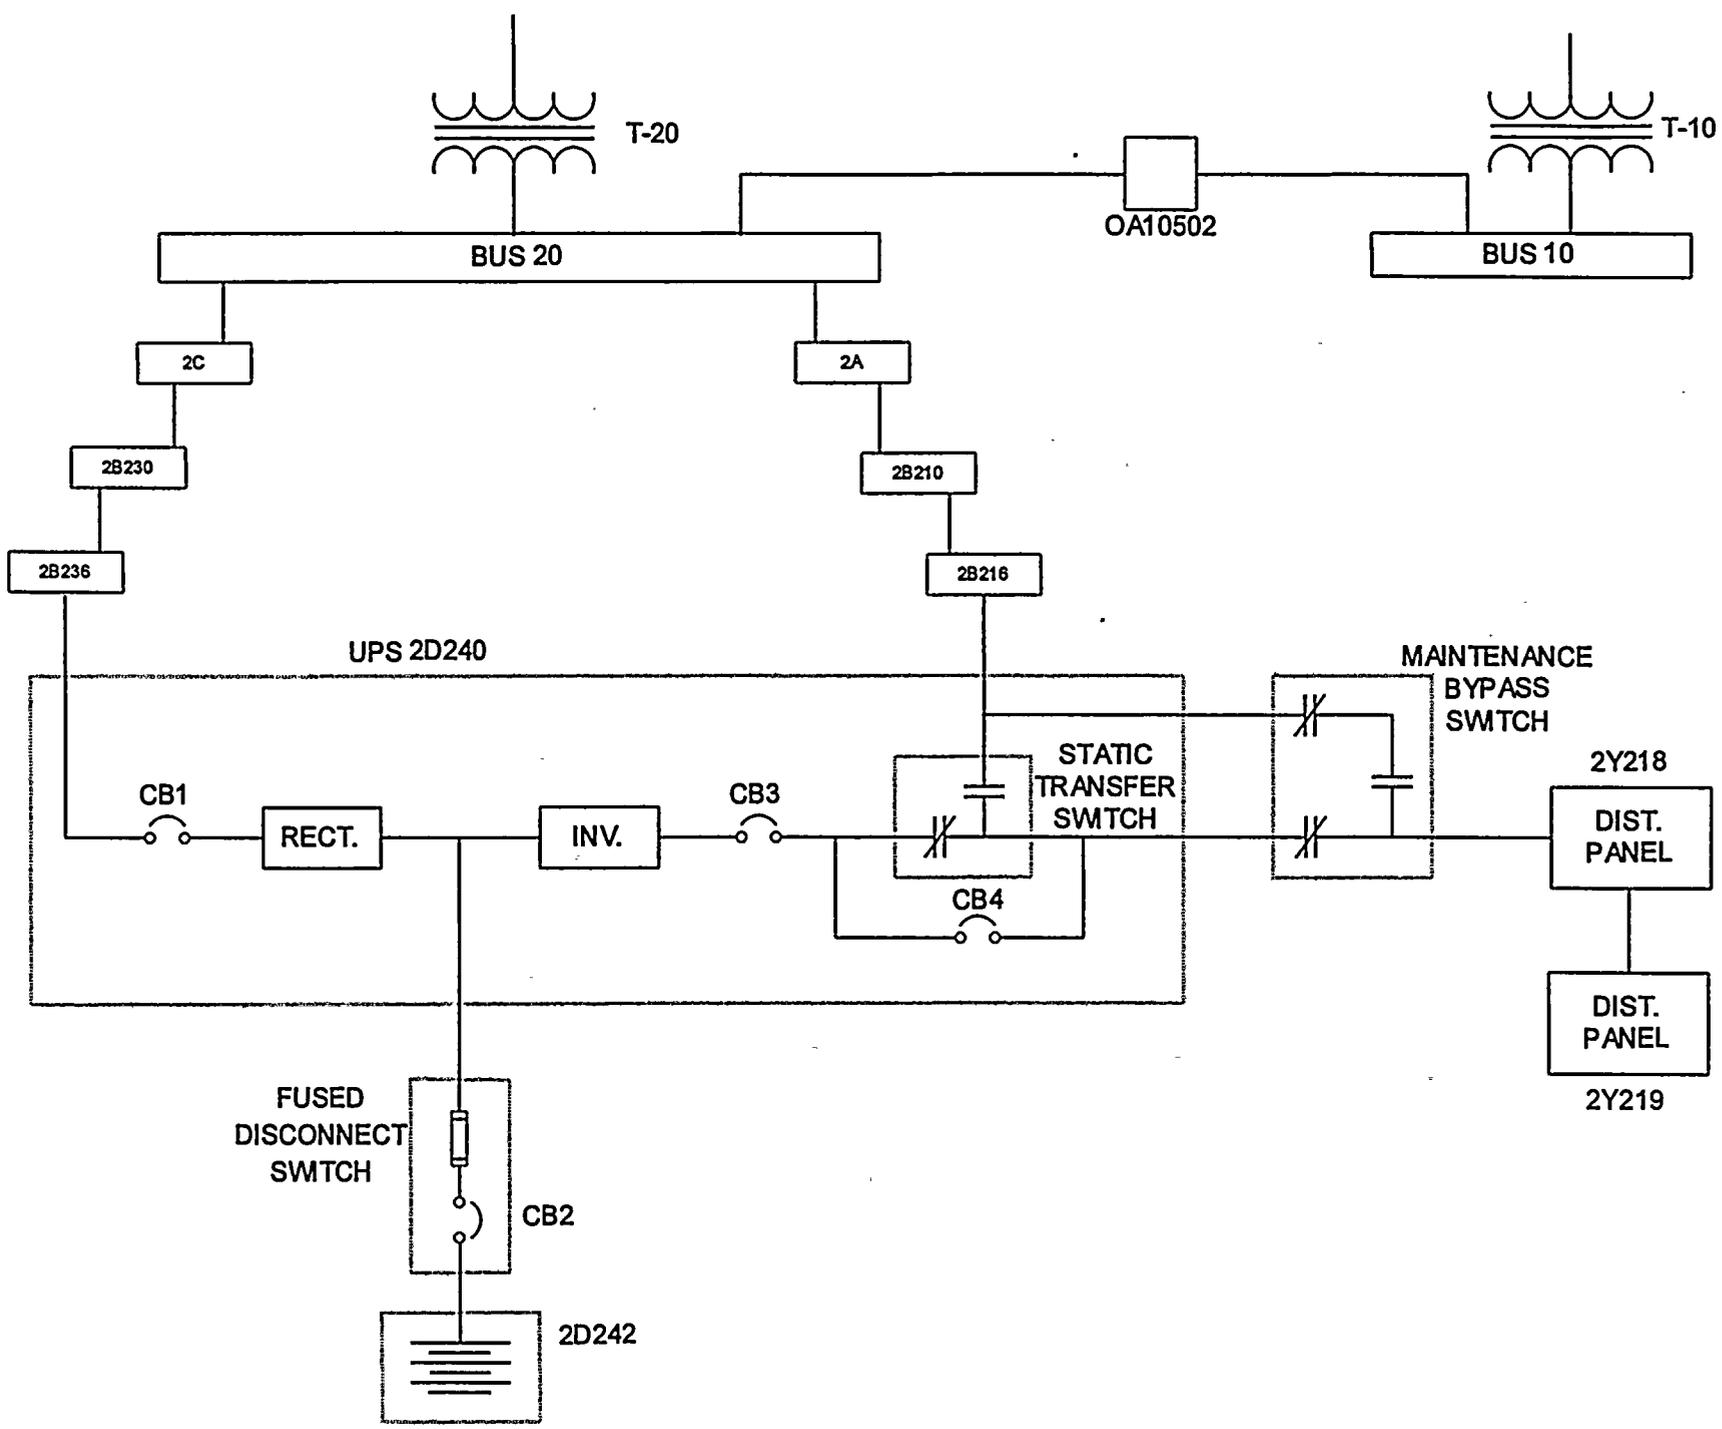
# UPS 2D240 POWER SUPPLY SIMPLIFIED DRAWING

Contrary to the above, after UPS 2D240 failed a post-maintenance test on January 30, 1995, the external maintenance bypass switch was not positioned to bypass the UPS and supply the distribution panel directly from the alternate supply. The UPS was in its normal service

alignment until April 15, 1995, when it failed to provide backup battery power or a transfer (to) its alternate supply in response to an electrical perturbation."

The event which occurred on April 15, 1995 resulted in a degraded voltage condition on both the primary and alternate supplies. This condition, coupled with the degraded battery, prevented power from being supplied to the non-vital instrument buses. If the external maintenance bypass switch had been placed in its bypass position (i.e., power aligned from the alternate source), power to the instrument buses would have been maintained, since the alternate source was only degraded momentarily, and was never completely lost.

- a. Revising the FSAR to clarify the purpose of the maintenance bypass switch, and that its position will be controlled by plant procedures.
- b. Ensuring that this commitment is properly controlled through Operations procedures. This action will also ensure that the basis for any proposed future changes to this commitment are properly documented.
- c. Training of appropriate personnel on the new procedural requirements and their basis.
