U.S. NUCLEAR REGULATORY COMMISSION  
REGION I

Report Nos.            96-06  
                          96-06

Facility Name:         SUSQUEHANNA STEAM ELECTRIC STATION

Inspection Period:     April 30, 1996 through June 10, 1996

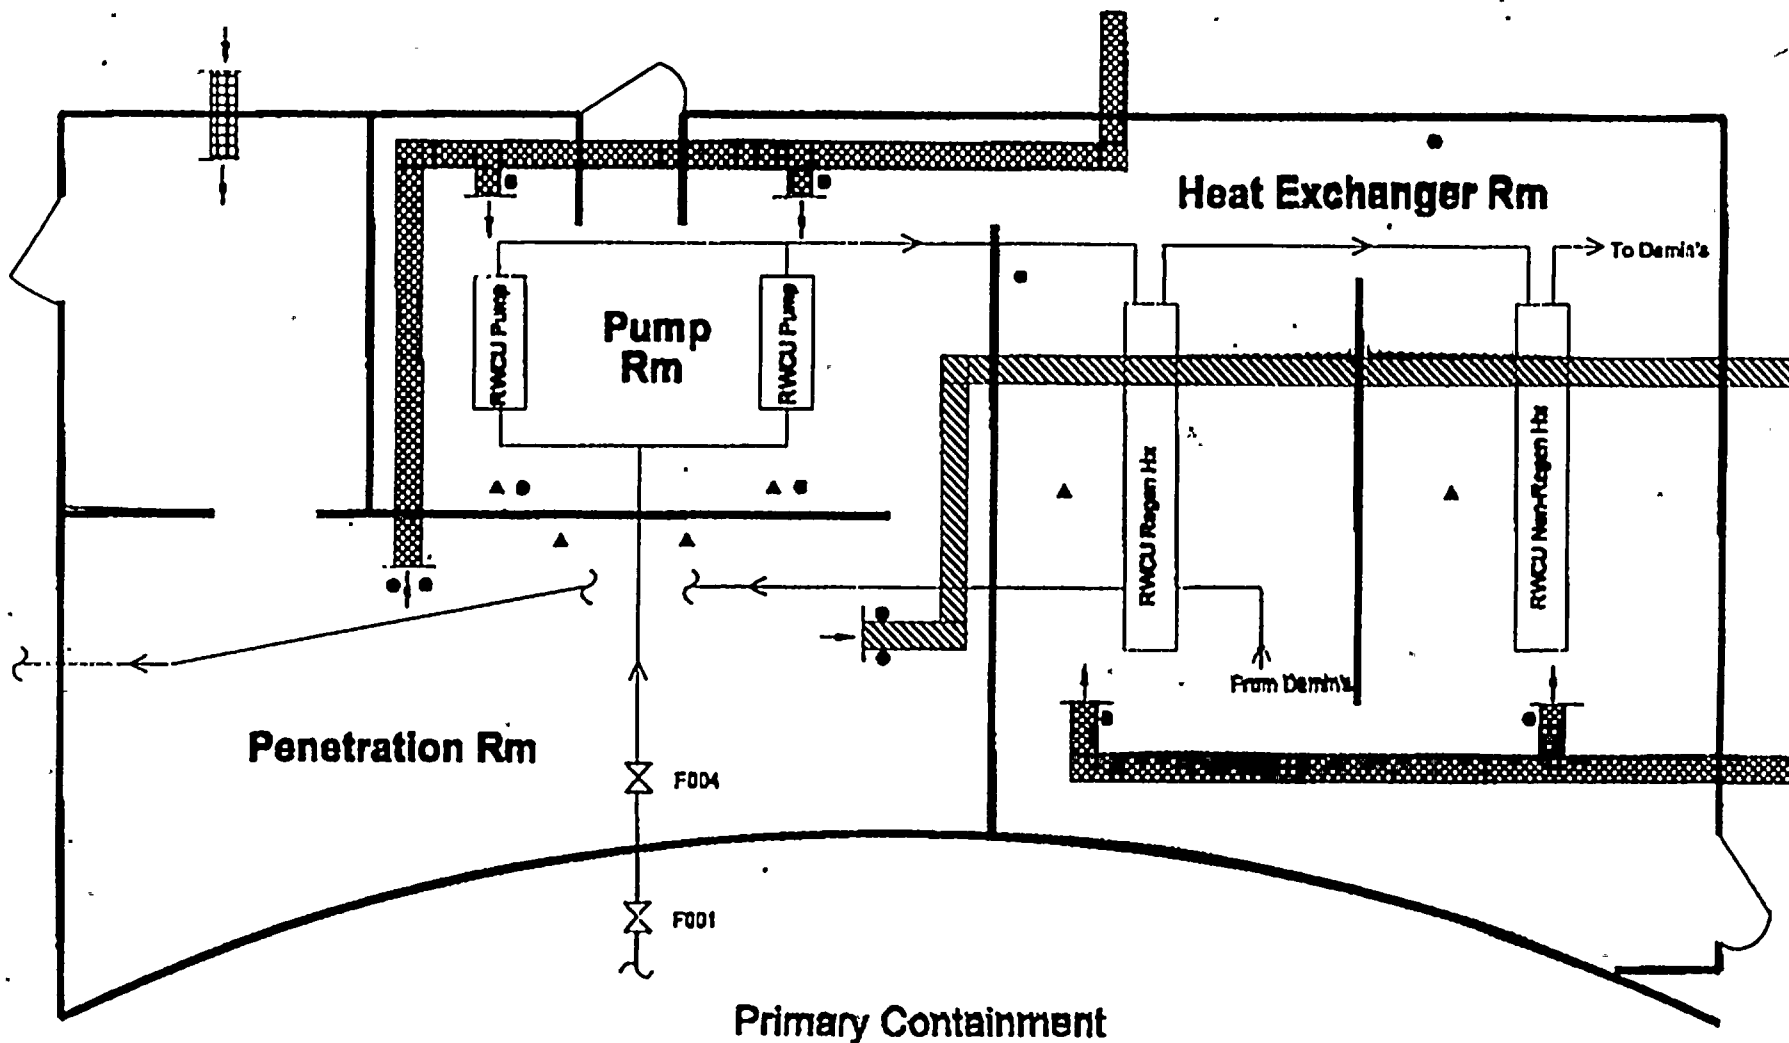
# RWCU Area Steam Leak Detection Room Temperature Instrumentation

- Specified Functions:
  - » Avoid Spurious Isolations
  - » Isolate Pipe Leak Before Break
- EDR Contains Reference to Detection of 30 - 60 Gpm (U1) and 200 Gpm (U2) Leaks
- NRC SER Contains Reference to Detection of 25 Gpm Leak

- Calculational Basis For Calculated Values Understood to Be Very Conservative
- 25 Gpm Not Considered an Absolute Indication of Operability
- Documentation Weak
- Tie to Critical Crack Size Missed
- Unit 2 Channels Were Inoperable Between April 1993 and June 1995

- *Operability:*
  - NRC Staff Findings:
    - » “..the leakage detection system initiate system isolation when the area temperature conditions exceed the threshold for spurious isolation...”
    - » “The isolation leakage rate under the most conservative initial conditions should normally be less than 25 gpm.”
