SUBJECT: SUMMARY OF CONFERENCE CALL WITH PALISADES NUCLEAR PLANT
REGARDING THE SPRING 2017 STEAM GENERATOR INSPECTIONS (CAC
NO. MF9396)

CONFERENCE CALL SUMMARY
REGARDING PALISADES NUCLEAR PLANT
SPRING 2017 STEAM GENERATOR INSPECTIONS
DOCKET NO. 50-255
CAC NO. MF9396

**STEAM GENERATOR TUBE INSPECTION DISCUSSION DURING
PALISADES 2017 (RF25) OUTAGE (Preliminary Information)**

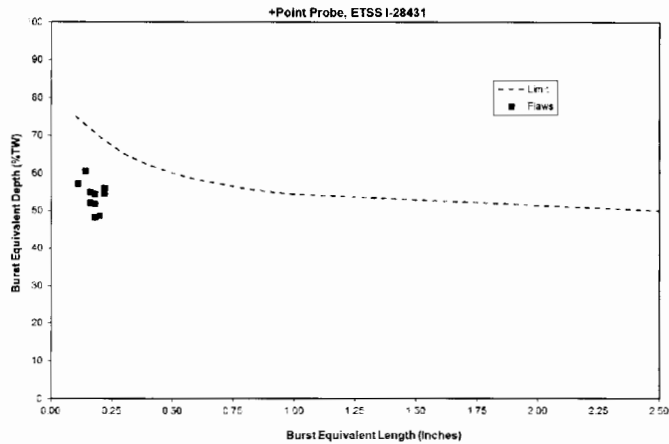
SG A

- Axial ODSCC at TSH

- Axial PWSCC within tubesheet. Indication parameters:
 - Max voltage: 1.67 V
 - Length: 0.45"
 - Max depth: 100 %TW
 - SIPC and AILPC criteria satisfied
- Circ ODSCC at TSH. Max indication parameters (not the same indication):
 - Voltage: 0.97 V
 - Circumferential extent: 0.47" (72 degrees)
 - Depth: 79 %TW
 - PDA: 9.7
 - SIPC and AILPC criteria satisfied
- Tube support wear:
 - Max depth: 46 %TW
 - SIPC and AILPC criteria satisfied
- No foreign object wear flaws

All stress corrosion cracking (SCC) indications will be plugged. Any circumferential SCC indications near the top-of-tubesheet (TTS) will be stabilized and plugged. C* depth is applicable to the HL and CL

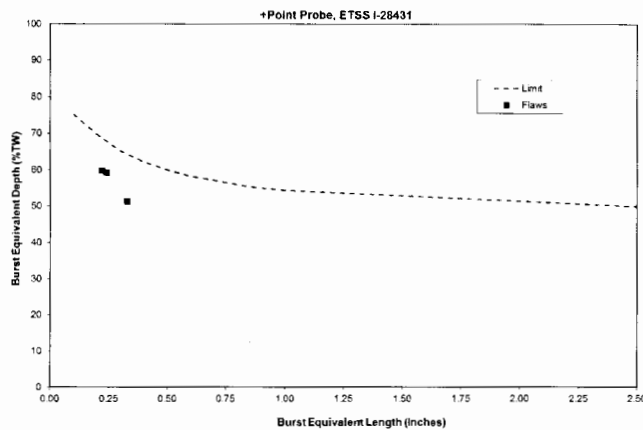
SG B

- Axial ODSCC at TSH

- Axial ODSCC in the Free Span
 - Max Voltage: 1.18
 - Length: 0.65"
 - Max depth 70.5%
 - Exceeded Screening for Burst
- No foreign object wear flaws

There is one indication in SGB (Tube 62-101) that has an indication between the 04hot and 03hot support plates. It has a total length of ~ 12 inches with 9 indications. The second indication is the largest and exceeded the screening criteria for burst. It has been scheduled for in-situ testing. The details of the flaw are identified above for SGB.

Based on the available data to date, there is one tube that will be tested in SGB.

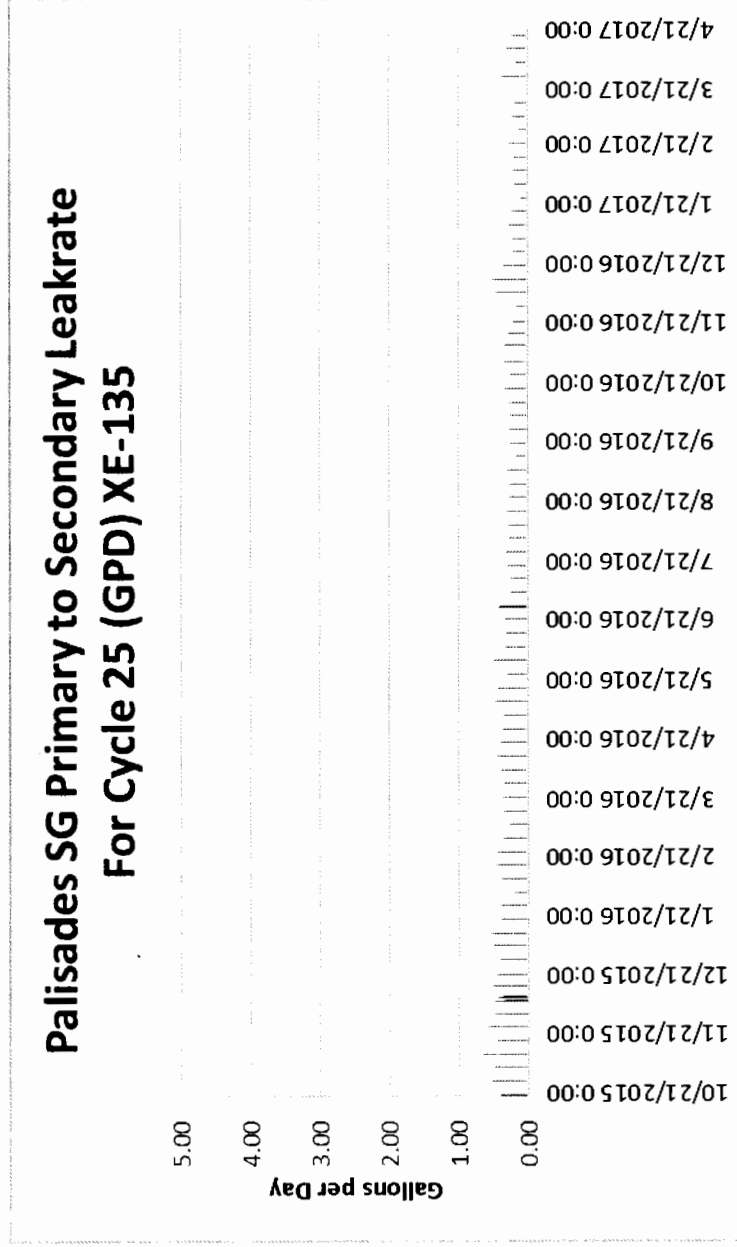
Refer to attached Primary to Secondary Leak Rate for Operational Cycle 25 Primary to Secondary Leak Rate graph. Leakage has been minimal all cycle.

The following is the primary to secondary leak trend for the last fuel cycle

Note: Units in gallons per day

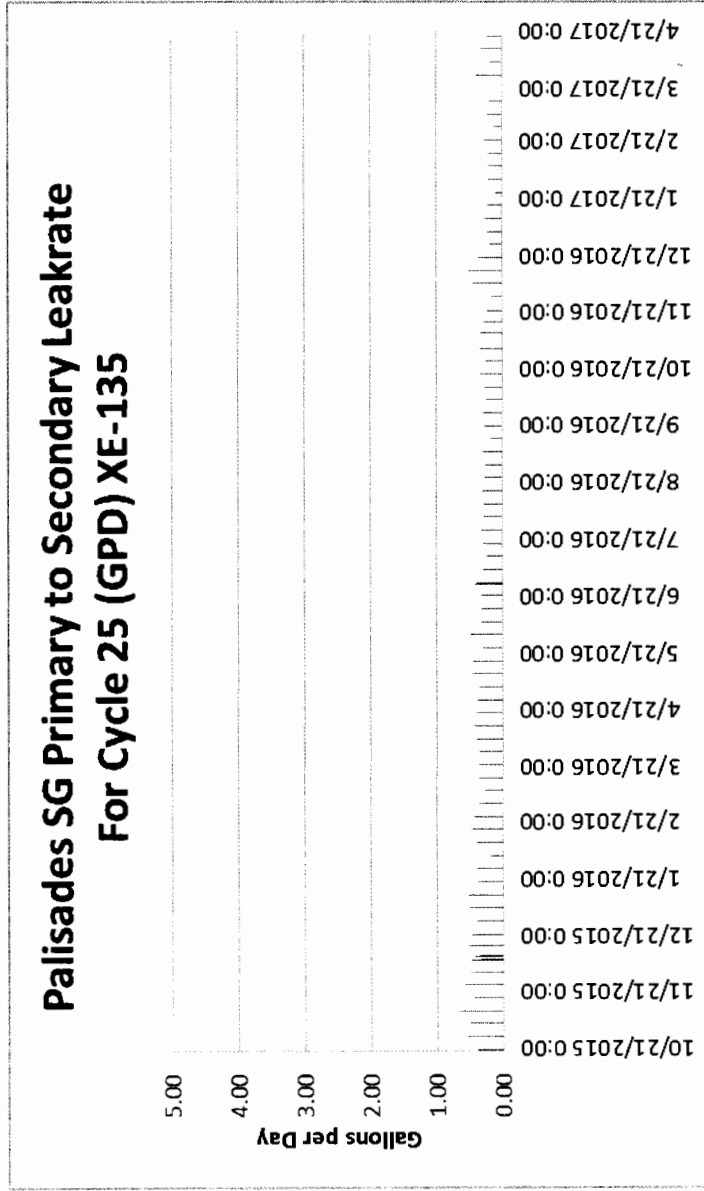
The following is the primary to secondary leak trend for the last fuel cycle

Note: Units in gallons per day
