ACCESSION NBR: 9412090007 DOC.DATE: 94/12/02 NOTARIZED: NO DOCKET #
 FACIL: 50-387 Susquehanna Steam Electric Station, Unit 1, Pennsylv 05000387
 AUTH.NAME AUTHOR AFFILIATION
 BYRAM, R.G. Pennsylvania Power & Light Co.
 RECIP.NAME RECIPIENT AFFILIATION
 Document Control Branch (Document Control Desk)

SUBJECT: Informs NRC of util continuing investigations of
 Feedwater Sys erosion/corrosion & to advise NRC of future
 actions re issue.

SUSQUEHANNA STEAM ELECTRIC STATION
FEEDWATER SYSTEM EROSION/CORROSION REPAIR
PLA-4226 **FILE R41-2**

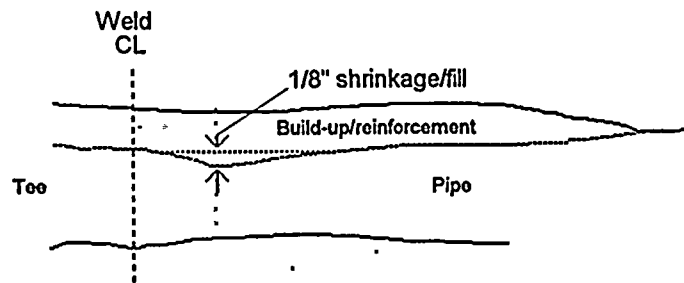
Figure 1
Connection X-175 Cross-section

External surface profile measurements and visual inspections performed prior to application of the reinforcement identified an approximate 1/8" (maximum depth) depression in the area of corrosion similar to that which would occur during outside diameter (O.D.) shrinkage resulting from localized weld repair. (Refer to Figure 1.) Also, construction documentation indicates that the original field weld had been cut out completely, re-fit and re-welded, apparently to achieve proper strain free alignment at the reactor pressure vessel nozzle connection on the upper end of this portion of pipe. During the course of fit-up for the new (second) weld, any permanent O.D. pipe shrinkage resulting from weld-out or repair of the original joint would require compensatory inside diameter (I.D.) grinding in order to meet Code fit-up requirements. This would result in localized reduction of pipe wall at the area of concern. Based on the actual O.D. surface profiles taken before the weld build-up was applied, this would have reduced the available wall thickness by about 1/8" prior to weld-out of the joint for the second time. This would account for the observed difference in thickness between the area of concern and the remainder of the joint.

The initial estimate of 0.150" per cycle erosion between the U15RIO and U16RIO was based on a single data point taken during U15RIO. If this initial data was taken on the shoulder of the weld crown (all subsequent data was taken at the toe of the crown), calculations would indicate a discrepant erosion rate of about 0.150" for the sixth fuel-cycle vs. the .020" - .030" presently observed.

Based on the above, we have concluded that the reduction in pipe wall observed at X-175 (DCA-110-1, FW 15) actually occurred during original construction. We consider this construction discrepancy rectified by taking credit for that portion of the weld overlay (1/8" maximum in the area of concern) which restored the wall lost due to I.D. grinding during fit-up of the final installation weld. Note that when considered as a repair for an original construction deficiency, any provisions of ASME Section XI inferring requirements for removal of service induced defects no longer apply.
