LICENSEE EVENT REPORT (LER)

FACILITY NAME (1) Susquehanna Steam Electric Station - Unit 1		DOCKET NUMBER (2) 05000387	PAGE (3) 1 OF 7
--	--	-------------------------------	--------------------

TITLE (4)
Loss Of Both Loops Of Residual Heat Removal - Low Pressure Coolant Injection

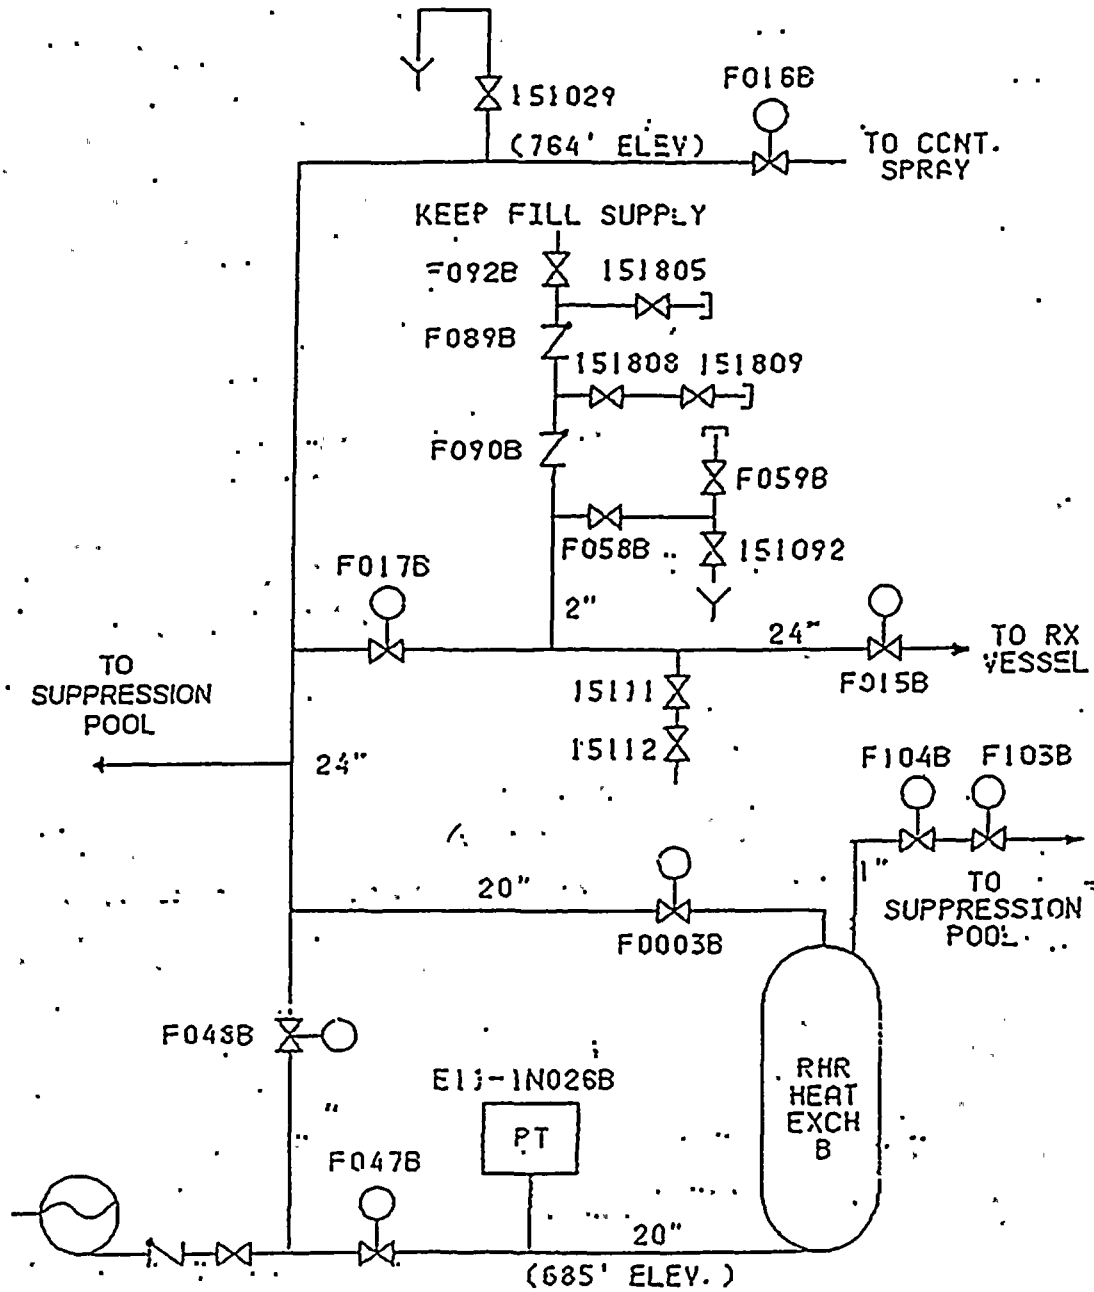
FIGURE 1

A schematic diagram of the applicable portion of the Unit 1 'B' Loop of RHR is provided as the last page of this LER. ECCS systems at Susquehanna SES are continuously supplied with condensate water at approximately 150 psig by a Condensate Transfer system. This "keep-fill" system assures that the ECCS discharge lines are full of water thereby ensuring that the ECCS will perform properly by injecting its full capacity into the Reactor Coolant system upon demand. This system also prevents water hammer following an ECCS initiation signal. Due to this design, the RHR discharge piping is pressurized to approximately 150 psig. For the Unit 1 B Loop of RHR this pressure is measured at a pressure instrument located at the RHR heat exchanger. (PT E11-1N026B on the diagram.) Pressure is continuously displayed in the control room.

The automatic RHR LPCI injection valve (F015) is normally closed. The RHR LPCI throttle valve (F017) is normally open. The Condensate Transfer system taps into the RHR system between the normally closed F015 valve and the normally open F017 valve. The piping system that contains the F015 valve and F017 valve is the injection flow path for RHR LPCI and the return path for RHR Shutdown Cooling.
