Part 21 (PAR)

PART 21 REPORT - DEFECTIVE MOTOR OPERATED POTENTIOMETER

Report No. 10CFR21-0117
Rev. 0: 06/09/17

COMPONENT: Motor operated potentiometer without pre-position feature
P/Ns: 72-07900-100-ESI
2-04E-184-103-ESI
2-00G-009-002-ESI

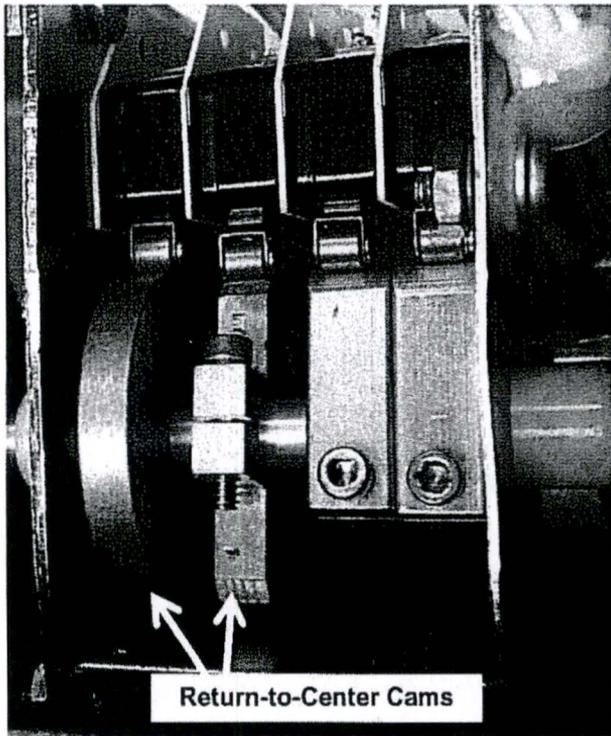
Photo 1: Desired Return-to-Center Cam Arrangement

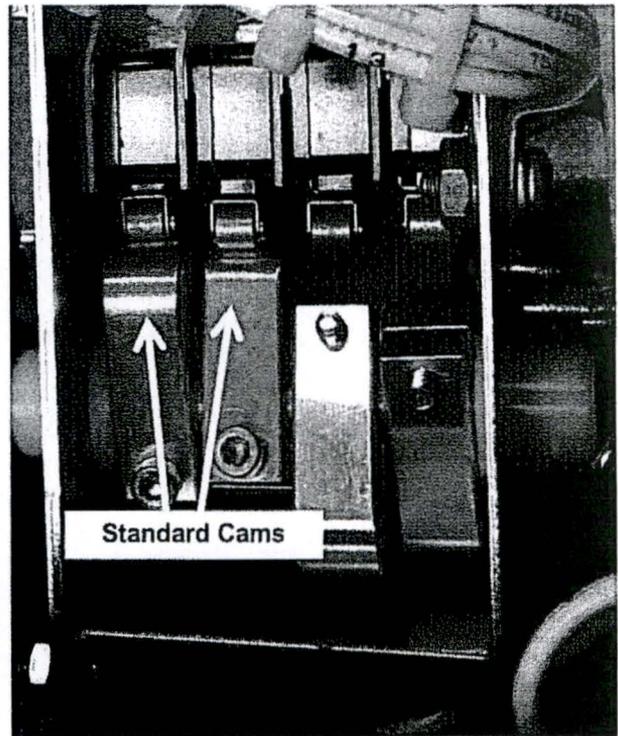
The Basler MOP selected by ESI for the assembly was model MOC2103. A review of Basler model MOC2103 indicates that it is not a return-to-center style device and instead contains a standard cam arrangement. Photos on the following page depict the differences between the two cam arrangement styles. ESI inadvertently selected the incorrect model for this application. Reviewing the qualification testing performed by ESI revealed that ESI's testing duplicated the original Portec test procedure (whereby one cam is set to close above setpoint and one cam is set to close below setpoint). However, the testing was shown to be inadequate to fully ensure the return-to-center functionality. Though the cams were properly set above and below setpoint, a further verification that the unit would return to center, even if sufficiently away from setpoint, was not performed. For installations that rely on the pre-position function, it is possible that the MOPs supplied by ESI would not return the potentiometer to setpoint. Since the MOP is used to set output voltage of the emergency diesel generator, the consequences of this issue are that the EDG may not maintain voltage within its required range to support its safety-related loads.

ESI selected the incorrect MOP to be used for this assembly. The original MOP used was an Portec/NEI P/N 72-07900-100 which became obsolete in the 1990s. ESI offered a replacement assembly (using the "-ESI" suffix) that included a Basler brand MOP, modified by replacing the factory supplied potentiometer to replicate the original Portec design. The original Portec MOP had the return-to-center feature and Basler offers some models with return-to-center and some without. ESI inadvertently selected the model without return-to-center.

As a secondary cause, ESI's functional testing did not adequately verify the MOPs ability to return to center. The test procedure has steps to set the cams and limit switches as would be performed for the return-to-center style; however, the testing did not ensure that the cams would return the potentiometer back to the center, regardless of starting position.

Photo 2: As-Supplied Standard Cam Arrangement

- Customers that have installed the motor operated potentiometer must evaluate the impact on their specific system. It may be acceptable to continue to use the MOP if other provisions are in place to ensure the EDG voltage is within an acceptable range for safety-related operation. Credit may also be taken for site acceptance testing following installation of the MOP. If the MOP is deemed acceptable for the application, no further action is necessary.

- For those customers that have determined the MOP is unacceptable for their application and/or would simply rather ensure they have the correct MOP, it may be returned to ESI for warranty replacement. Once a warranty order and Return Goods Authorization (RGA) is issued, supply of safety-related replacement MOP(s) is expected to be complete within 90 days.

- To prevent recurrence of this issue, ESI is implementing a revision to the procurement process for this assembly to update the part number of the MOP utilized. In addition, the dedication inspection and testing activities are being revised to ensure testing properly validates the return-to-center feature. This action is currently underway and will be completed prior to any future shipments.

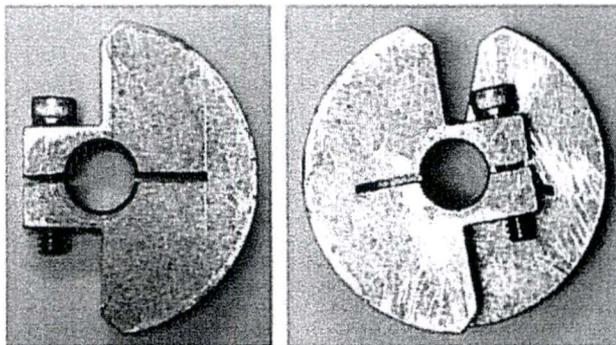
Photos 3&4: Return-to-Center Cam Profile & Arrangement

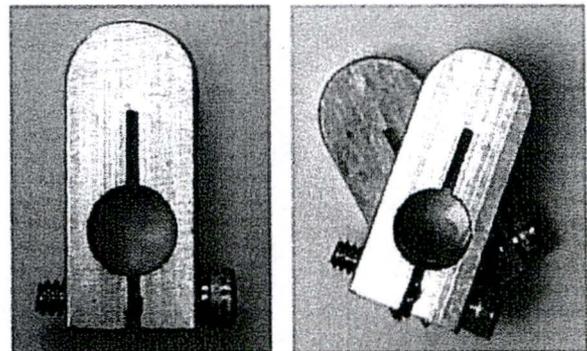
Photo 5&6: Standard Cam Profile & Arrangement
