STEAM GENERATOR TUBE INSPECTION DISCUSSION DURING PALISADES 2017 (1R25) OUTAGE (Preliminary Information)

Currently Palisades is ~ 93% through the base scope eddy current inspection and starting the special interest inspection scope as of 5/5/2017 at ~ 0430 hours

Steam Generator Degradation Assessment for Palisades 1R25 Inspection, Spring 2017

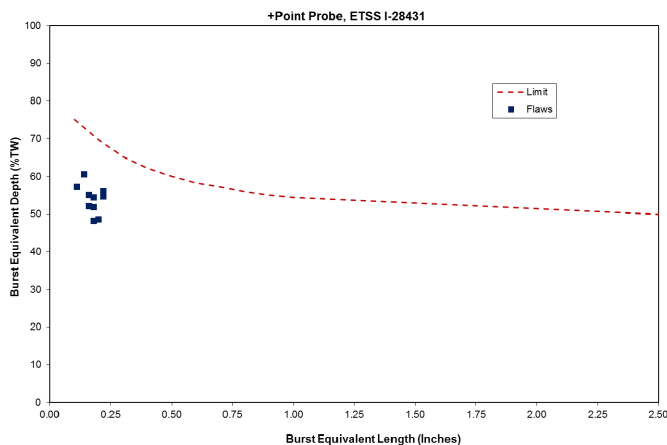
SG A

- Axial ODSCC at TSH

All stress corrosion cracking (SCC) indications will be plugged. Any circumferential SCC indications near the top-of-tubesheet (TTS) will be stabilized and plugged. C* depth is applicable to the HL and CL

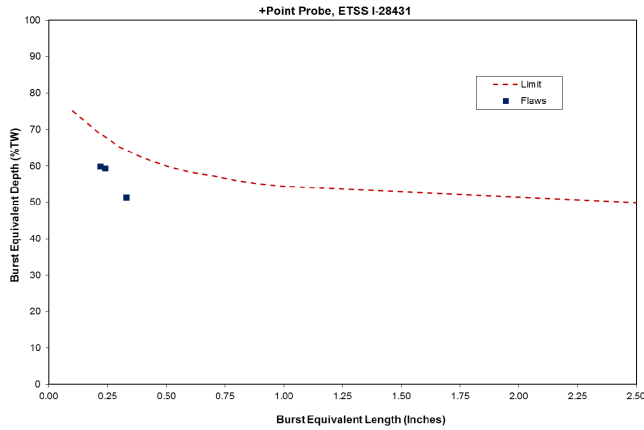
SG B

- Axial ODSCC at TSH

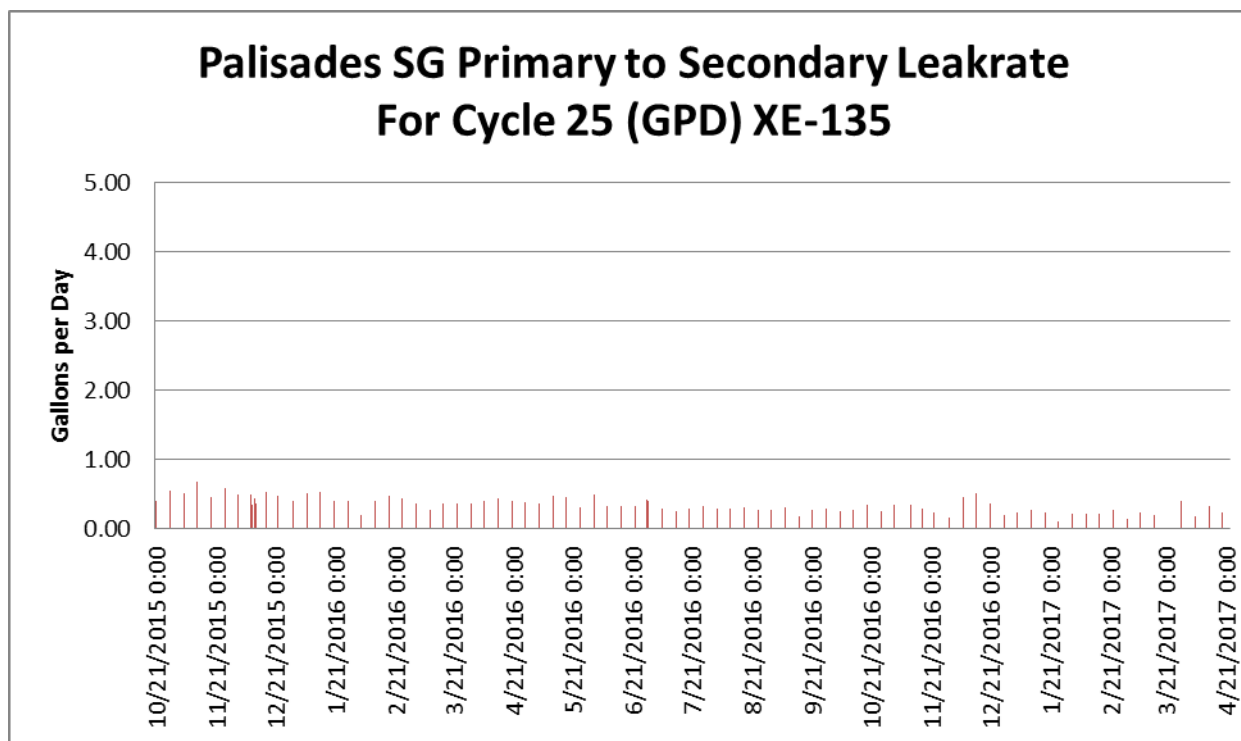
Refer to attached Primary to Secondary Leak Rate for Operational Cycle 25 Primary to Secondary Leak Rate graph. Leakage has been minimal all cycle.

The following is the primary to secondary leak trend for the last fuel cycle
Note: Units in gallons per day
