Subject: 10CFR21 Reporting of Defects and Non-Compliance -  
Engine Systems, Inc. Report No. 10CFR21-0117, Rev. 0

Motor Operated Potentiometer Without Pre-Position Feature  
PNs: 72-07900-100-ESI, 2-04E-184-103-ESI, 2-00G-009-002-ESI

**Report No. 10CFR21-0117**

**10CFR21 REPORTING OF DEFECTS  
AND NON-COMPLIANCE**

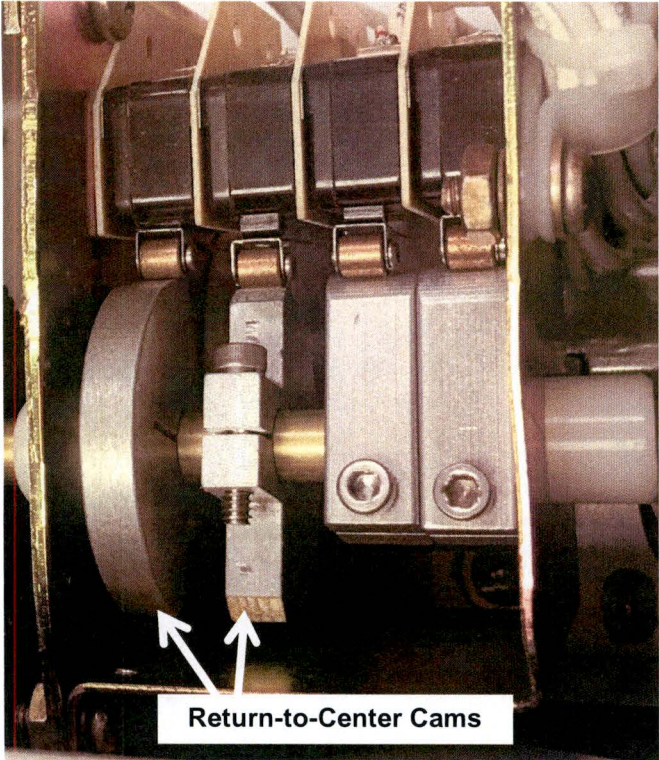
The Basler MOP selected by ESI for the assembly was model MOC2103. A review of Basler model MOC2103 indicates that it is not a return-to-center style device and instead contains a standard cam arrangement. Photos on the following page depict the differences between the two cam arrangement styles. ESI inadvertently selected the incorrect model for this application. Reviewing the qualification testing performed by ESI revealed that ESI's testing duplicated the original Portec test procedure (whereby one cam is set to close above setpoint and one cam is set to close below setpoint). However, the testing was shown to be inadequate to fully ensure the return-to-center functionality. Though the cams were properly set above and below setpoint, a further verification that the unit would return to center, even if sufficiently away from setpoint, was not performed. For installations that rely on the pre-position function, it is possible that the MOPs supplied by ESI would not return the potentiometer to setpoint. Since the MOP is used to set output voltage of the emergency diesel generator, the consequences of this issue are that the EDG may not maintain voltage within its required range to support its safety-related loads.

Photo 1: Desired Return-to-Center Cam Arrangement

- To prevent recurrence of this issue, ESI is implementing a revision to the procurement process for this assembly to update the part number of the MOP utilized. In addition, the dedication inspection and testing activities are being revised to ensure testing properly validates the return-to-center feature. This action is currently underway and will be completed prior to any future shipments.

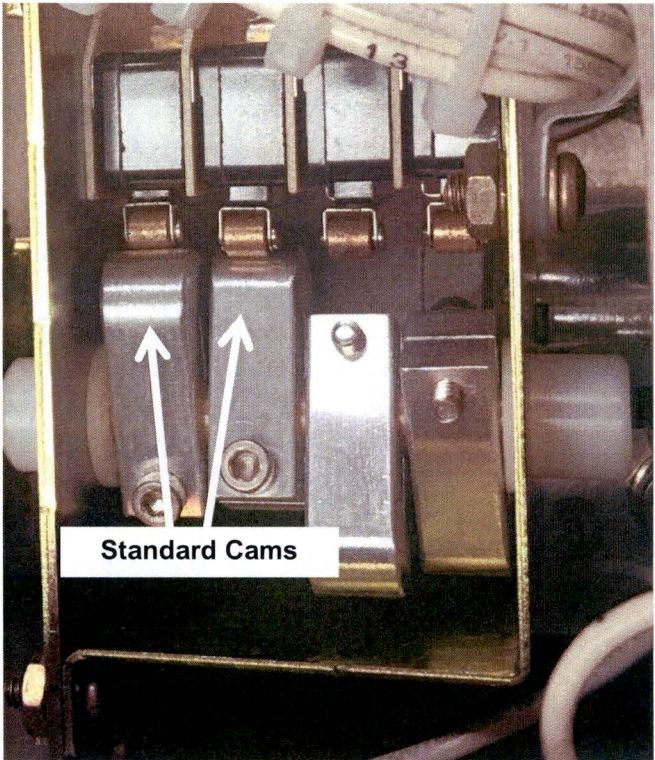
ESI selected the incorrect MOP to be used for this assembly. The original MOP used was an Portec/NEI P/N 72-07900-100 which became obsolete in the 1990s. ESI offered a replacement assembly (using the "-ESI" suffix) that included a Basler brand MOP, modified by replacing the factory supplied potentiometer to replicate the original Portec design. The original Portec MOP had the return-to-center feature and Basler offers some models with return-to-center and some without. ESI inadvertently selected the model without return-to-center.

As a secondary cause, ESI's functional testing did not adequately verify the MOPs ability to return to center. The test procedure has steps to set the cams and limit switches as would be performed for the return-to-center style; however, the testing did not ensure that the cams would return the potentiometer back to the center, regardless of starting position.

Photo 2: As-Supplied Standard Cam Arrangement

- Customers that have installed the motor operated potentiometer must evaluate the impact on their specific system. It may be acceptable to continue to use the MOP if other provisions are in place to ensure the EDG voltage is within an acceptable range for safety-related operation. Credit may also be taken for site acceptance testing following installation of the MOP. If the MOP is deemed acceptable for the application, no further action is necessary.

- For those customers that have determined the MOP is unacceptable for their application and/or would simply rather ensure they have the correct MOP, it may be returned to ESI for warranty replacement. Once a warranty order and Return Goods Authorization (RGA) is issued, supply of safety-related replacement MOP(s) is expected to be complete within 90 days.

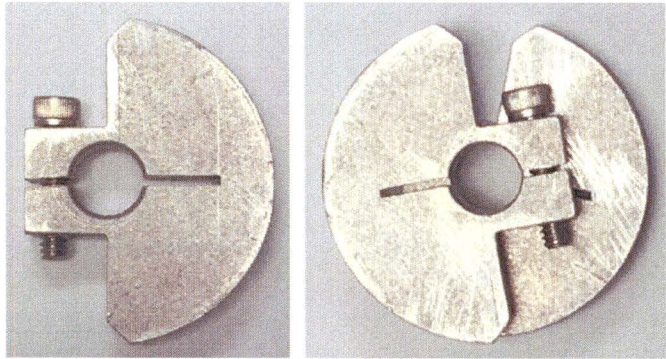
Photos 3&4: Return-to-Center Cam Profile & Arrangement

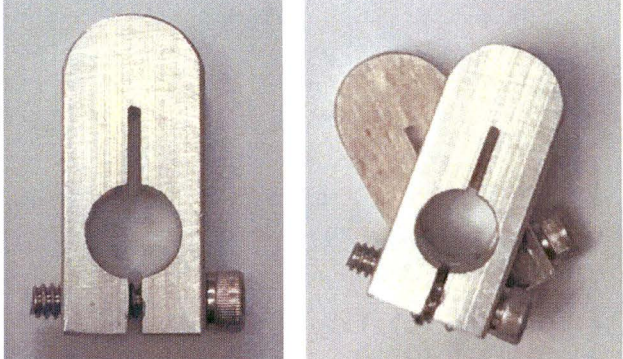
Photo 5&6: Standard Cam Profile & Arrangement
