Commonwealth Edison

December 5, 1978

Subject: Dresden Station Unit 2
Feedwater Nozzle/Sparger and
Control Rod Drive Return Line
Nozzle Inspection Programs
NRC Docket No. 50-237

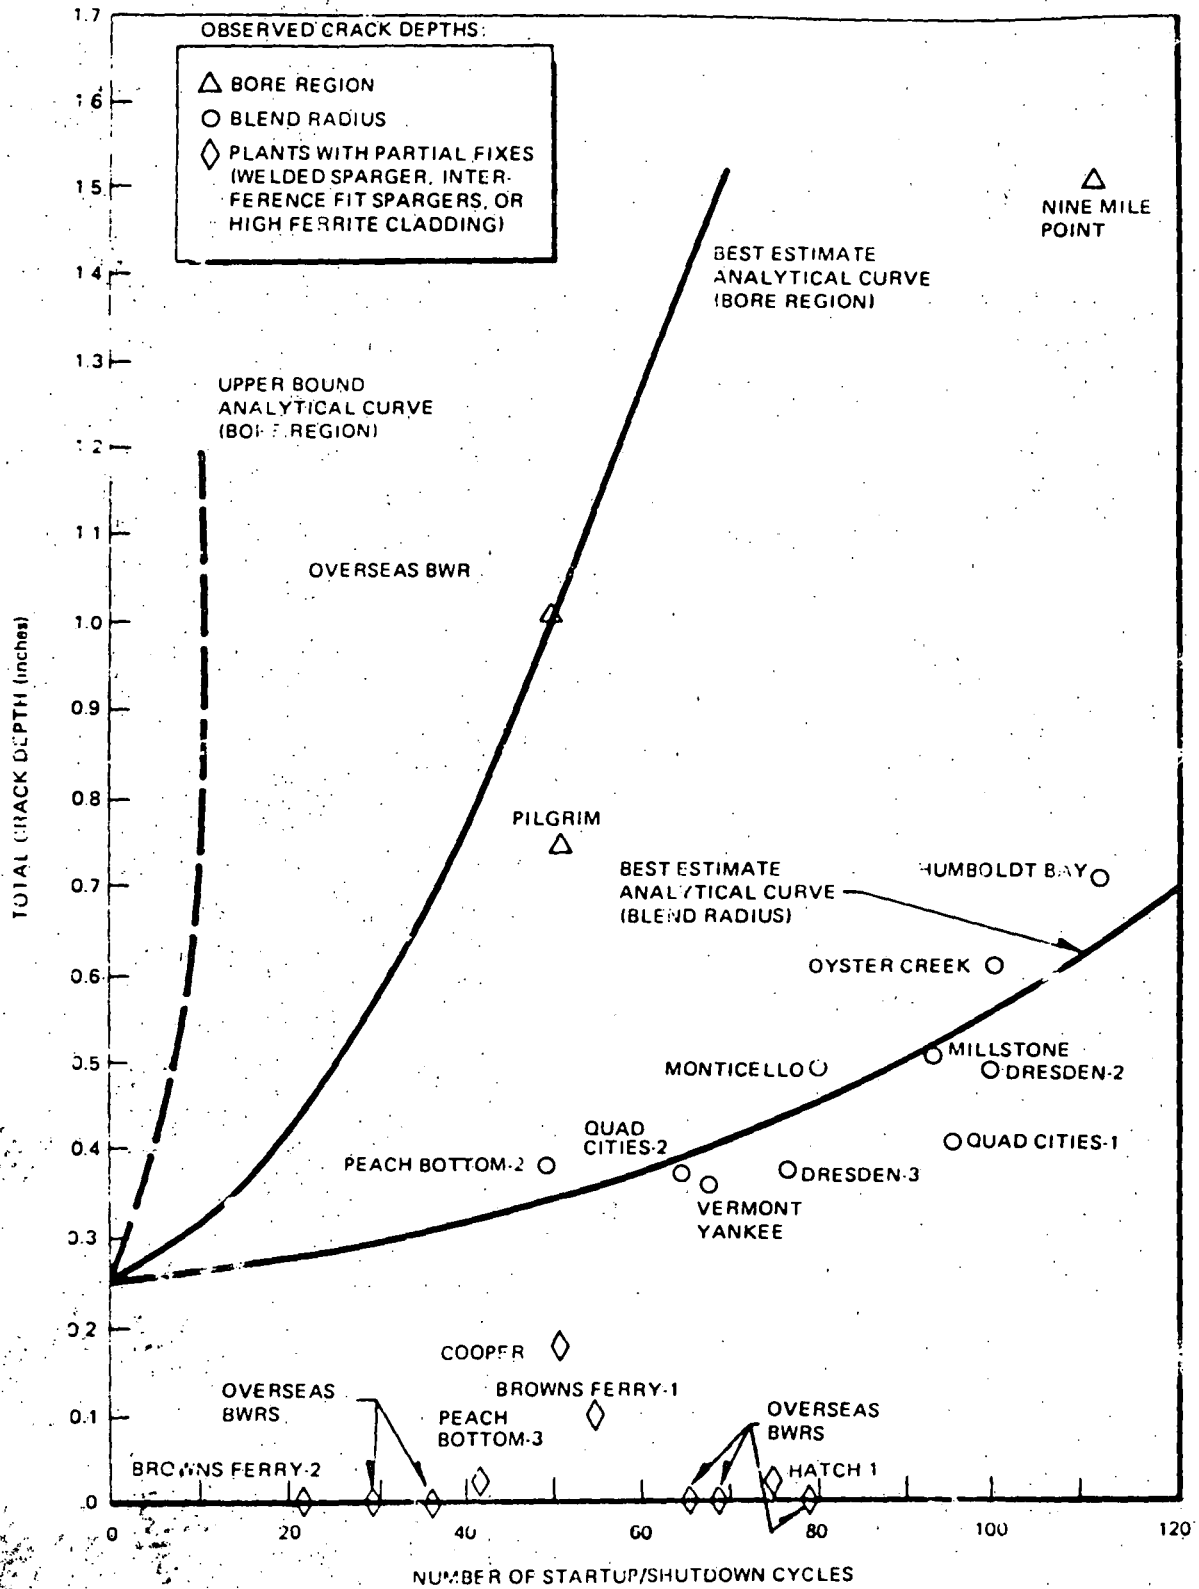
Experience accumulated with the new interference fit sparger, however, has pointed out the conservatism even in the CECO. crack growth curves. Figure 1 contains data accumulated by General Electric on crack depth for up to 75 SU/SD cycles with the interference sparger in use. A curve established using the G.E. generic SU/SD cycle is compared to this actual interference fit data. It can be seen that the worst case of the 10 units with the interference fit sparger has a maximum crack depth of 0.2", with only one other unit having a maximum crack depth of 0.1". The remaining eight units, however, had maximum crack depths that were much smaller or nonexistent. The above data points out the effectiveness of the interference fit sparger in eliminating the leakage flow which is the mechanism initiating the cracking in the feedwater nozzles.

6. Feedwater nozzle inspection data from GE and CECO. has proven the effectiveness of the interference fit sparger for providing an end to the effects of the thermal cycling on the feedwater nozzles in that after 75 SU/SD cycles, the deepest crack found to date has been 0.2" (approximately 25 percent of the critical flaw size).
