U.S. NUCLEAR REGULATORY COMMISSION  
OFFICE OF INSPECTION AND ENFORCEMENT

Report No. 50-237/79-25; 50-249/79-23

Facility Name: Dresden Nuclear Power Station, Units 2 and 3

Areas Inspected: Review of cooling lake construction; observation of soil borings on north dike; review of monthly surveillance reports on dike structure; and observation of environmental impact of local private property from apparent leakage of cooling lake. The inspection involved a total of 46 onsite inspector-hours by two NRC inspectors.

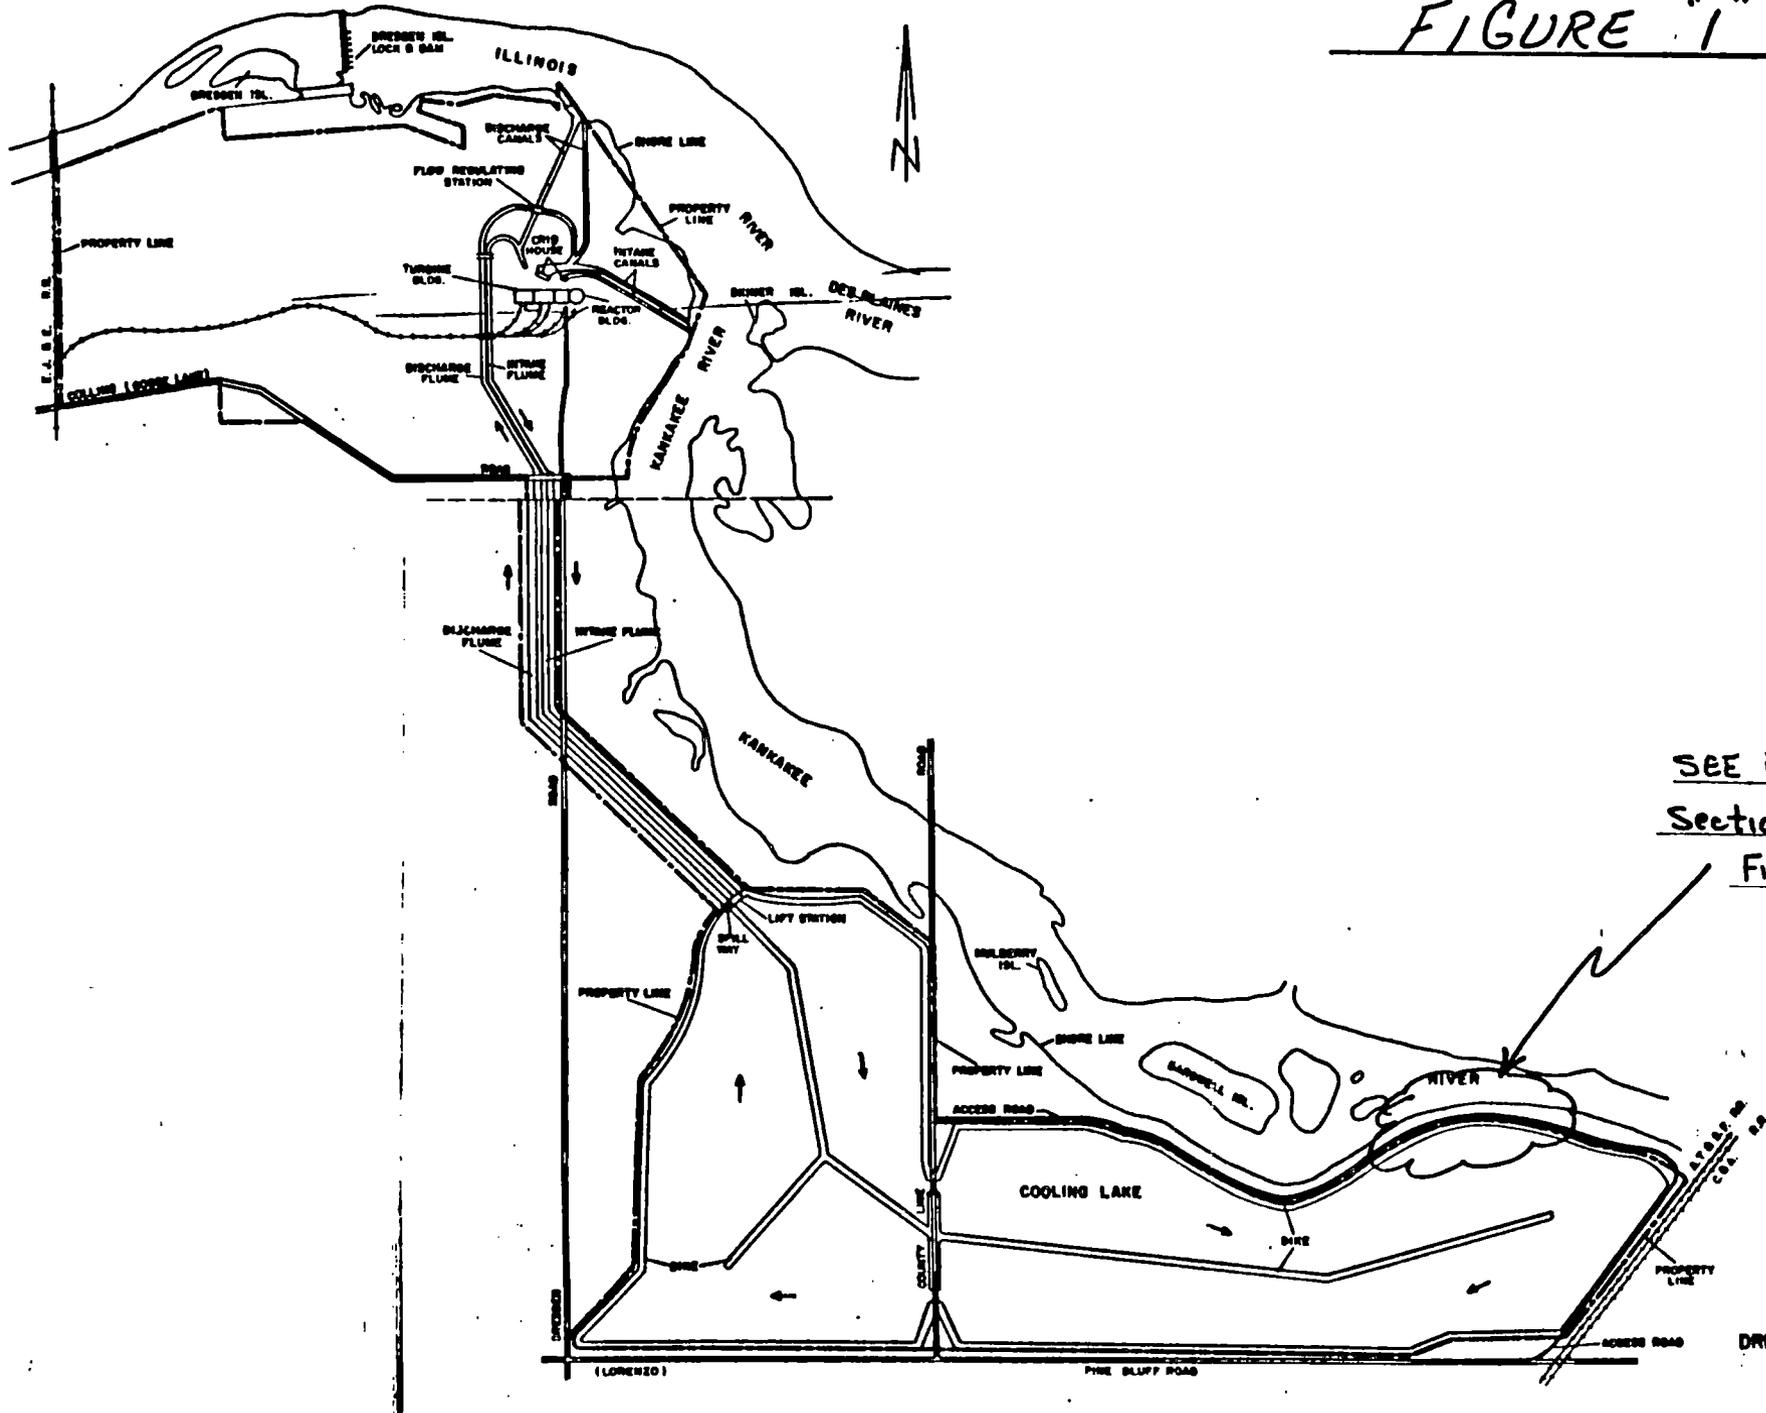
FIGURE "1"

SEE BORING LOCATION  
Section thru Dike  
Figure 1A & 1B

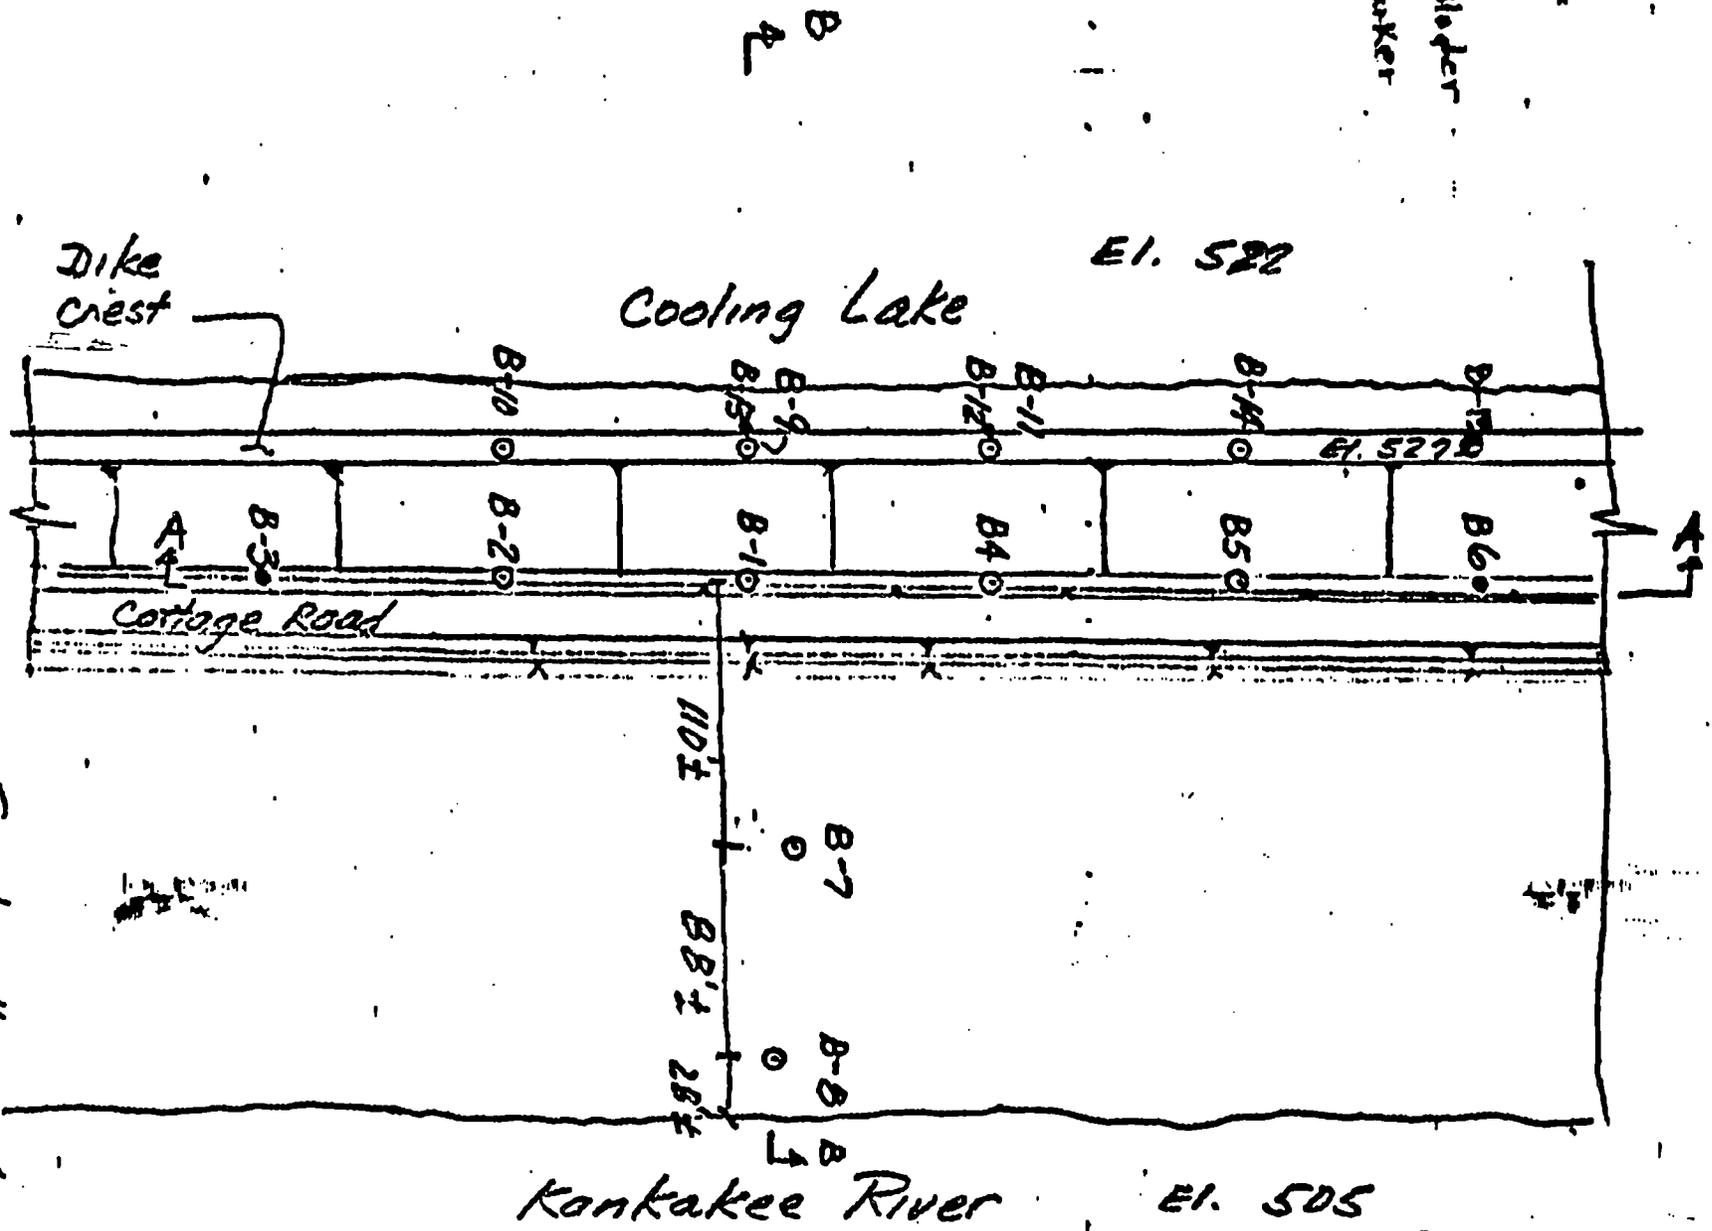
FIGURE 1A

Fig. I. Boring Location  
Scale 1"=100'

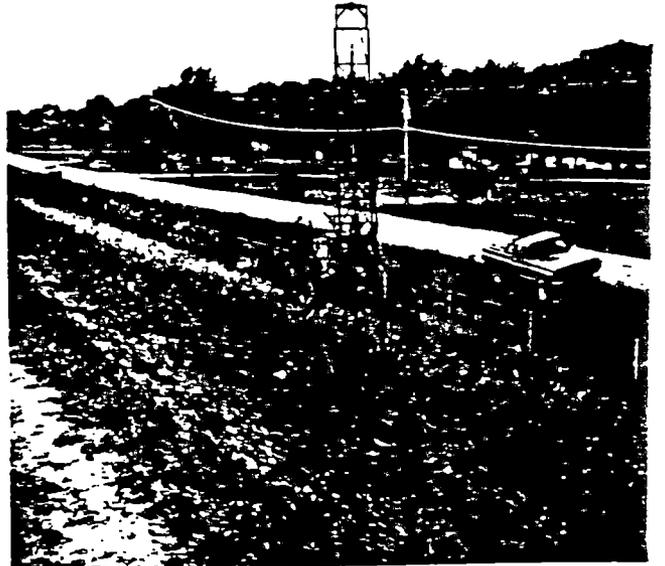
4

1. Dresden Station Unit 1
2. Cooling lake looking east along North Dike
3. Cooling lake looking west along North Dike
4. North Dike - boring on toe of Dike
5. Seepage on Kankakee River bank
6. Seepage on Kankakee River bank
7. Seepage on Kankakee River bank
8. Seepage on Kankakee River bank
9. Seepage on Kankakee River bank
10. Measurement of Seepage Along River bank (Harza Engineers)
11. Measurement of seepage along river bank (Harza Engineers)
12. Kankakee River bank
13. Boring at toe of North Dike
14. Boring at toe of North Dike
15. Soil boring #1 granular material above shale
16. Soil boring #1 granular material and blue shale
17. Soil samples from boring #4
18. Soil samples from boring #5

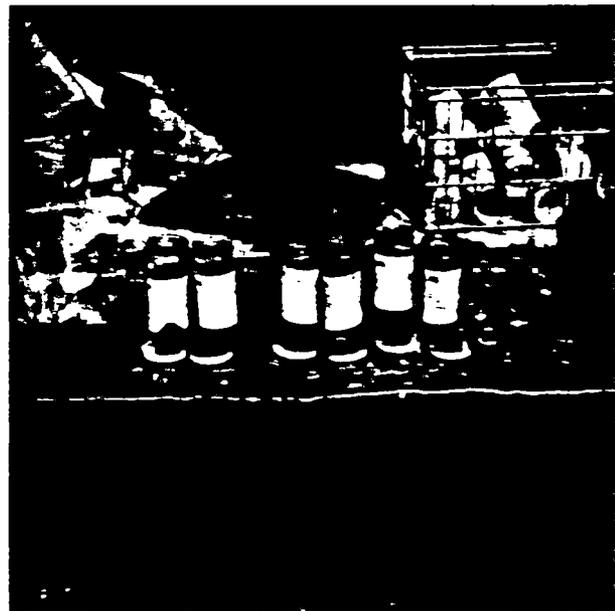
BORING #5

<u>Sample</u>	<u>Depth (Ft.)</u>	<u>Blows per Ft.</u>	<u>Material Description</u>
1	0-1.5	42	Brown clay
2	2.5-4	15	Sandy clay
3	5-6.5	8	Sand and gravel
4	7.5-9	11	Sand and gravel
5	10-11.5	50 for 6"	-
