Licensee Event Report #88-018-1, Docket #050237 is being submitted as required by Technical Specification 6.6, NUREG 1022 and 10 CFR 50.73(a)(2)(i)(B). This supplemental report is submitted to provide the final results of Unit 2 1988 refuel outage primary containment local leak rate testing.

Dresden Nuclear Power Station, Unit 2

Title (4) Leak Rate Limits Exceeded in Drywell Head Seal and MSIV 2-203-1D Tests

Due to Misalignment and Seat Wear

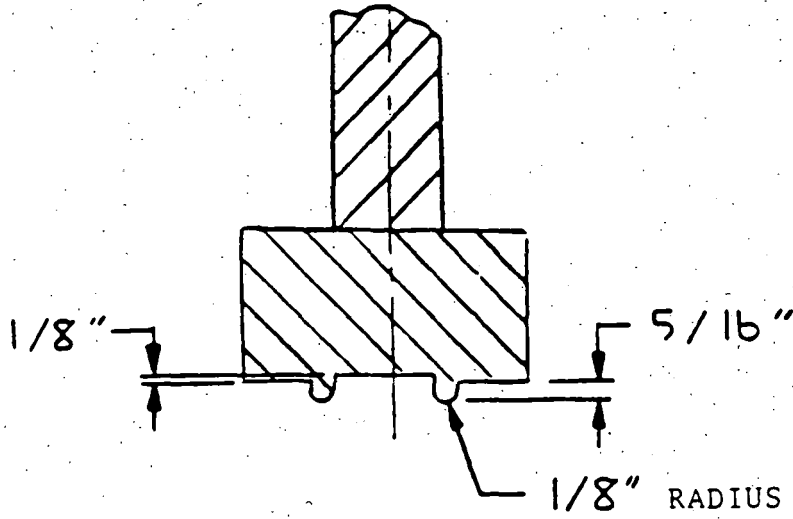
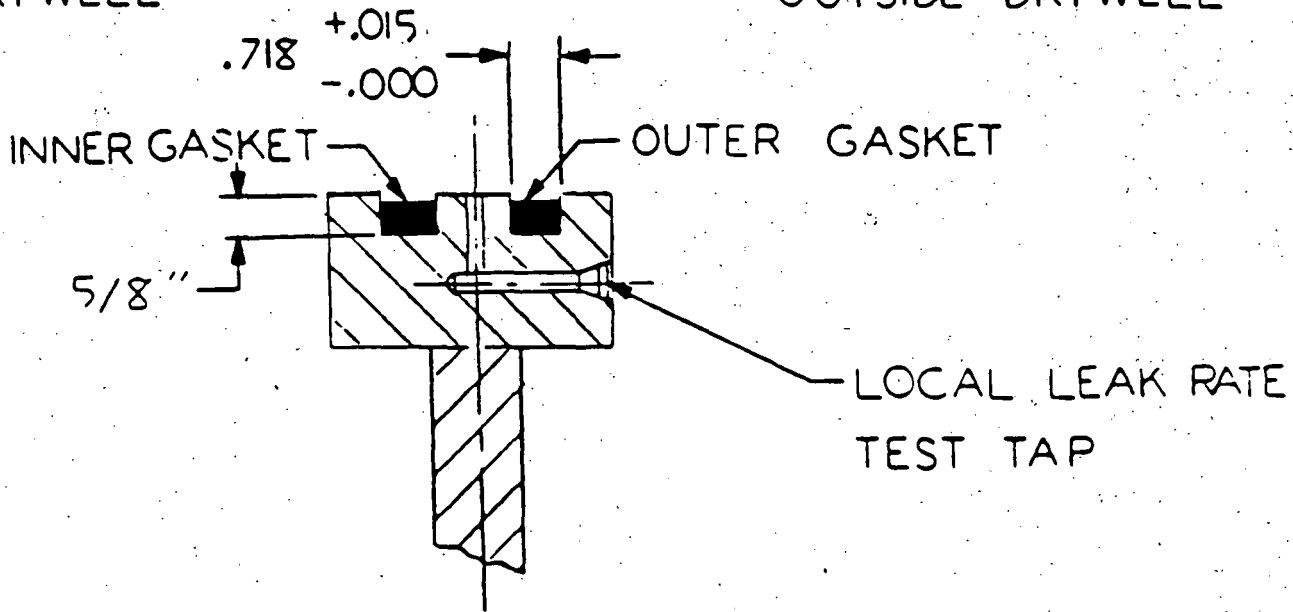
Figure 1

The arrangement of the drywell head, gaskets, and drywell head flange are shown in Figure 1. Rounded "knife edges" on the drywell head are designed to seat on the inner and outer gaskets on the drywell head flange. The endless gaskets used are 3/4" wide by 1/2" thick.

Improper seating of the outer gasket is believed to have resulted from the intermediate cause of that section of the outer gasket not being fully inserted in the drywell head flange groove prior to installation of the drywell head. As shown in Figure 1, the knife edges are rounded with a 1/8" radius. Therefore any section of the gasket extending more than approximately 1/8" above the drywell head flange would have been caught by the knife edge when the southeast section of the drywell head was jacked inward to allow the knife edges to seat into the grooves. This conclusion is further supported by the fact that the improperly seated length of outer gasket was located in the southeast section of the drywell head flange.

DOUBLE - GASKETED
DRYWELL HEAD SEAL

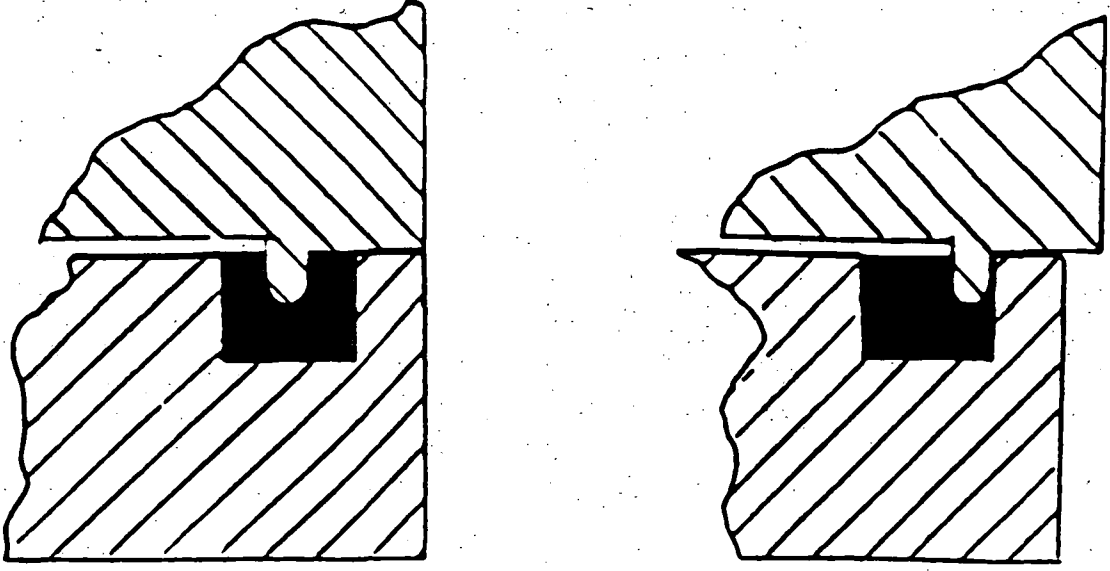
Figure 2

Following removal of the drywell head on October 31, 1988, a continuous impression from the inner knife edge was seen on the inner gasket for the full circumference of the drywell head flange. Examples of normal gasket seating are illustrated in Figure 2. No damage to either knife edge was observed and the gasket material was found to be pliable.

NORMAL GASKET SEATING EXAMPLES

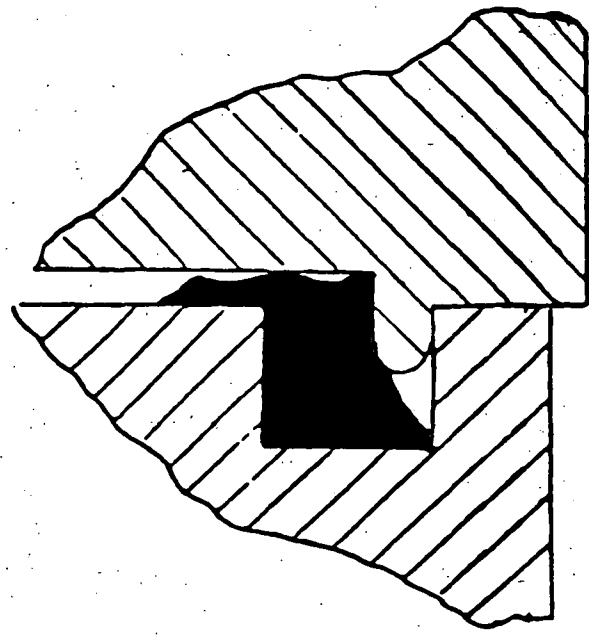
Figure 3

However, for approximately six inches of the outer gasket, the knife edge was beside rather than atop the outer gasket, and a portion of the gasket material appeared to have been forced into the normally empty volume between the two knife edges. This improper gasket seating is illustrated in Figure 3. It was concluded that the leakage path was caused by this improperly seated outer gasket.

The low leakage rate observed following installation is evidence that the inner gasket provided a tight seal and that the outer gasket initially made sufficient contact with the knife edge to provide a tight seal. The six inch section of the outer gasket apparently pulled away from the side of the knife edge due to the thermal cycling of the drywell head flange during operation and subsequent cooldown, thus providing the leakage path.

DMP 1600-5 was reviewed and found to contain inadequate instructions for ensuring that the gaskets were properly inserted into the grooves prior to installation of the drywell head. The root cause of the drywell head seal leakage was therefore attributed to procedure deficiency.

IMPROPER GASKET SEATING EXAMPLE

Prior to Unit 2 startup, DMP 1600-5 was revised to require a Quality Control inspection to ensure that the gaskets are properly inserted into the grooves in the drywell head flange prior to installing the drywell head. DTS 1600-15 was also revised to include troubleshooting guidance should a double gasketed seal show significant leakage during an LLRT (237-200-88-13102). Gaskets for the drywell head flange which were in stock were also verified to be of the proper material. The drywell head gasket was then replaced and the drywell head reinstalled on February 11, 1990. The subsequent LLRT on the gasketed seal yielded a satisfactory leakage of 0.09 scfh.
