Commonwealth Edison
Dresden Nuclear Power Station
R.R. #1
Morris, Illinois 60450
Telephone 815/942-2920

Licensee Event Report #88-018-1, Docket #050237 is being submitted as required by Technical Specification 6.6, NUREG 1022 and 10 CFR 50.73(a)(2)(i)(B). This supplemental report is submitted to provide the final results of Unit 2 1988 refuel outage primary containment local leak rate testing.

Title (4) Leak Rate Limits Exceeded in Drywell Head Seal and MSIV 2-203-1D Tests
Due to Misalignment and Seat Wear

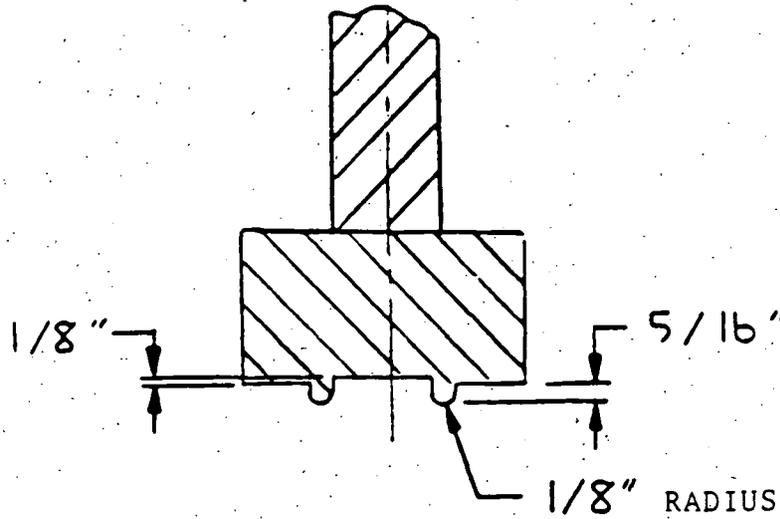
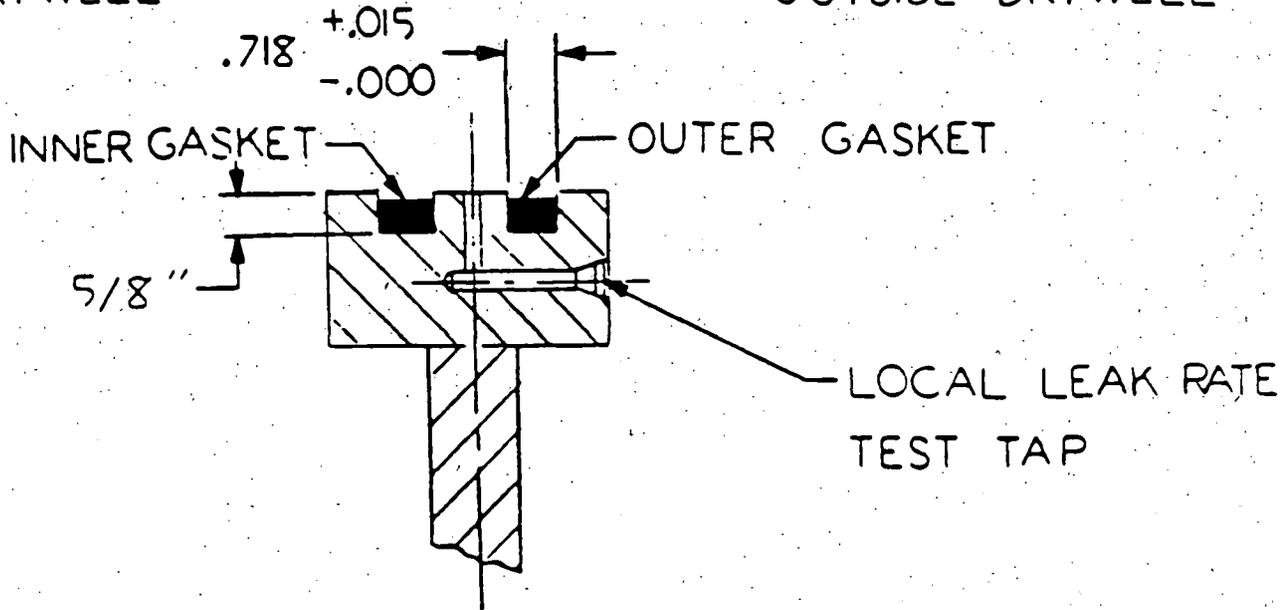
Figure 1

The arrangement of the drywell head, gaskets, and drywell head flange are shown in Figure 1. Rounded "knife edges" on the drywell head are designed to seat on the inner and outer gaskets on the drywell head flange. The endless gaskets used are 3/4" wide by 1/2" thick.

Improper seating of the outer gasket is believed to have resulted from the intermediate cause of that section of the outer gasket not being fully inserted in the drywell head flange groove prior to installation of the drywell head. As shown in Figure 1, the knife edges are rounded with a 1/8" radius. Therefore any section of the gasket extending more than approximately 1/8" above the drywell head flange would have been caught by the knife edge when the southeast section of the drywell head was jacked inward to allow the knife edges to seat into the grooves. This conclusion is further supported by the fact that the improperly seated length of outer gasket was located in the southeast section of the drywell head flange.

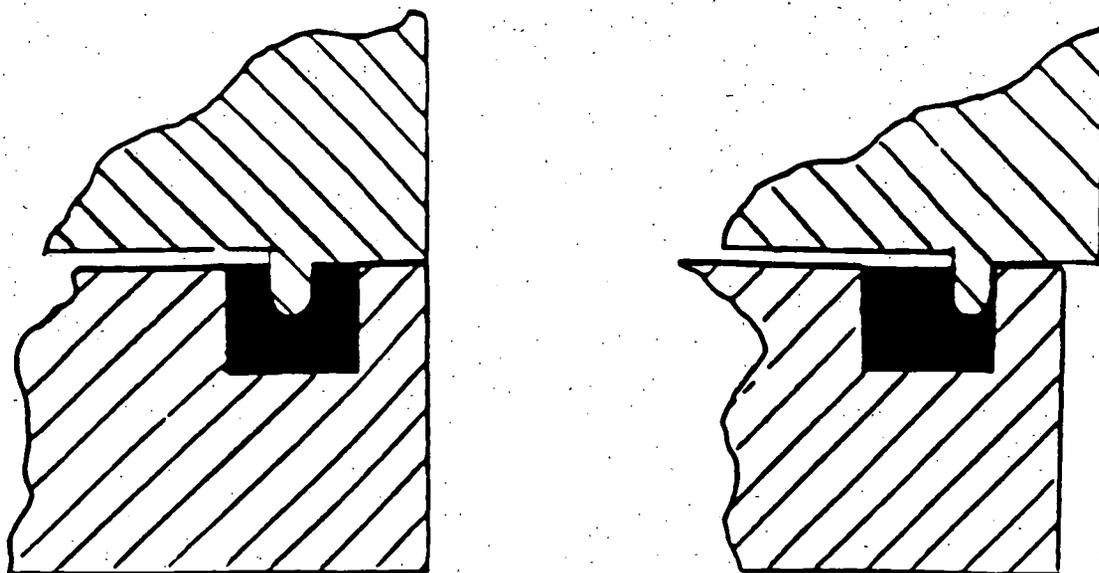
Figure 2

Following removal of the drywell head on October 31, 1988, a continuous impression from the inner knife edge was seen on the inner gasket for the full circumference of the drywell head flange. Examples of normal gasket seating are illustrated in Figure 2. No damage to either knife edge was observed and the gasket material was found to be pliable.

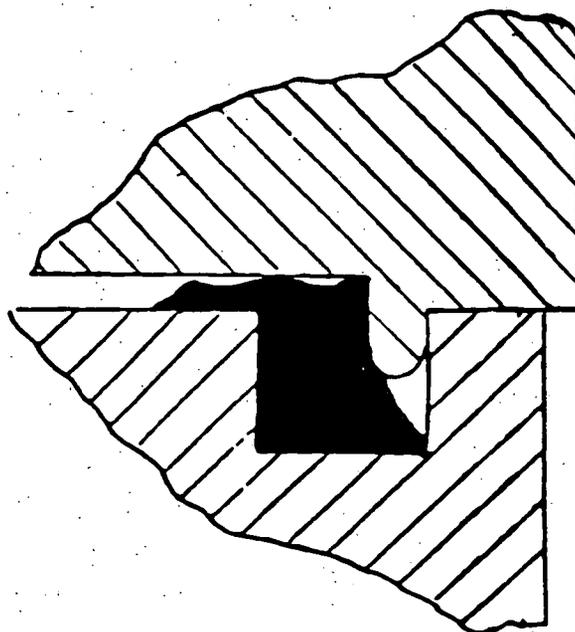
Figure 3

However, for approximately six inches of the outer gasket, the knife edge was beside rather than atop the outer gasket, and a portion of the gasket material appeared to have been forced into the normally empty volume between the two knife edges. This improper gasket seating is illustrated in Figure 3. It was concluded that the leakage path was caused by this improperly seated outer gasket.

The low leakage rate observed following installation is evidence that the inner gasket provided a tight seal and that the outer gasket initially made sufficient contact with the knife edge to provide a tight seal. The six inch section of the outer gasket apparently pulled away from the side of the knife edge due to the thermal cycling of the drywell head flange during operation and subsequent cooldown, thus providing the leakage path.

DMP 1600-5 was reviewed and found to contain inadequate instructions for ensuring that the gaskets were properly inserted into the grooves prior to installation of the drywell head. The root cause of the drywell head seal leakage was therefore attributed to procedure deficiency.

Prior to Unit 2 startup, DMP 1600-5 was revised to require a Quality Control inspection to ensure that the gaskets are properly inserted into the grooves in the drywell head flange prior to installing the drywell head. DTS 1600-15 was also revised to include troubleshooting guidance should a double gasketed seal show significant leakage during an LLRT (237-200-88-13102). Gaskets for the drywell head flange which were in stock were also verified to be of the proper material. The drywell head gasket was then replaced and the drywell head reinstalled on February 11, 1990. The subsequent LLRT on the gasketed seal yielded a satisfactory leakage of 0.09 scfh.
