Commonwealth Edison

LICENSEE EVENT REPORT (LER)

Facility Name (1) Dresden Nuclear Power Station, Unit 2	Docket Number (2) 0 5 0 0 0 2 3 7	Page (3) 1 of 0 6
--	--	----------------------------

Title (4)
Failure of Standby Gas Treatment System Charcoal Adsorber Leak Test Due to Seal Leakage

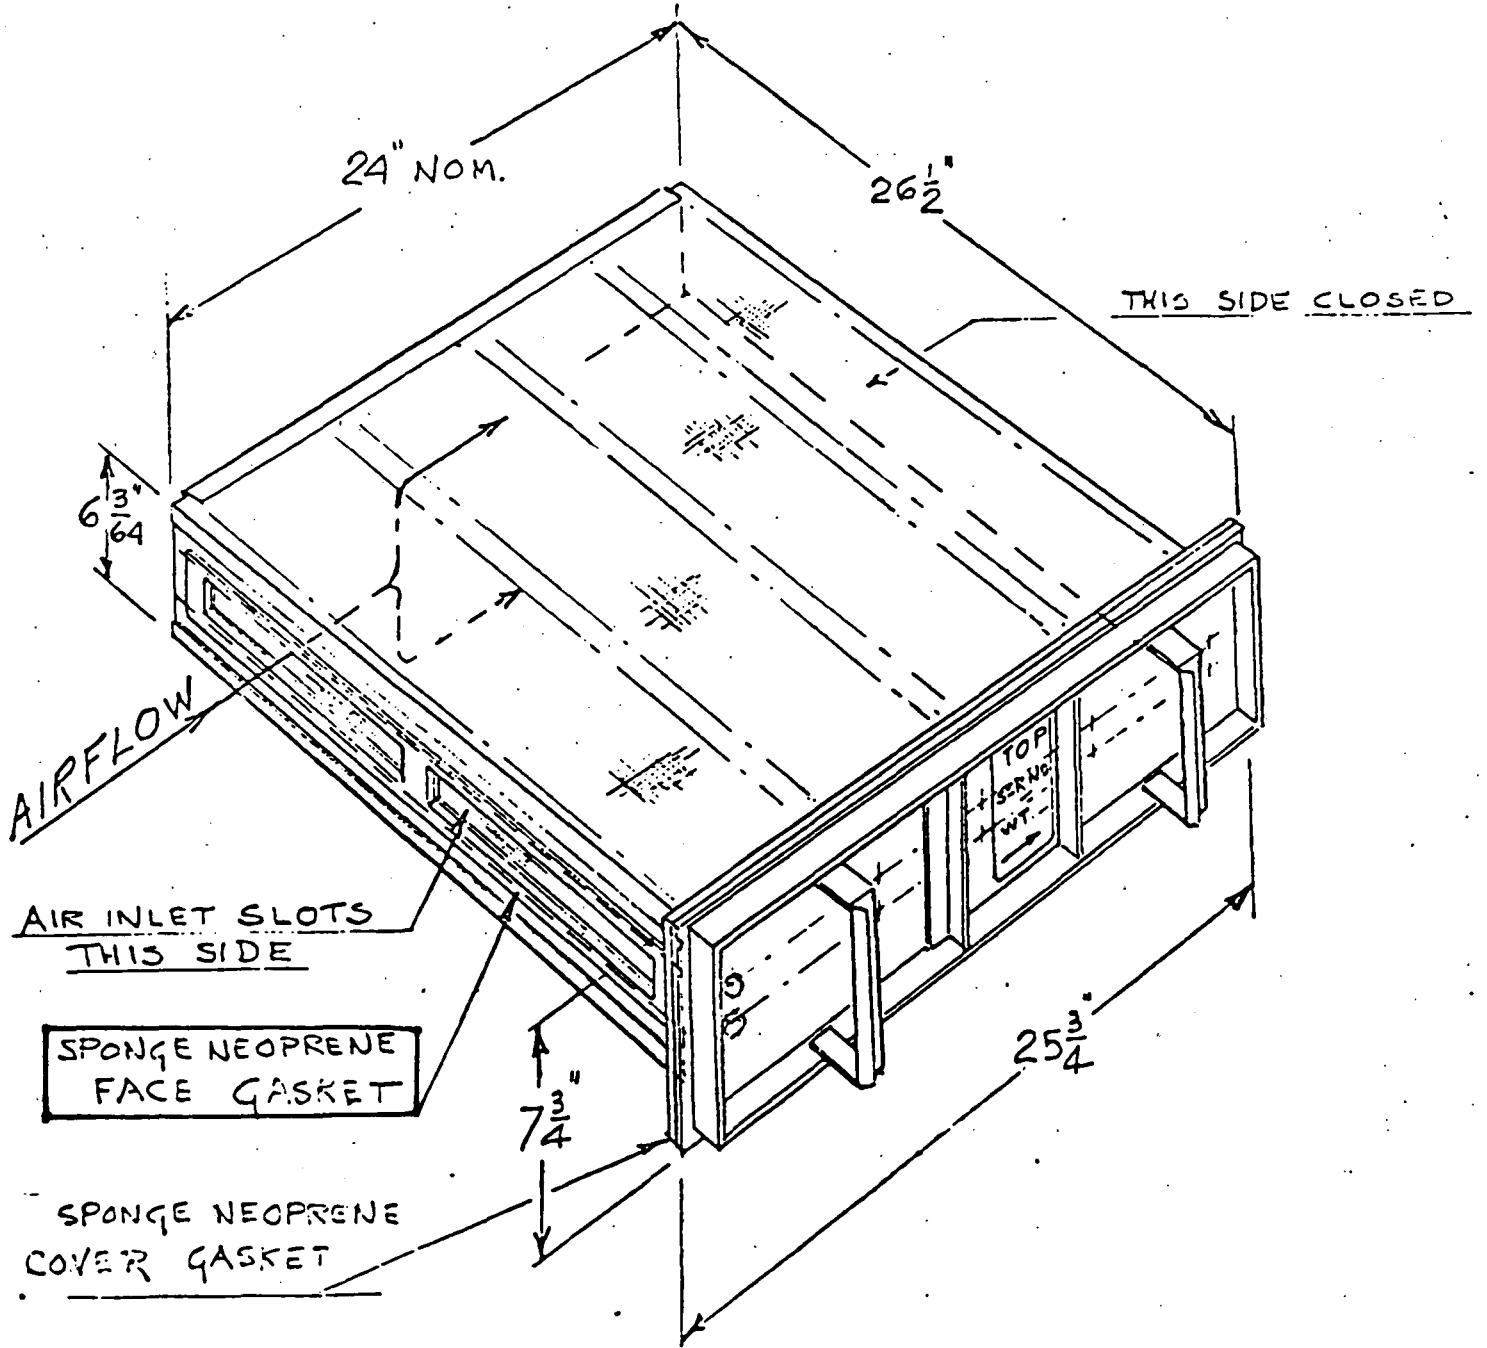
Figure 1

Since the test results improved dramatically when the sealing gaskets were replaced on each of the charcoal trays, the leakage was attributed primarily to degradation of the gaskets (see Figure 1). The B Train exhibited only 0.12 percent leakage and the A Train exhibited .01 percent leakage in their most recent leakage tests on December 18, 1989. No significant change has occurred in the operating conditions of Standby Gas Treatment since the last test. Therefore, the cause of the gasket degradation is unknown at this time.

Several contributing factors were identified during corrective maintenance on the system. The internal latching mechanisms on each train were found to be in disrepair. These mechanisms are responsible for maintaining pressure between the gaskets on each charcoal tray and their sealing surfaces. The primary cause of the damage to these mechanisms is improper operation of the latching lever due to a lack of a procedure. The latching lever is designed to be moved to a certain position for removal of the trays and a different position for operation. There is no labeling that indicates these positions.

Charcoal Adsorber Tray

The primary source of leakage was identified as the seal between the charcoal trays and the housing of the trays. The gaskets were replaced on each tray and the sealing mechanisms were repaired. Much of the damage could have been avoided by proper installation and removal of the charcoal trays. A detailed illustration and instructions for the operation of the latching mechanism will be added to Dresden Maintenance Procedure (DMP) 7500-01, Removal and Installation of Standby Gas Treatment Charcoal Filters by the Maintenance Department (237-200-91-08401). This will be completed by December 31, 1991. The open and closed positions of the latching lever will be labeled at the Standby Gas Treatment trains along with a reference to DMP 7500-01; the System Engineer will submit a request for this labeling change by June 30, 1991 (237-200-91-08402).
