**Commo Health Edison**  
Dresden Nuclear Power Station  
R.R. #1  
Morris, Illinois 60450  
Telephone 815/942-2920

LICENSEE EVENT REPORT (LER)

Facility Name (1) Dresden Nuclear Power Station, Unit 2 Docket Number (2) 0 5 10 10 2 13 17 Page (3) 1 of 0 5

Title (4) Control Rod Dive F-3 Drift Due to Pilot Solenoid Failure

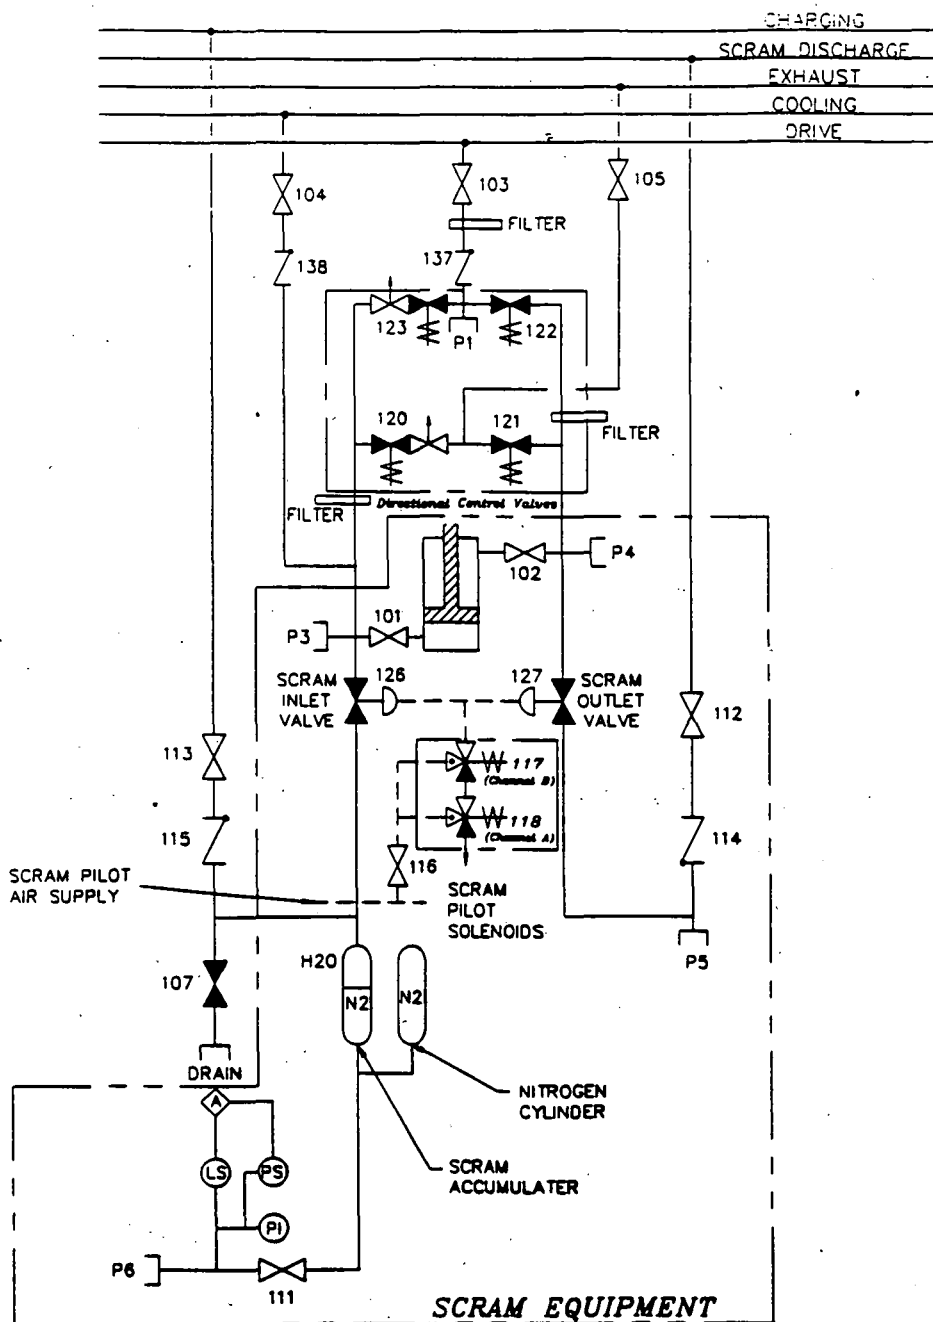
FIGURE 1

Conclusions indicate that due to the solenoid valve configuration (see figure 1), no pilot air should have been exhausted. Upon deenergizing the channel B pilot solenoid valve, pilot air should have remained isolated by the Channel A solenoid valve. The failure mode was therefore concluded to be leakage past the exhaust port diaphragm of the Channel A solenoid valve. When reenergizing the Channel A solenoid valve, the exhaust diaphragm may not have completely seated. Upon deenergizing the Channel B solenoid, pilot air leaking past the Channel A exhaust port diaphragm may have forced the diaphragm back into position. Inspection of the pilot solenoid valves that were removed will be conducted to verify that the failure mode is as suspected.

As described above, the failure mode is believed to be leakage past the scram pilot solenoid exhaust port manifold diaphragm. Further testing will be conducted to verify the failure mode. If the testing reveals any further significant information, results of these tests will be provided in a supplement to this report. These actions will be tracked by Nuclear Tracking System (NTS) number 237-200-91-13201.

Immediate corrective actions were to troubleshoot the CRD F-3, replace the scram pilot solenoid valves, and verify scram operability per Dresden Technical Procedure (DTS) 300-2, Control Rod Drive Scram Testing and Scram Valve Timing Test.
