**Commonwealth Edison**  
Dresden Nuclear Power Station  
R.R. #1  
Morris, Illinois 60450  
Telephone 815/942-2920

LICENSEE EVENT REPORT (LER)

Facility Name (1) Dresden Nuclear Power Station, Unit 3 Docket Number (2) 0 5 10 10 10 12 14 19 Page (3) 1 of 0 9

Title (4) Reactor Scram Due to Degraded Main Stop Valve Fast Acting Solenoid Valve

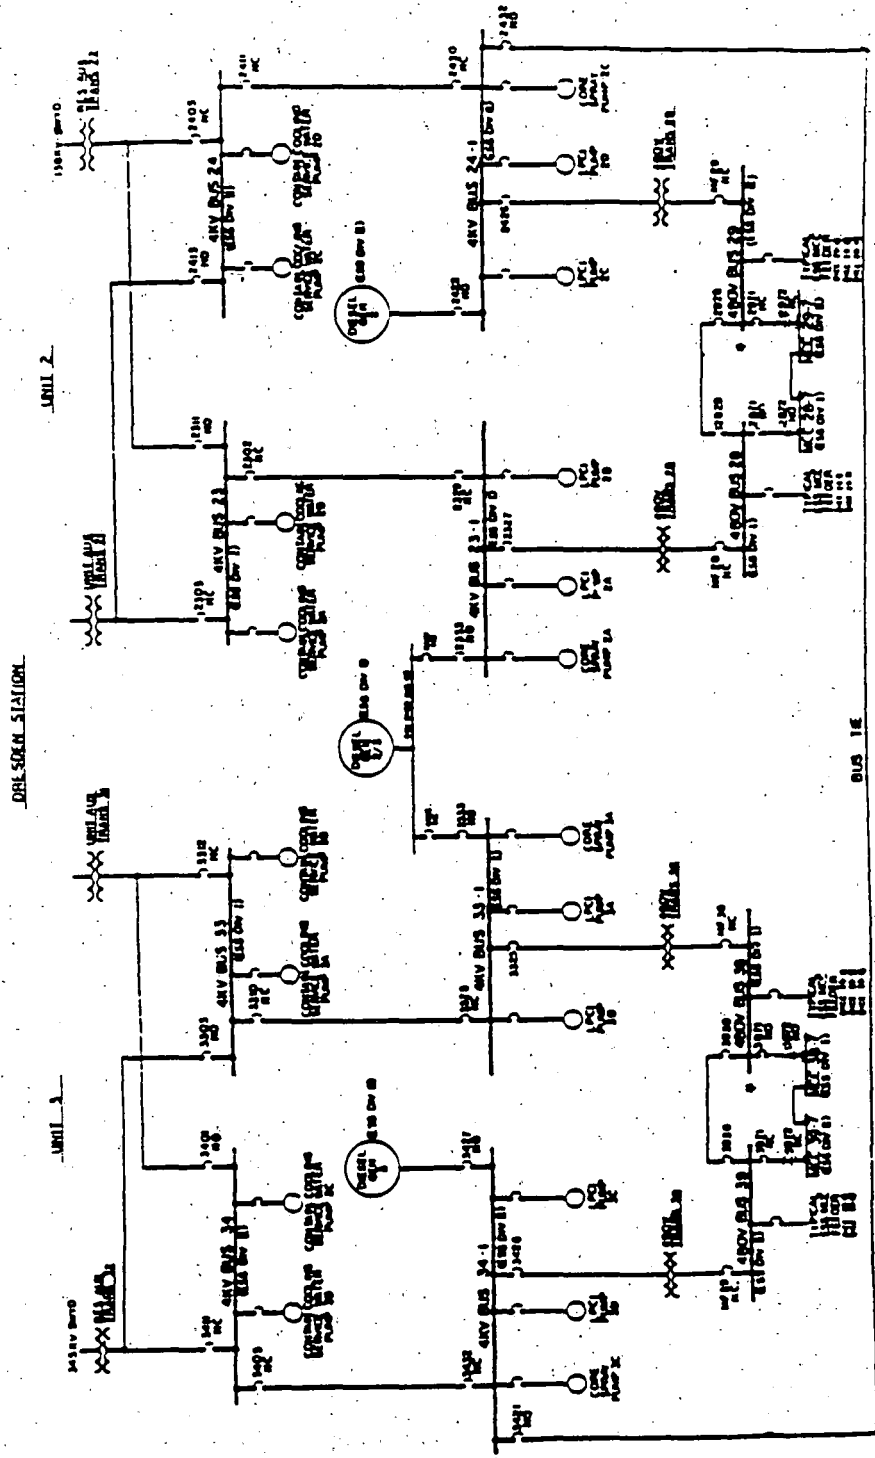
FIGURE 1

Figure 1 presents a simplified single line diagram of the AC power distribution system for Dresden Station. Prior to the scram, 4 kV safety bus 33-1 was fed from the unit auxiliary transformer (UAT) through bus 33, and 4kV safety bus 34-1 was fed from the reserve auxiliary transformer (RAT) through bus 34 (see Figure 1). In preparation for the manual scram, bus 33 was manually transferred to the RAT.

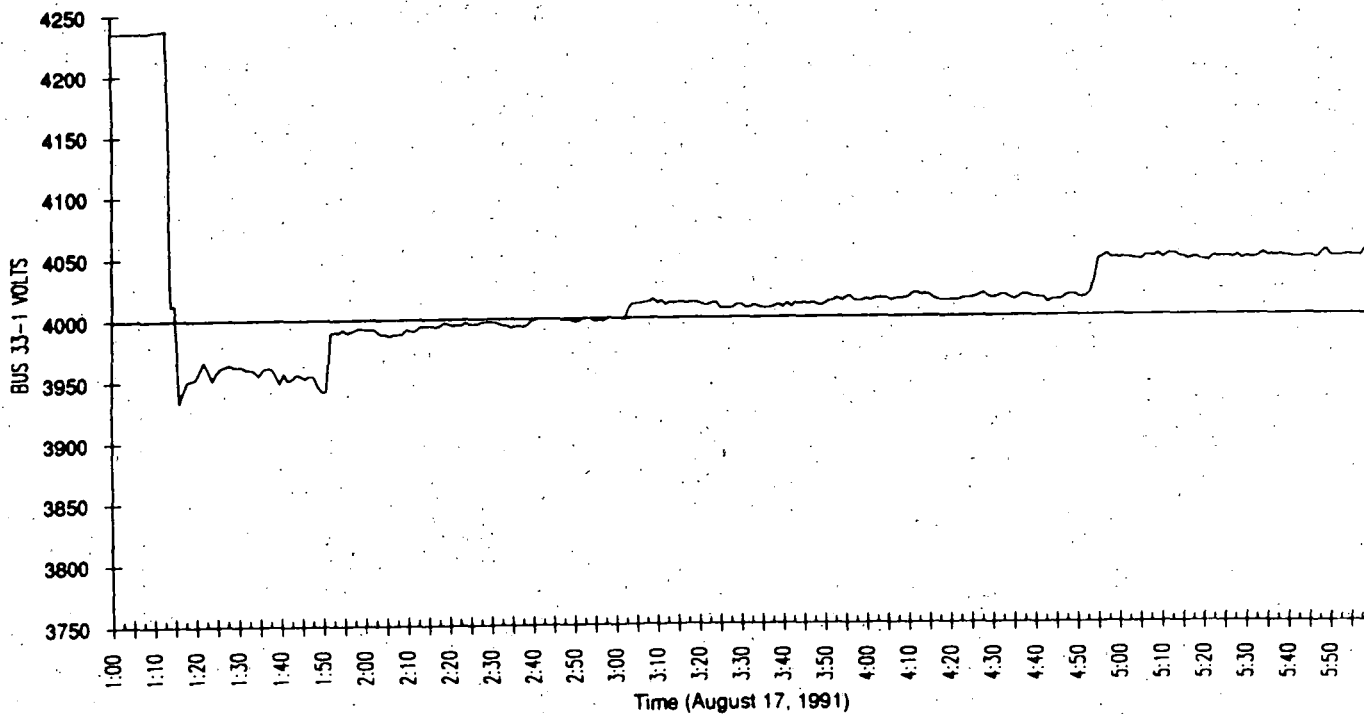
FIGURE 2

The voltage response of the 345 kv switchyard [EL] and 4 kv safety busses (33-1 and 34-1) are presented in the following table. Figure 2 presents the voltage response for safety bus 33-1 during the event.

345 kv Switchyard	4 kv Safety Bus 33-1	4 kv Safety Bus 34-1*
Before scram	355 kv	4240V	4370V (4160V)
Following scram	352 kv	3940V	4160V (3950V)

As shown in the table above, the voltage in the 345 kv switchyard decreased by approximately 1% following the scram. This decrease is expected since the Unit 3 output is provided to the 345 kv switchyard. Voltage on 4 kv safety bus 34-1, which was fed from normal off-site power throughout the event, decreased by approximately 210 volts (approximately 5%). Voltage on bus 33-1, which was transferred from the UAT to the RAT, decreased approximately 300 volts (approximately 7%) and indicated below 4000 volts. The majority of the voltage decrease on the safety buses has been attributed to the increased load on the RAT due to bus 33-1 load transfer to the RAT. A historical review of the most recent previous scram (from power) for each unit revealed that safety bus voltage had not decreased below 4000 volts. It is difficult, however, to predict the exact voltage drop associated with a scram due to variable operational factors such as: system load, switchyard voltage, UAT and RAT loading, and generator output (MWe and MVARs)..
