LICENSEE EVENT REPORT (LER)

Facility Name (1) <p style="text-align:center;">Dresden Nuclear Power Station, Unit 3</p>	Docket Number (2) 0 5 0 0 0 2 4 9	Page (3) 1 of 0 5
Title (4) Unplanned Primary Containment Group V Isolation Due to a Blown Bulb

Unplanned Primary Containment Group V Isolation Due to a Blown Blub.

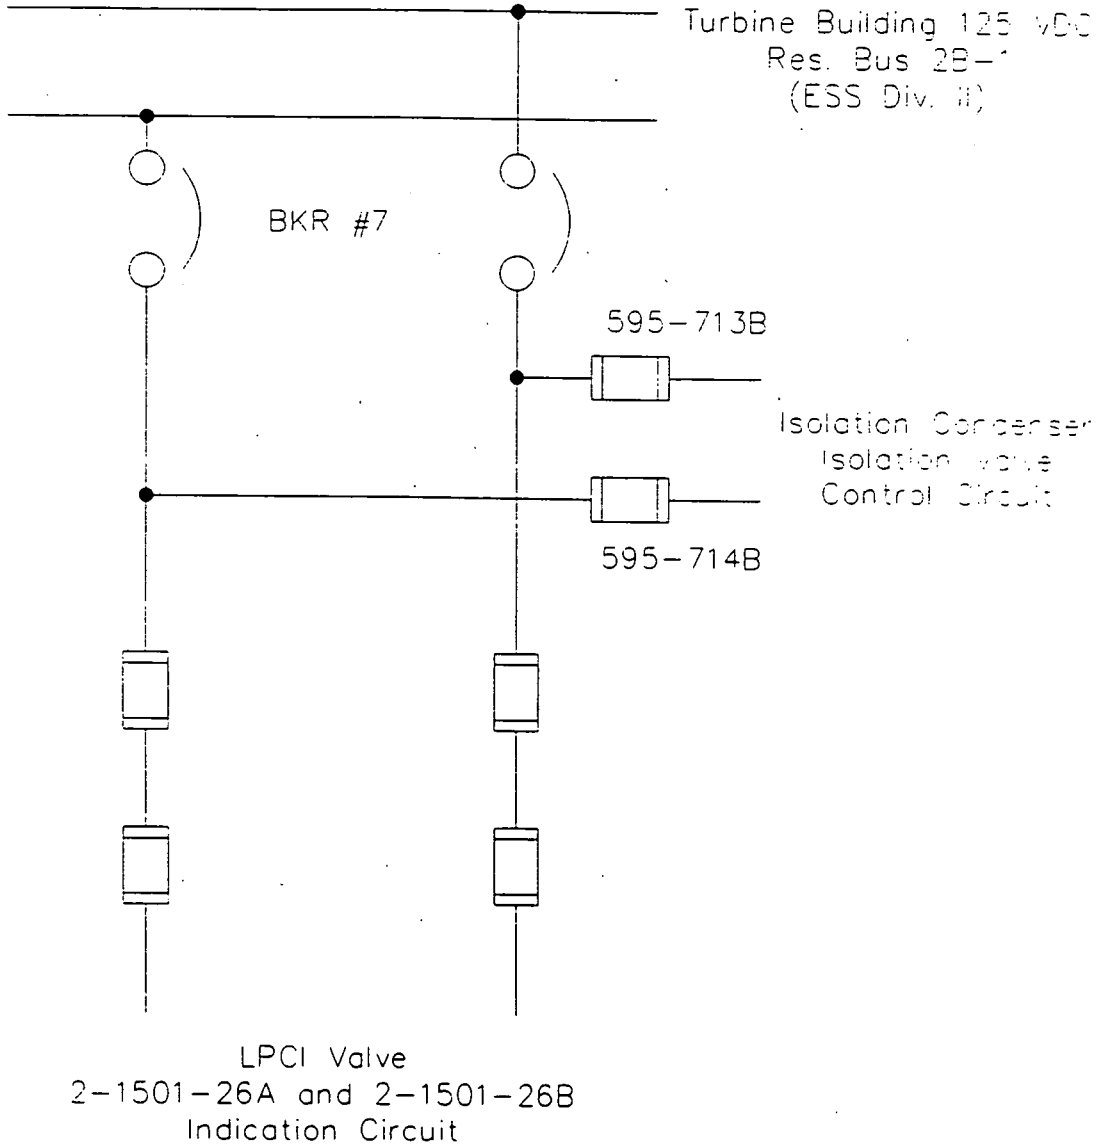
Figure 1

On August 30, 1991 at 1503 hours with Unit 3 in the Run mode at 10% of rated core thermal power, it was observed that the light bulb on the Control Room position indication [JL] for Low Pressure Coolant Injection (LPCI) [B0] System inboard manual isolation valve 3-1501-26A was burned out. When the new bulb was inserted the Nuclear Station Operator (NSO) observed it flash, then extinguish. The low resistance flash in the light bulb apparently caused the opening of fuse 595-714B. Simultaneously with the light indication flash, a Primary Containment Group V Isolation [JM] signal was received and the Isolation Condenser [BL] 3-1301-1, -2, and -4 motor-operated (MO) and 3-1301-17 and -20 air-operated (AO) valves repositioned to the close position as designed. Fuse 595-714B is the supply power fuse for both the 3-1501-26A position indication and the Isolation Condenser Primary Containment Group V Isolation circuitry.

Proposed Changes

Also during the current Unit 3 refueling outage (D3R12) and the next Unit 2 refueling outage (D2R13) a Minor Plant Modification will add two fuses in series (see attached Figure 1) to isolate the LPCI indication circuit from the isolation condenser isolation valve control circuitry. The fuses will be coordinated with the upstream circuit breaker such that a similiar short will not cause an unwanted Group V isolation (249-200-91-00803).
