Dresden Nuclear Power Station

LICENSEE EVENT REPORT (LER)

Facility Name (1) <b>Dresden Nuclear Power Station, Unit 3</b>	Docket Number (2) <b>0 15 10 10 10 12 14 9 1</b>	Page (3) <b>1 of 0 7</b>
Title (4) Failure to Perform Post-Maintenance Local Leak Rate Test Due to Management Deficiency

Failure to Perform Post-Maintenance Local Leak Rate Test Due to Management Deficiency

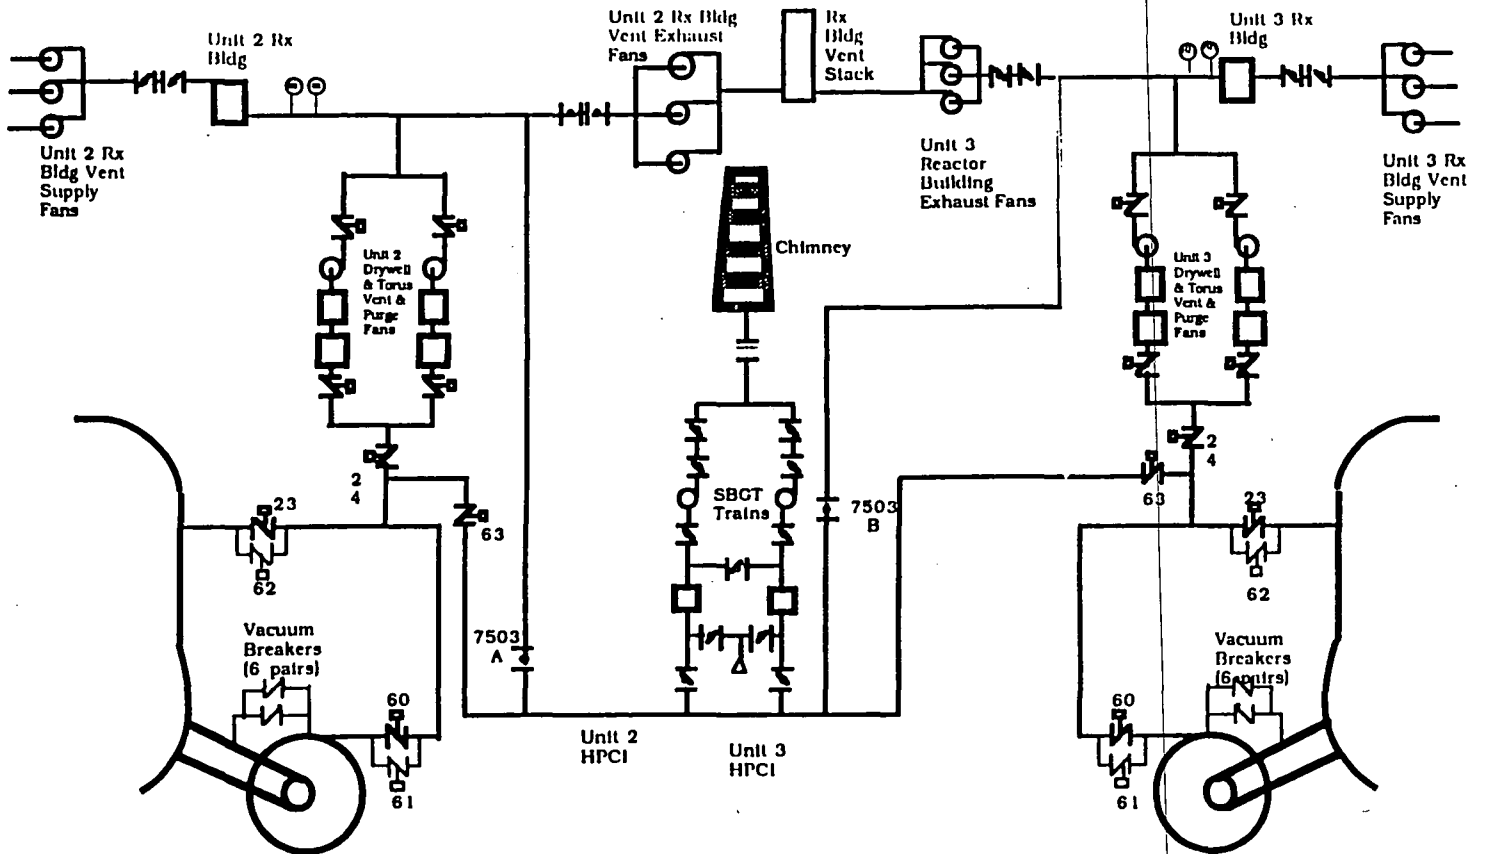
Figure 1 Drywell & Torus Vent Flowpaths

On September 16, 1991, with Unit 3 shutdown for refueling and maintenance, during performance of 10CFR50 Appendix J type C LLRT testing, the volume containing containment vent and purge system [BF] valves 3-1601-23, -24, -60, -61, -62 and -63 (see Figure 1) was identified to have excessive leakage. Further diagnostic testing concluded that valve 3-1601-24 was the leakage source. On September 20, 1991, at 1330 hours, while performing a maintenance history review, it was discovered that maintenance work had been performed on the 3-1601-24 valve during the previous refuel outage (D3R11) without completion of a proper post-maintenance LLRT as was required by 10CFR50 Appendix J. The valve operator cylinder was rebuilt on February 2, 1990, under Work Request (WR) 90166. The work package indicated that a new piston rod was installed and the cylinder was reassembled. The package required Post Maintenance Testing (PMT) as follows: (a) Dresden Technical Surveillance (DTS) 1600-29, Isolation valve Fail Safe Mode and Air Operator Accumulator System Integrity Test, (b) Dresden Operating Surveillance (DOS) 040-7, Remote Position Indication Verification, (c) DOS 1600-1, Quarterly Valve Timing. PMT did not require performance of DTS 1600-1, LLRT of Primary Containment Isolation Valves. An as found LLRT had been performed on this volume (12/5/89) and passed.
