Commonwealth Edison
Dresden Nuclear Power Station
R.R. #1
Morris, Illinois 60450
Telephone 815/942-2920

Licensee Event Report #91-010-00, Docket #050249 is being submitted as required by Technical Specification 6.6, NUREG 1022 and 10 CFR 50.73(a)(2)(iv).

Title (4) Bus 38 Undervoltage Relay Actuation Due to Inadvertent Shorting of Relay Terminals

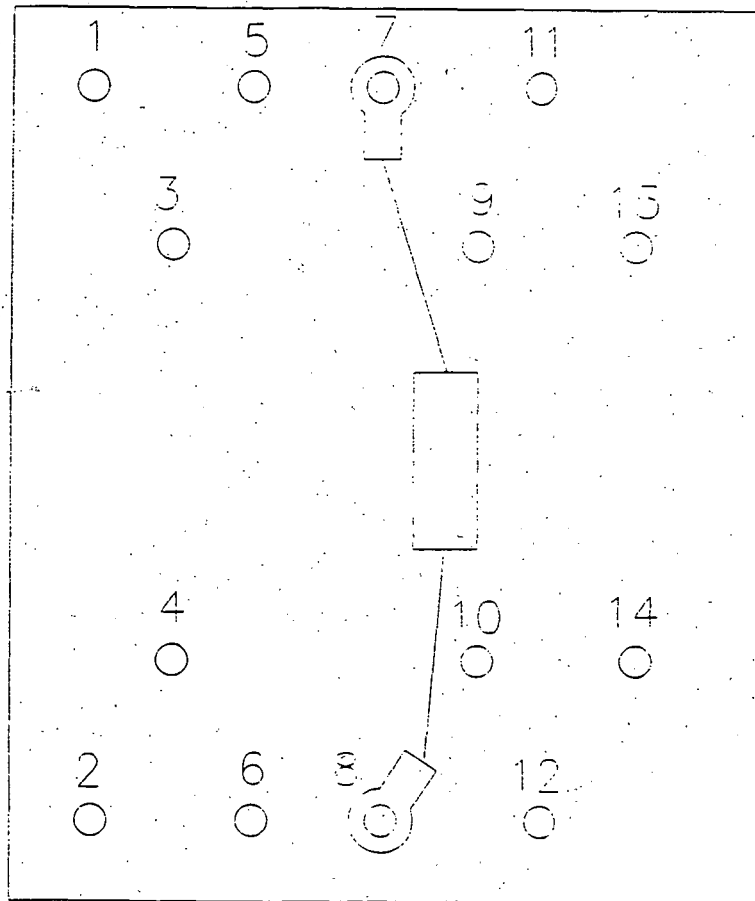
Figure 1.

The cause of this event is attributed to the Electrician's tool coming in contact with two terminals on the undervoltage relay (Refer to Figure 1). During a tightness check of a wire termination nut at the rear of relay #227-B38-X1, the Electrician had put a taped nut driver on terminal #10 when the exposed lower face of the nut driver contacted a non-insulated lug installed on terminal #8. Lug #8 was in close proximity to terminal #10. The short propagated through an installed resistor between terminals #7 and #8 from terminal #10. It is believed that the momentary short caused relay #227-B38-X1 to actuate, shedding all active equipment off of Bus 38 (Refer to Figure 2).

Back View of Relay 227-B38-X1 Terminals

The immediate corrective actions were to terminate the surveillance and restore all affected equipment to normal operation. The event was reviewed with the personnel involved; it should be noted that the Electrician had taped the nut driver shaft and was using caution against accidental shorts. In order to help prevent future problems of this type, the System Engineer and the Master Electrician are investigating the possibility of procuring insulated tools for this type of activity (249-200-91-07501). WR 04274 was also written to further investigate the potential wiring discrepancy (249-200-91-07502). Upon completion of the investigation, a supplemental report will be issued (249-200-91-07503).

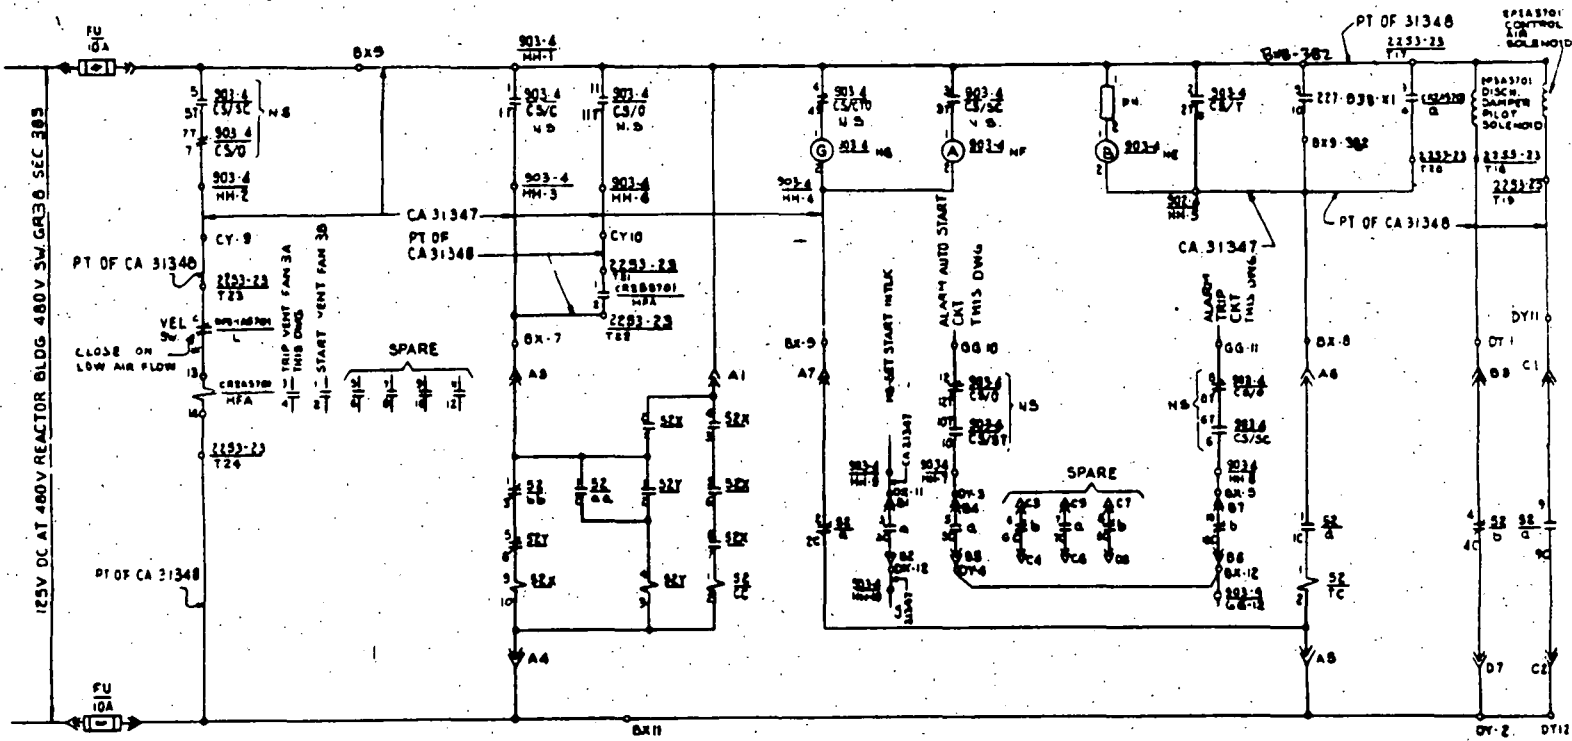
Figure 3

It is currently suspected that terminals #9 and #10 may be electrically reversed; this potential discrepancy has no affect on proper operation of the circuitry. A check for circuit continuity utilizing approved drawings, with the fuses pulled and the Recirculation [AD] Motor Generator Set (MG-Set) Vent Fan 3A Out-Of-Service (OOS), confirmed a properly wired circuit between points BX5 to 382-BX8 and BX8 to BX9-382 (refer to Figure 3). However, with the blue indicator bulb removed (refer to Figure 3), checks from BX5 to terminal #10 and from BX8 to BX5 also indicated continuity. It is believed that the control switch for the MG-Set Vent Fan 3A on panel 903-4, which is presently in its pull-to-lock position, provides the route for continuity of the circuit between points BX5 to BX8. Work Request (WR) 04274 was written to further investigate the wiring to relay #227-B38-X1. Under WR 04274, the leads from points BX9-382 and BX8-382 will be lifted and continuity verified back to terminals #10 and #9 respectively. This work will be completed prior to Unit 3 startup. A supplemental report will be issued following the conclusion of the investigation.

RECIRC. MG-SET VENT FAN 3A
