LICENSEE EVENT REPORT (LER)

Facility Name (1) Dresden Nuclear Power Station, Unit 2 Docket Number (2) 0 15 10 10 10 12 13 17 Page (3) 1 of 0 5

Title (4) Vent and Purge System Exhaust Ductwork Separation Due to Construction/Installation Deficiency

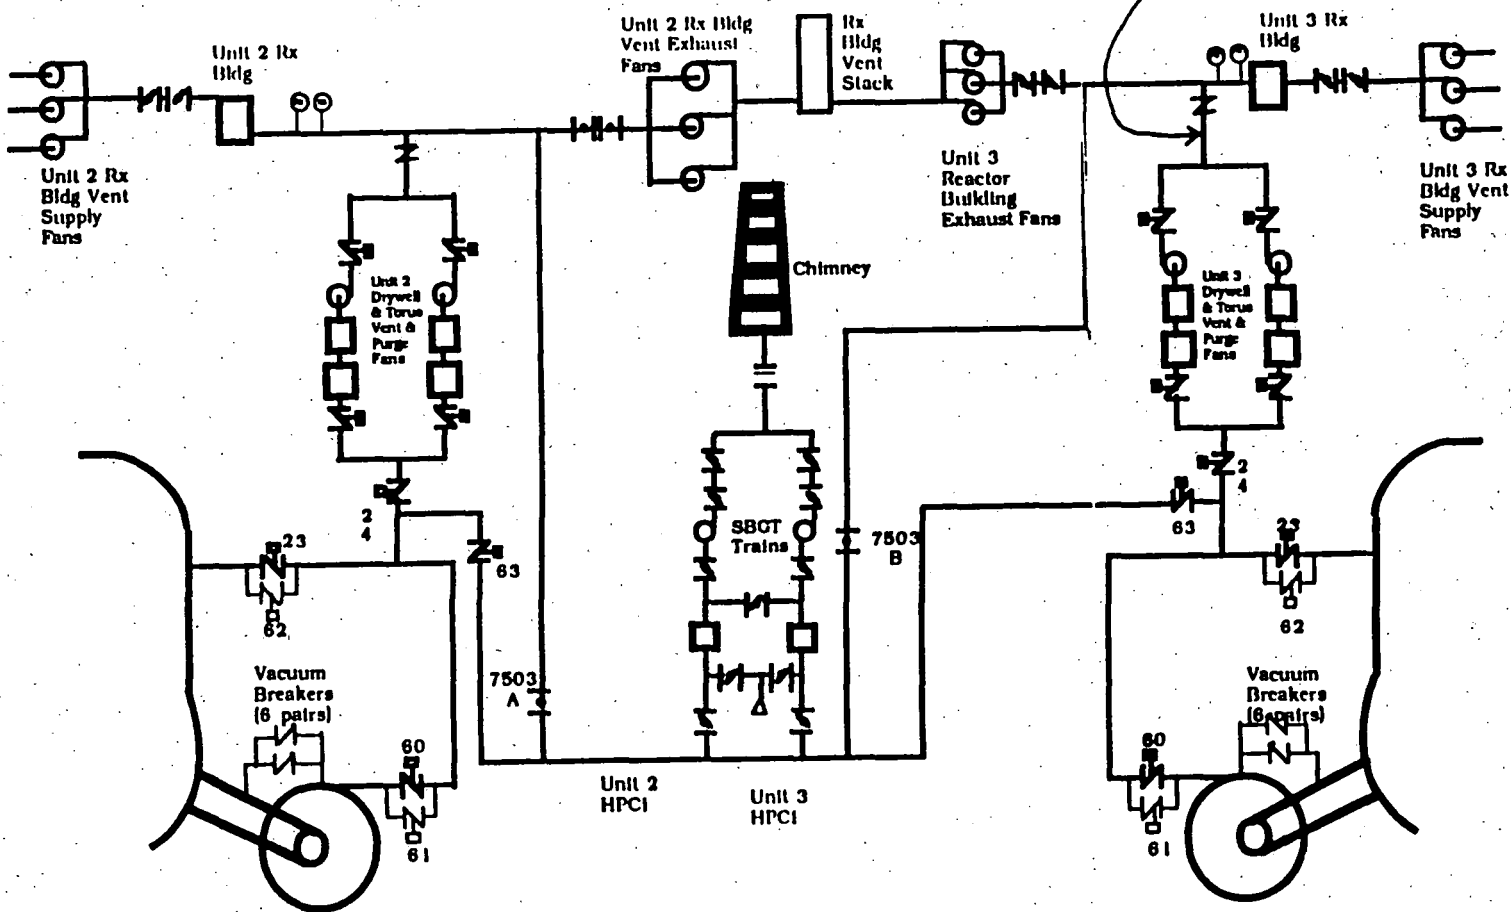
Figure 1 Drywell & Torus Vent Flowpaths

During a walkdown on September 18, 1991, a joint in the exhaust ductwork of the Unit 3 Drywell Vent and Purge System was found separated. The two pieces of exhaust ductwork were touching and slightly out of alignment. The time of discovery was at 0515 hours and the condition was repaired by 0600 hours under WR 03724. Refer to attached Figure 1.

This report is being submitted in accordance with 10CFR50.73(a)(2)(ii)(b), which requires the reporting of any condition outside the design basis. It should be noted that 10CFR 50.72 notification was performed concerning this event on September 18, 1991, due to the potential for degraded secondary containment integrity pending repairs and further investigation. Initial investigation focused on scaffolding work in the area as a potential cause of damage; however, further review concluded, on November 12, 1991, that the as-found joint configuration did not meet design requirements.

The root cause of this event was construction/installation deficiency in that the proper fastening configuration was apparently not adhered to. It could not be determined if this had occurred at original construction, or at some later time. Extensive interviews could not pinpoint a proximate cause of the separation other than vibration. Review of records shows that this type of event has not been a recurring trend.

Separation Occured Here

The Unit 3 Vent and Purge System exhaust ductwork joint was repaired under WR 03724 in a timely manner. The SQUG Team performed a walkdown to verify the installation of the exhaust ductwork. It was determined that the basic installation was correct, but the joint that separated was not properly secured as required by the Low Velocity and Duct Construction Standards Fourth Edition - 1969. Two WRs (03998 for Unit 2 and 03997 for Unit 3) were written to verify that each exhaust ductwork joint of the Unit 2 and Unit 3 Vent and Purge System was properly secured with a minimum of four sheet metal screws, one in each quadrant. Both WRs were completed resulting with the installation of two additional sheet metal screws in the Unit 2 exhaust ductwork.
