Commonwealth Edison

LICENSEE EVENT REPORT (LER)

Title (4) Reactor Scram Following Condensate/Condensate Booster Pump

Failure and Subsequent Loss of Offsite Power

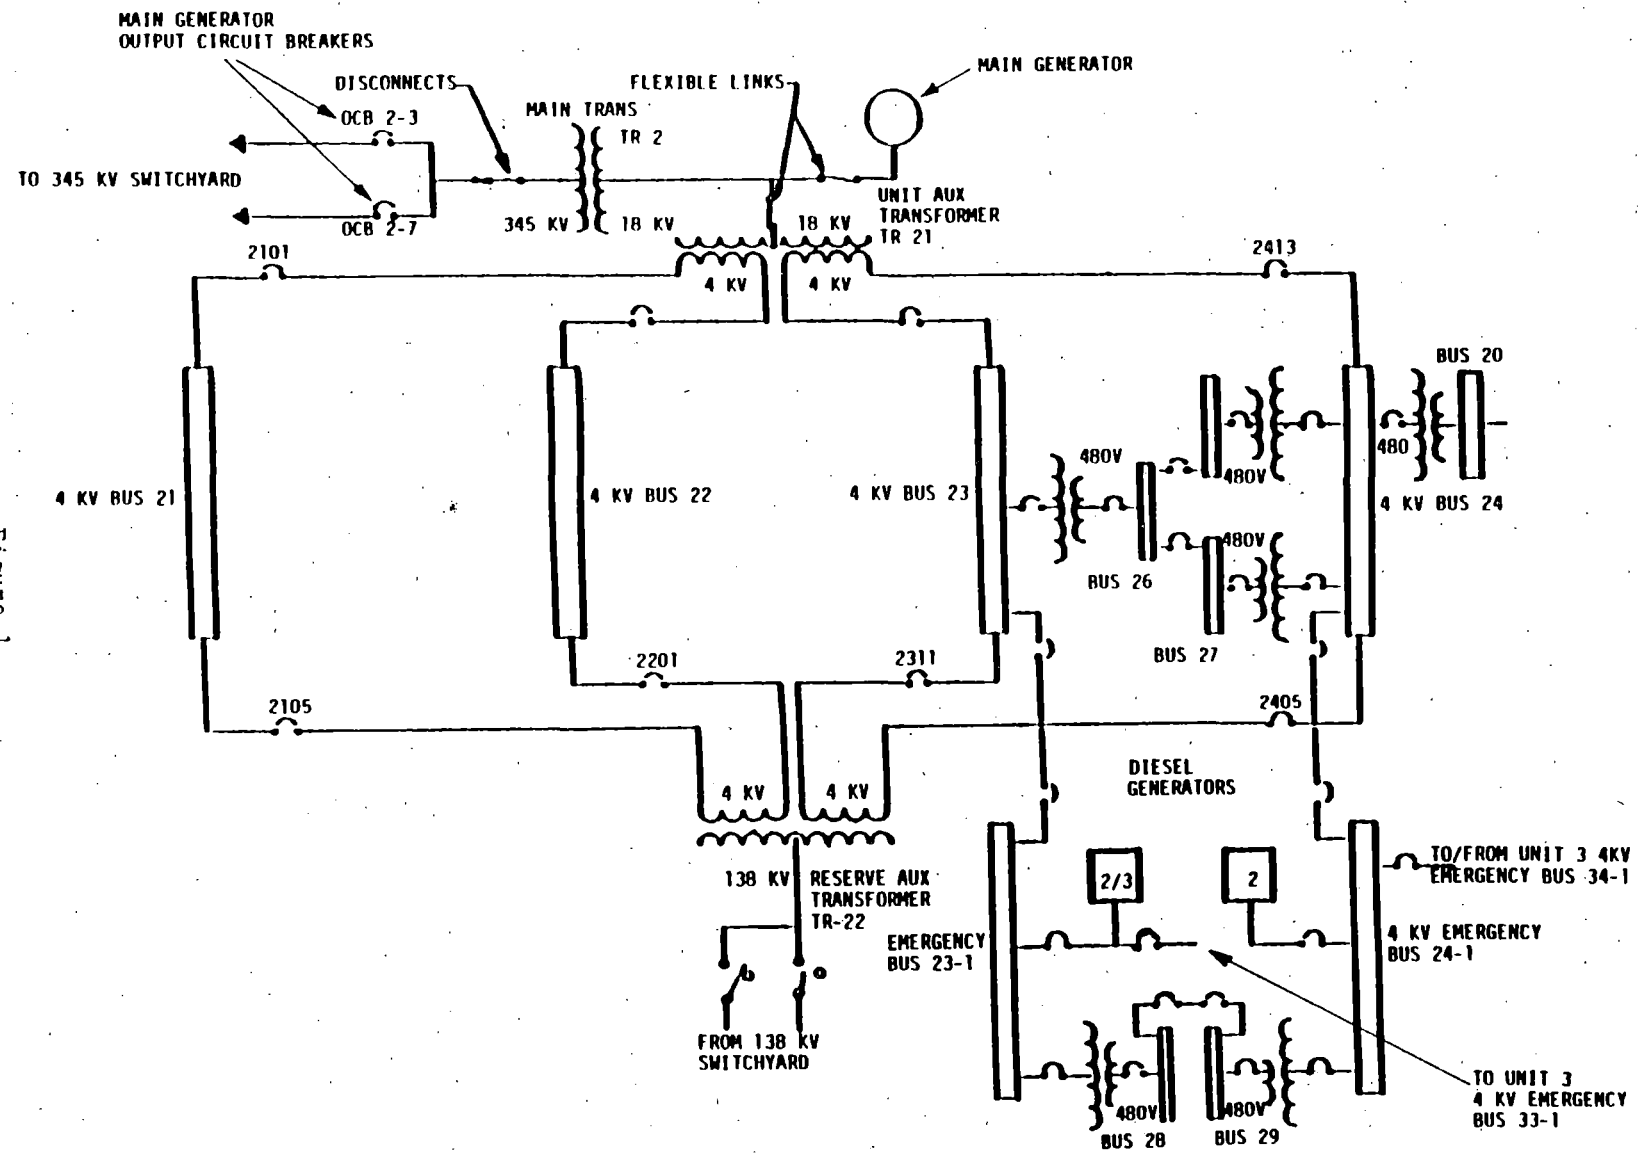
Figure 1

Refer to Attachment 1 for a detailed sequence of events. A Unit 2 electrical arrangement is provided by Figure 1. Note that the event times listed throughout this report are approximate, based on computer output data, Operator log books, chart recorder traces, etc. The following apparent problems were initially identified by the Scram Investigation Committee.
