Commonwealth Edison
 Dresden Nuclear Power Station
 R.R. #1
 Morris, Illinois 60450
 Telephone 815/942-2920

LICENSEE EVENT REPORT (LER)

| Facility Name (1) Dresden Nuclear Power Station, Unit 2 | Docket Number (2) 0 5 0 0 0 2 13 17 | Page (3) 1 of 0 4 |
| Title (4) Auto Closure of Reactor Building Ventilation Inlet Isolation Dampers Due to Setpoint Design Deficiency | | |

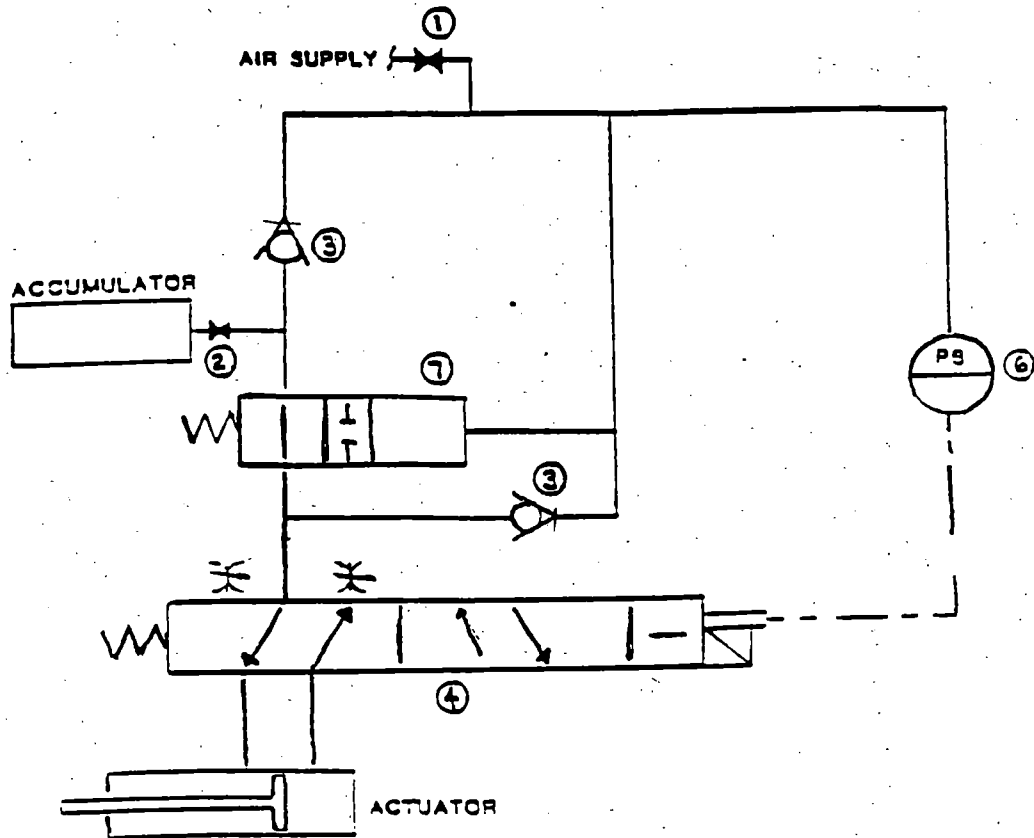
Figure 1

Investigation revealed that the air operator pressure switch setpoints associated with the 2A-5741 and 2B-5741 dampers had been revised on September 25, 1991 and October 26, 1991, respectively, as part of an engineering study. The cause of the unplanned damper movements was insufficient margin between the damper operator pressure switch setpoint and Instrument Air [LD] header pressure (see figure 1). The pressure switch on damper operator 2A-5741 was set to trip at 79.6 psig. and reset at 84.6 psig. The pressure switch on damper operator 2B-5741 was set to trip at 80.0 psig. and reset at 83.0 psig. Instrument air is the motive air required to operate these dampers. A single 1-inch header provides air to the inlet and outlet isolation damper operators. The instrument air system operates at 95 psig at the air receivers. However, due to system demands and line losses, the air pressure to the dampers is normally approximately 90 psig. A single control switch operates a pair of inlet dampers and another control switch operates the pair of outlet isolation dampers. When the dampers get an open or close signal, there is a surge in air demand by the damper operators resulting in a momentary reduction of the air header pressure. A possible contributing cause of the event was the configuration of Instrument Air system. One of the Instrument Air Compressors had tripped previously, resulting in lower than normal Instrument Air header pressure. Although the inlet and outlet isolation dampers were successfully operated earlier that day at 0820 and 1130 hours to briefly operate the Reactor Building ventilation system, it is

believed that the slightly reduced Instrument Air header pressure contributed in the occurrence of this event. However, the root cause of the event was attributed to design deficiency in that the revised operator pressure switch setpoints were inadequate to prevent unplanned damper closure.

Schematic of Damper Operator

The Commonwealth Edison Nuclear Engineering Department has evaluated improvements to the pressure switch setpoints, such that momentary reductions in air header pressure will not cause spurious damper closure. The new pressure switch setpoints will be related to the minimum air pressure required for the damper closure timing to be less than 30 seconds. The pressure switch setpoint at the time of the event had been related to the maximum damper closure timing of 20 seconds. The damper timing was obtained upon review of the bostulated releases through the Reactor Building Ventilation System if a refueling accident were to occur. The calculated releases were determined not to exceed 10 CFR 100 release rate limits, and are also less than the calculated limits for the bounding main steam line break outside containment accident conditions. The Technical Staff System Engineer will perform a special test with assistance from the Instrument Maintenance Department to obtain the new pressure switch setpoints such that a damper closure occurs in 30 seconds or less. Appropriate procedure changes will be made for these new setpoints and damper closure times (237-200-91-22301).
