**Commonwealth Edison**  
Dresden Nuclear Power Station  
R.R. #1  
Morris, Illinois 60450  
Telephone 815/942-2920

LICENSEE EVENT REPORT (LER)

Title (4) Reactor Scram Following Condensate/Condensate Booster Pump

Failure and Subsequent Loss of Offsite Power

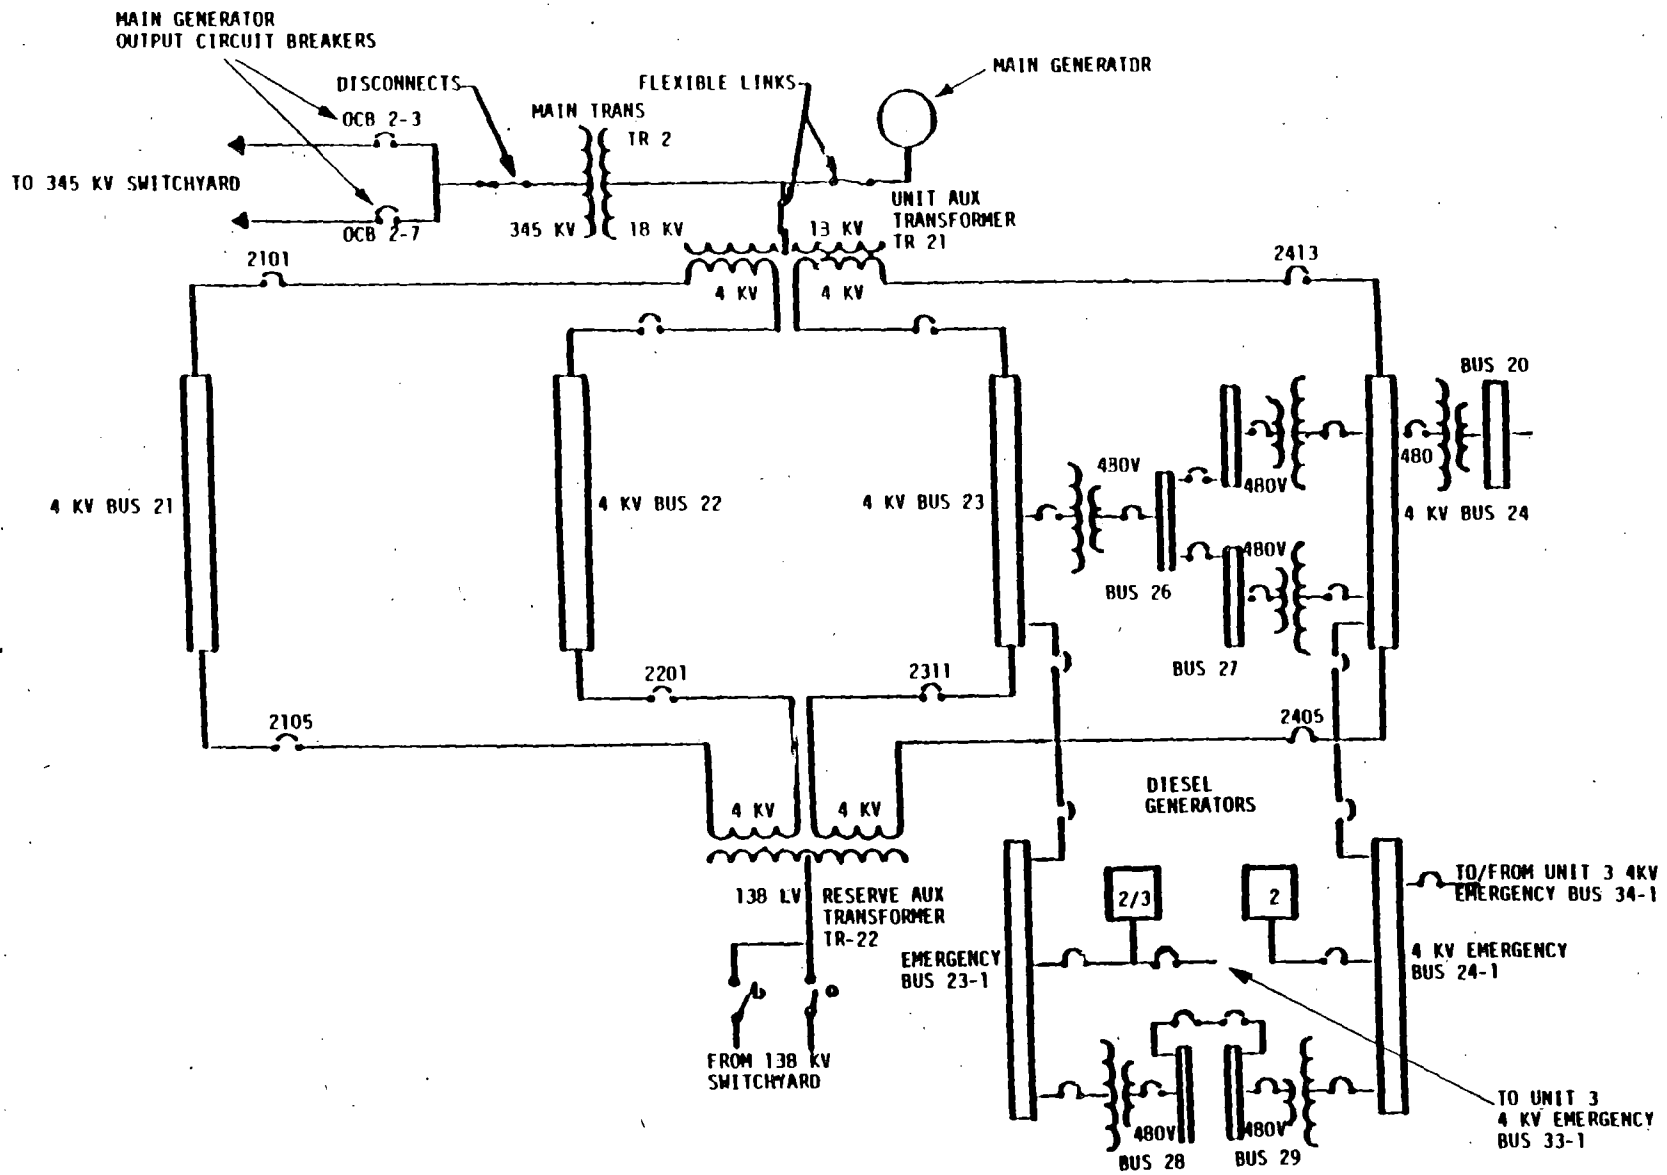
Figure 1

Refer to Attachment 1 for a detailed sequence of events. A Unit 2 electrical arrangement is provided by Figure 1. Note that the event times listed throughout this report are approximate, based on computer output data, Operator log books, chart recorder traces, etc. The following apparent problems were initially identified by the Scram Investigation Committee.
