Commonwealth Edison
Dresden Nuclear Power Station
R.R. #1
Morris, Illinois 60450
Telephone 815/942-2920

LICENSEE EVENT REPORT (LER)

Facility Name (1) Dresden Nuclear Power Station, Unit 3
 Docket Number (2) 0 15 10 10 10 12 14 19
 Page (3) 1 of 0 5

Title (4) Unplanned Primary Containment Group V Isolation Due to a Blown Bulb

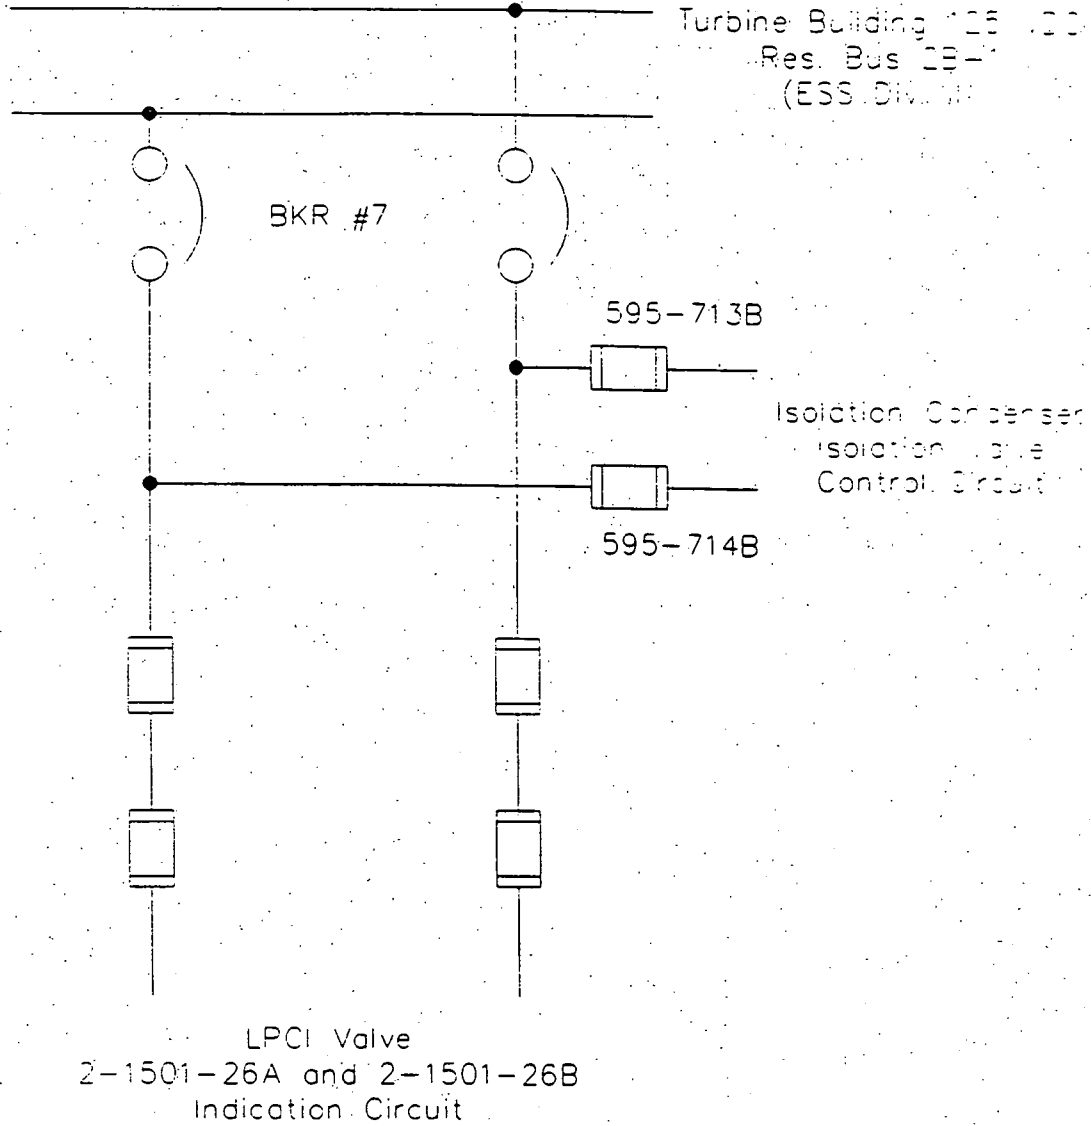
Figure 1

Proposed Changes

During the current Unit 3 refueling outage (D3R12), a Minor Plant Modification was completed to add two fuses in series (see attached Figure 1) to isolate the LPCI indication circuit from the isolation condenser isolation valve control circuitry. The fuses are coordinated with the upstream circuit breaker such that a similar short will not cause an unwanted Group V isolation. This modification is scheduled to be performed on Unit 2 during the next refueling outage (D2R13) (249-200-91-05803).
