Commonwealth Edison
Dresden Nuclear Power Station
R.R. #1
Morris, Illinois 60450
Telephone 815/942-2920

LICENSEE EVENT REPORT (LER)

Facility Name (1) Dresden Nuclear Power Station, Unit 2	Docket Number (2) 0 5 0 0 0 2 3 7	Page (3) 1 of 0 5
Title (4) Reactor Water Cleanup System Primary Containment Isolation Valve Closure Due to Procedure Deficiency

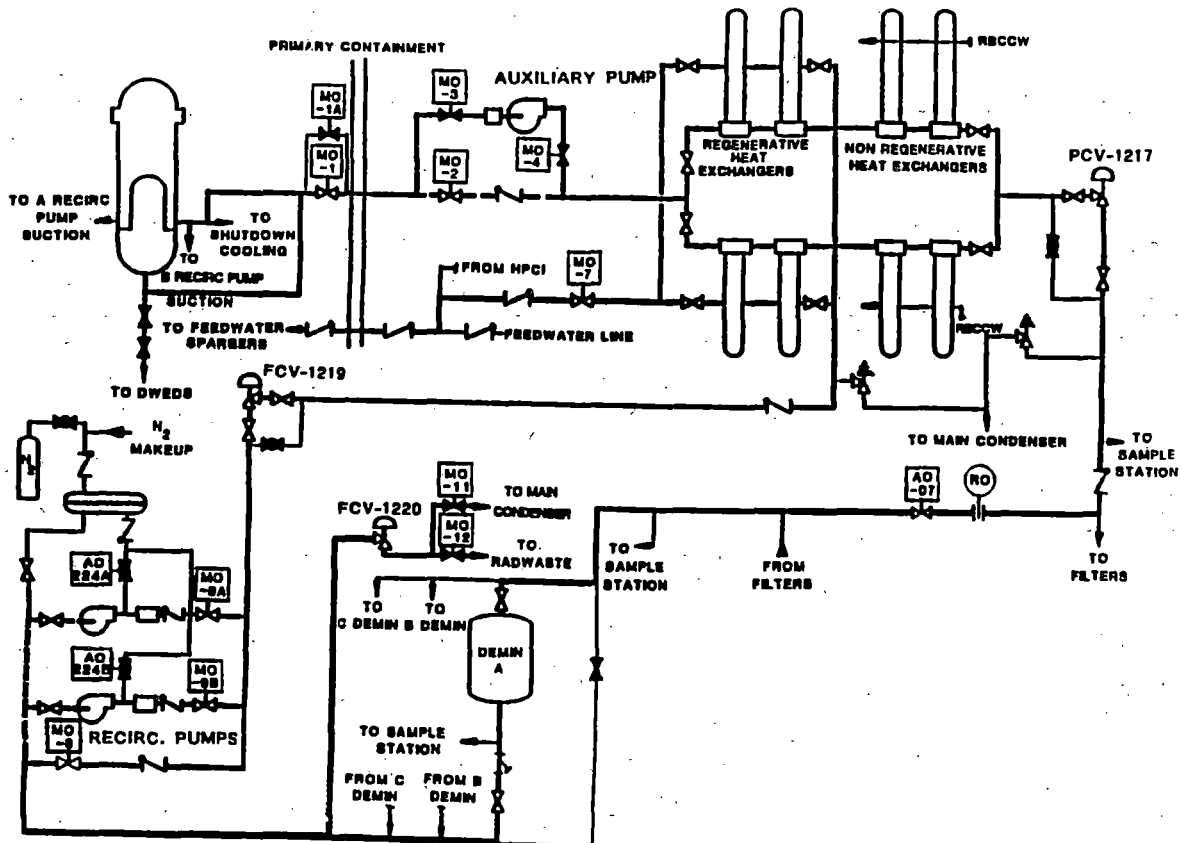
Attachment 1

The RWCU system takes water from the reactor vessel through the Reactor Recirculation [AD] system suction line (see attachment 1). During power operation, normal reactor pressure provides the driving force for the water to the RWCU system. The water then passes through heat exchangers and a pressure control valve (PCV 2-1217), to reduce the water temperature and pressure, prior to the demineralizers. After the demineralizers, the water is returned to the Feedwater [SJ] system through a recirculation pump and a flow control valve (FCV 2-1219).
