Commonwealth Edison
Dresden Nuclear Power Station
R.R. #1
Morris, Illinois 60450
Telephone 815/942-2920

LICENSEE EVENT REPORT (LER)

Facility Name (1) Dresden Nuclear Power Station, Unit 3 Docket Number (2) 0 15 10 10 10 12 14 19 Page (3) 1 of 0 6

Title (4) Unplanned Standby Gas Treatment System Automatic Initiation Signal Due to Personnel Error

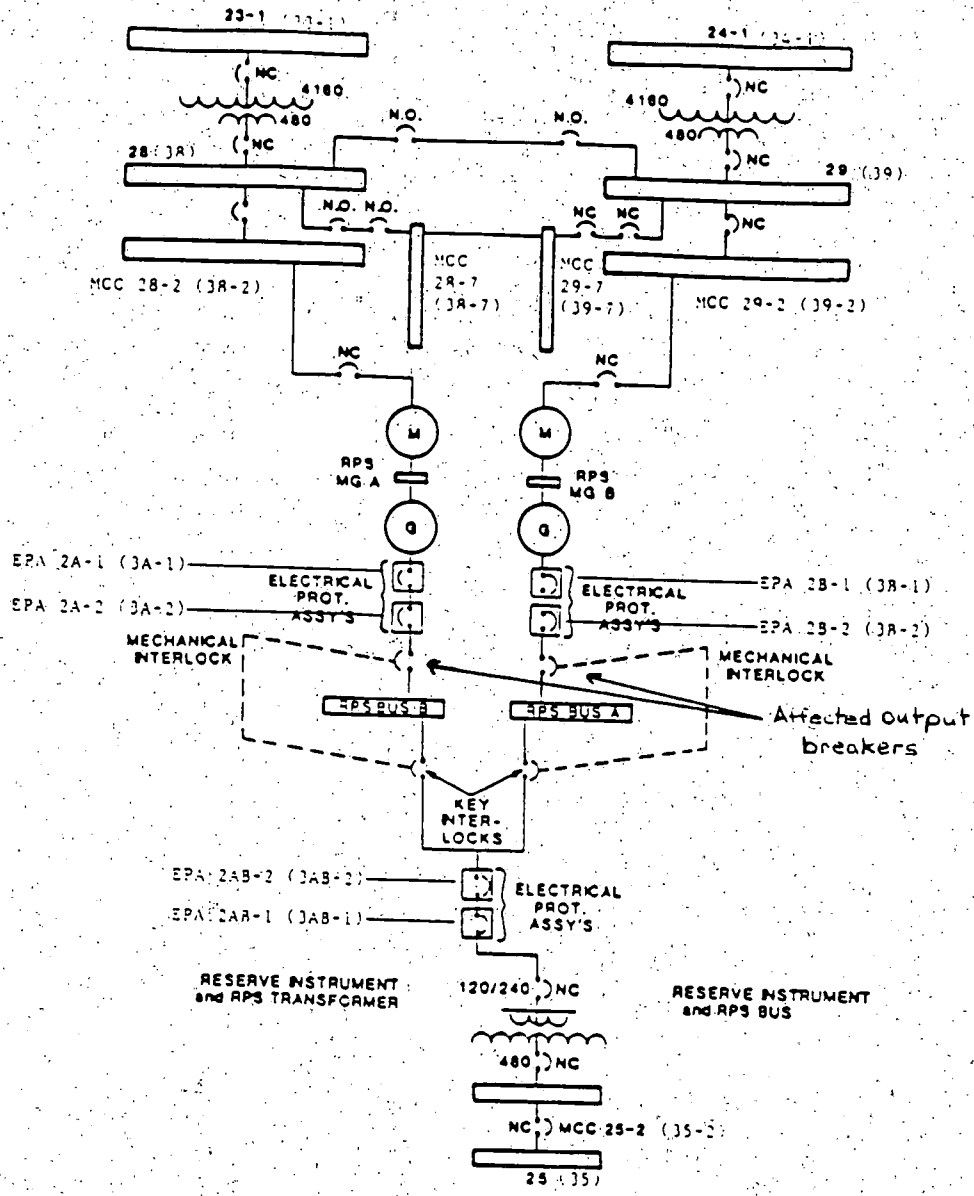
Reactor Protective System Distribution

1. The configuration of the 'A' RPS Bus (i.e., being supplied electrically from the 'B' RPS MG Set and the 'B' RPS Bus being supplied electrically from the 'A' RPS MG Set) presents an element of confusion.
2. The configuration of the Work Package, although technically sound and properly prepared, required careful sequencing in order to prevent this type of event. It was concluded that improved control of this evolution could be provided by developing a comprehensive surveillance procedure for this activity; as such, the procedure would include all necessary configuration alignments in one governing document.
