LICENSEE EVENT REPORT (LER)

Facility Name (1) <b>Dresden Nuclear Power Station, Unit 3</b>	Docket Number (2) <b>0 15 10 10 10 12 14 19</b>	Page (3) <b>1 of 0 5</b>
Title (4) <b>Primary Containment Isolation Valve Closure Due To Reactor Water Cleanup System Isolation</b>

Primary Containment Isolation [JM] Valve Closure Due To Reactor Water Cleanup [CE] System Isolation

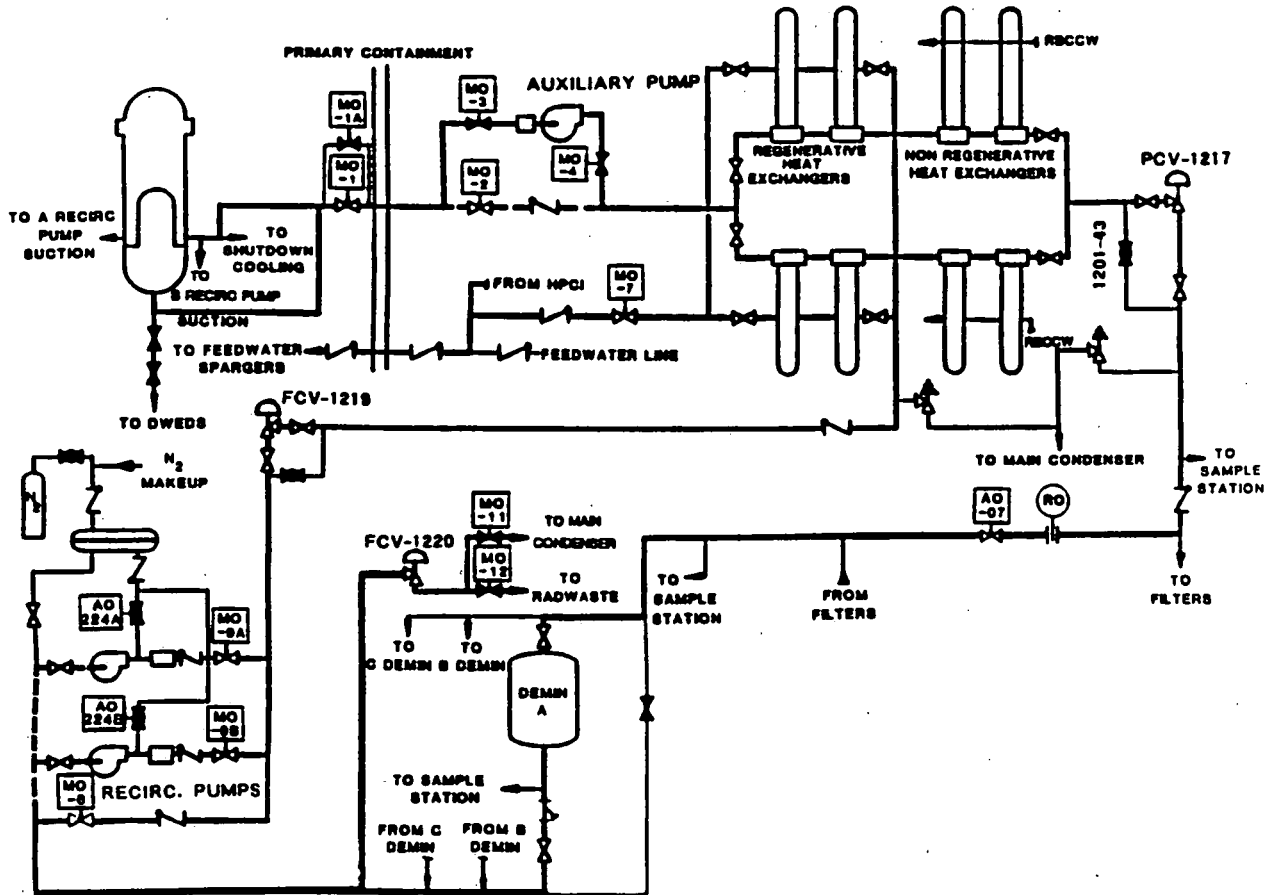
Attachment 1

The RWC system takes water from the reactor vessel through the Reactor Recirculation [AD] system suction line (see attachment 1). During power operation, normal reactor pressure provides the driving force for the water to the RWC system. The water then passes through heat exchangers and a pressure control valve (PCV 3-1217), to reduce the water temperature and pressure, prior to the demineralizers. After the demineralizers, the water is returned to the Feedwater [SJ] system through the RWC recirculation pump and flow control valve (FCV 3-1219).

Investigation concluded that the root cause of the two system isolations was a deficiency within Dresden Operating Procedure (DOP) 1200-01, RWCU System Operation During Startup and Shutdown, such that inadequate guidance was provided concerning positioning of pressure control bypass valve (PCBV) 3-1201-43. During a previous PCV-3-1217 operation difficulty, PCBV-3-1201-43 had been opened. Subsequently, the RWCU system was shutdown for refueling outage maintenance work. In support of other outage activities, restart of the RWCU system was required. The PCBV being open with PCV-3-1217 being open 20% in the manual position, caused system pressure to spike to the isolation setpoint. Pressure switch PS-3-1291-14, which initiates the high pressure isolation, senses system pressure downstream of PCV-3-1217 and PCBV-3-1201-43. Once system pressure increased to the isolation setpoint, the RWCU system isolation valves automatically closed as designed to protect the system from overpressurization. Restart of the RWCU system was completed satisfactorily by closing the PCV and having the PCBV open eight turns.

E/P converter replacement along with E/P and positioner calibrations were performed under work request number D01797 and completed on February 14, 1992. The RWCU system was restored to normal operation at 0303 hours on February 22, 1992. The Operations Department will revise DOP 1200-01 to include clarification concerning manipulation of the PCBV 2(3)-1201-43 valve (249-200-92-02301). The System Engineer is also assisting with a comprehensive review of the RWCU system configuration, and design improvements to the pressure and flow control valves are under evaluation.
