LICENSEE EVENT REPORT (LER)

Title (4) Unanticipated LPCI Minimum Flow Valve M02-501-13B Closure Due to Spurious Master Trip Unit Spike During Calibration

Unanticipated LPCI Minimum Flow Valve M02-1501-13B Closure Due to Spurious Master Trip Unit Spike During Calibration.

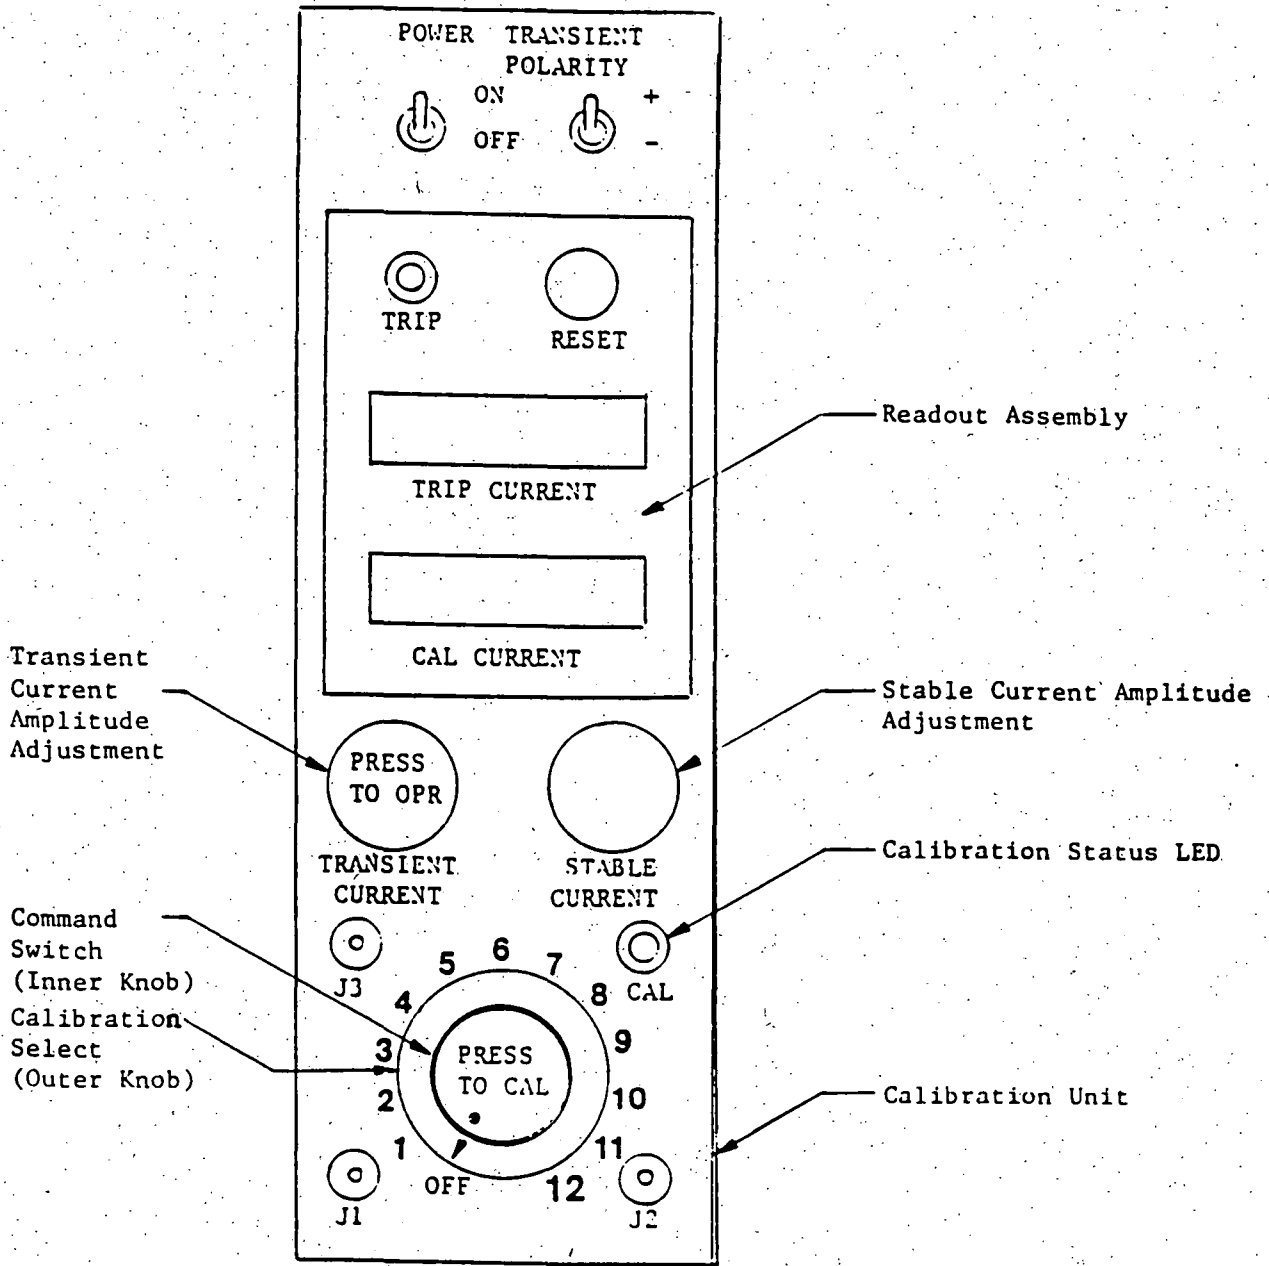
Figure 1. Calibration Unit and Readout Assembly Front Panel

Investigation concerning the spurious MTU spike is in progress, and a supplemental report will be provided. However, error on the part of the IMD technician is not believed to be a factor. Spurious MTU spikes during calibration have not been a previous adverse trend.

The immediate corrective action was to initiate WR 07621 to replace the existing MTU calibration unit for further inspection and failure analysis. On March 20, 1992, the MTU calibration unit was replaced by the IMD under WR 07621 and inspected by the System Engineer. For further failure mode analysis, the MTU calibration unit will be shipped out to the vendor. A supplemental report is scheduled to be submitted by July 31, 1992 giving the results of this further investigation (237-200-92-04501). Also, the IMD will continue to perform Analog Trip System (ATS) calibration on a monthly basis to verify proper function.

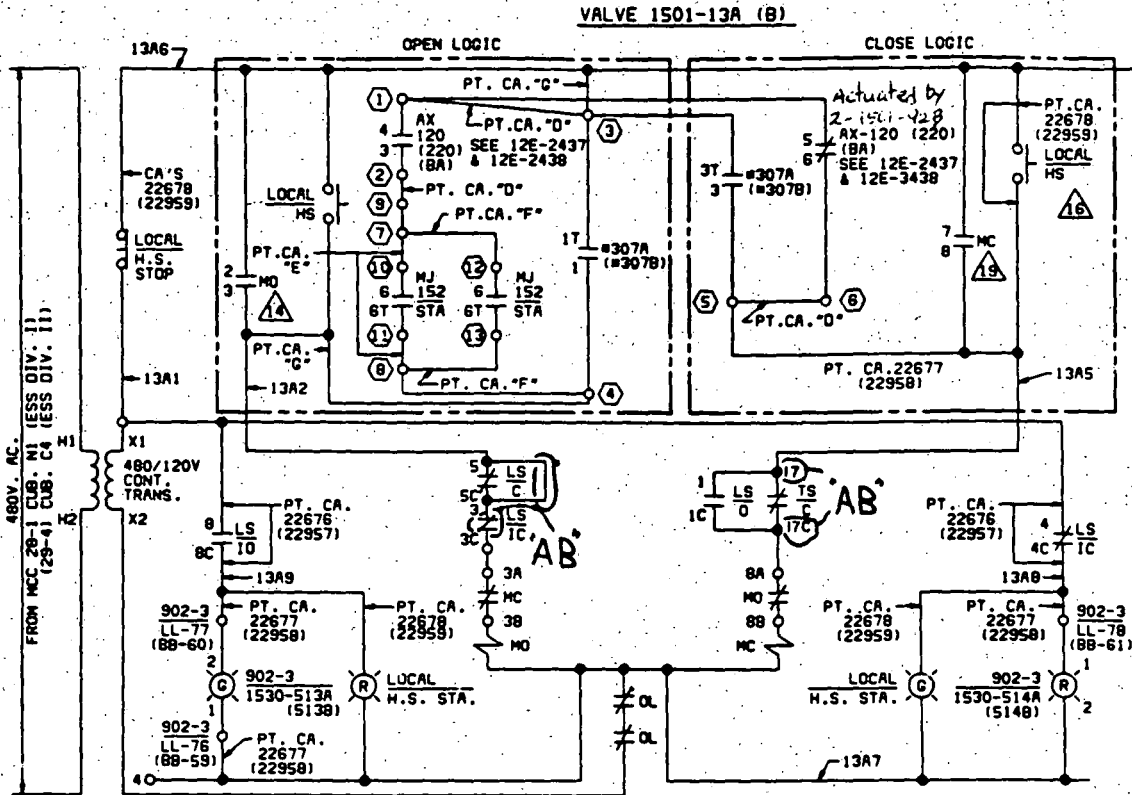
Figure 2. Schematic for MOV 2-1501-13B

The function of MO2-1501-13B is to provide a minimum flow path for the system II LPCI pumps in order to prevent pump damage. The valve is normally open. The LPCI logic (see Figure 2 attached) provides for opening the minimum flow valve. Also, the system II LPCI pumps were not operating at the time and redundant low pressure emergency cooling systems were unaffected. The valve was repositioned back to the open position immediately. Momentary closing of the LPCI minimum flow valve presented minimal potential for damaging the pump as damage would occur only after prolonged operation with no minimum flow protection. Safety significance of this event is therefore considered minimal.
