Dresden Nuclear Power Station

LICENSEE EVENT REPORT (LER)

Title (4) Unit 2 Reactor Scram and Containment Group I Isolation Due to Main Steam Line High Radiation Caused by Resin Intrusion

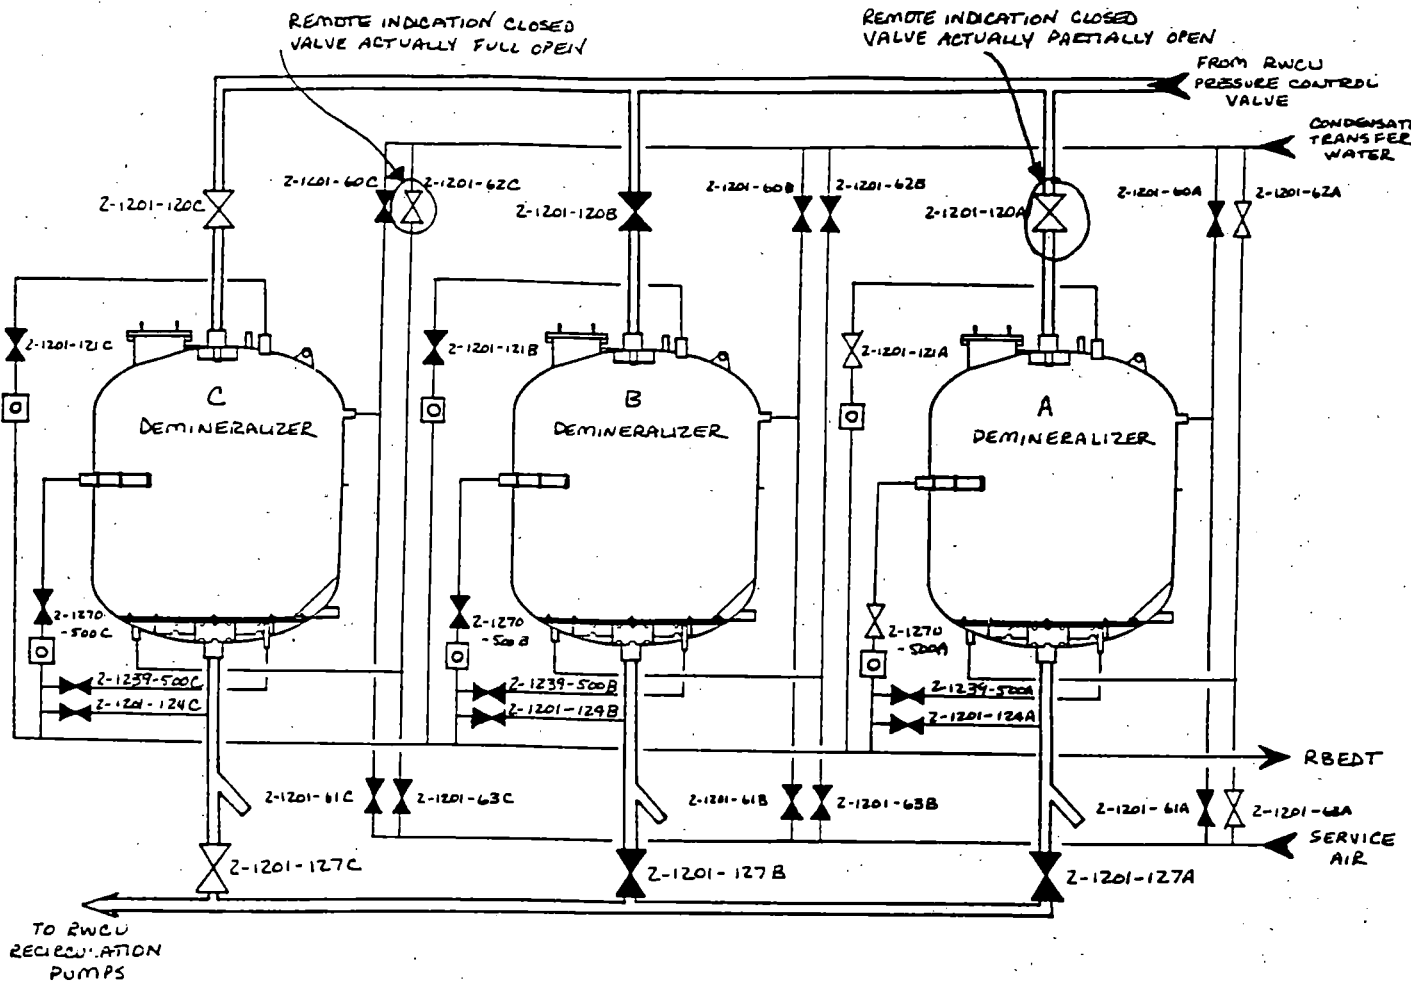
FIGURE 1  
Cleanup System Demineralizer

The introduction of the air agitated the 2C demineralizer resin bed allowing resin fines to be carried through the 2C demineralizer underdrain and into the post-strainer. As the resin fines collected in the post-strainer, the differential pressure (dP) increased to the point of post-strainer degradation. Some of the fines passed through the post-strainer and into the RWCU recirculation pump suction. As more resin fines entered the post-strainer, water flow through the strainer was restricted, causing a low suction pressure transient on the RWCU recirculation pumps, which then tripped. However, the resin fines had already passed through the RWCU recirculation pumps and into the reactor vessel. The reactor then scrambled due to high radiation in the main steam lines.

The intrusion through to the 2C demineralizer underdrain was confirmed by the presence of resin fines found in a sample line [KN] that taps in between the underdrain and the post-strainer. It was noted that the post-strainer dP on the 2C demineralizer was 9 psid just following the scram. On February 12, 1991 the 2C post-strainer dP was 1.8 psid, and after backflushing the post-strainer after the scram, the dP decreased to 1.6 psid.

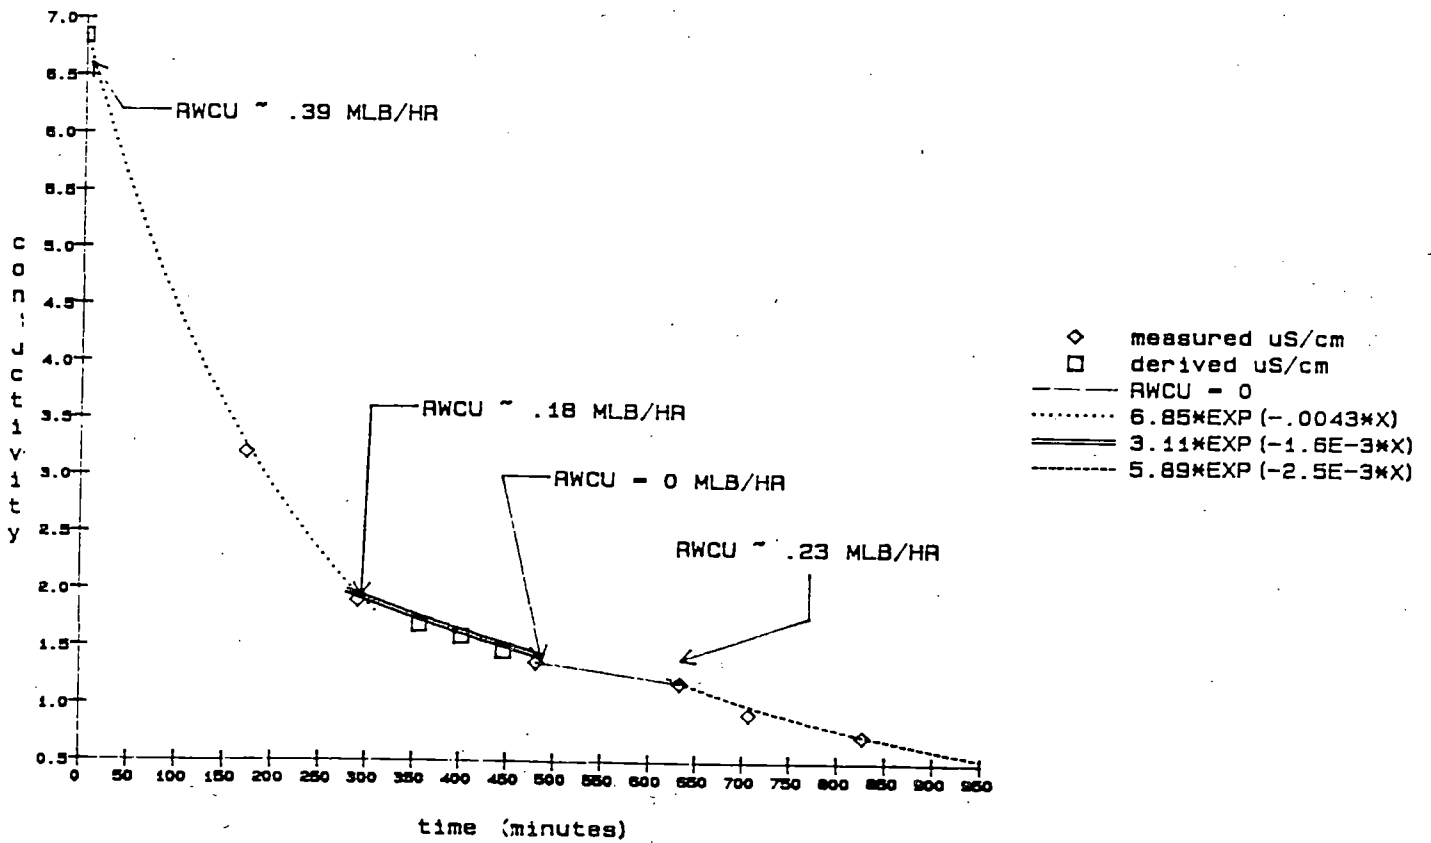
FIGURE 2  
Conductivity Trend

The conductivity of the reactor coolant reached 6.85 micro-mhos per centimeter during the event. Figure 2 shows the coolant conductivity trends after the event. Before the event, the conductivity measured 0.075 micro-mho per centimeter at 0810 hours on February 12, 1991.
