Commonwealth Edison  
Dresden Nuclear Power Station  
R.R. #1  
Morris, Illinois 60450  
Telephone 815/942-2920

LICENSEE EVENT REPORT (LER)

Title (4)  
Scram/Group I Isolation Due to Main Steam Line Radiation Monitor Lockup and Spurious Steam Tunnel Temperature Trip

FACILITY NAME (1)	DOCKET NUMBER (2)	LER NUMBER (6)						Page (3)		
		Year	///	Sequential Number	///	Revision Number				
Dresden Nuclear Power Station	0   5   0   0   0   2   3   7	8   9	-	0   1   9	-	0   1	3	OF	0   7

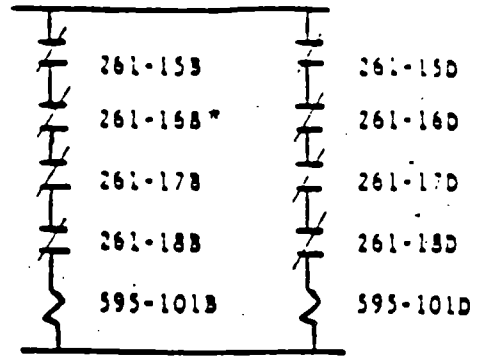
Channel B  
MSL Tunnel Temperature Switches  
and Sensor Relays

In this event, a spurious Channel 'B' MSL tunnel area temperature signal was initiated by one of the temperature switches which drives relay 595-101B. This in turn resulted in de-energization of relay 595-106B, which made up the Channel 'B' primary containment Group I isolation logic. Because a Channel 'A' primary Group I isolation signal was pre-existing due to difficulties in resetting the 'A' MSL LRM "lockup unknown" alarm (MSL high radiation is also a Group I initiation signal), a full Group I isolation and reactor scram on MSIV closure occurred.

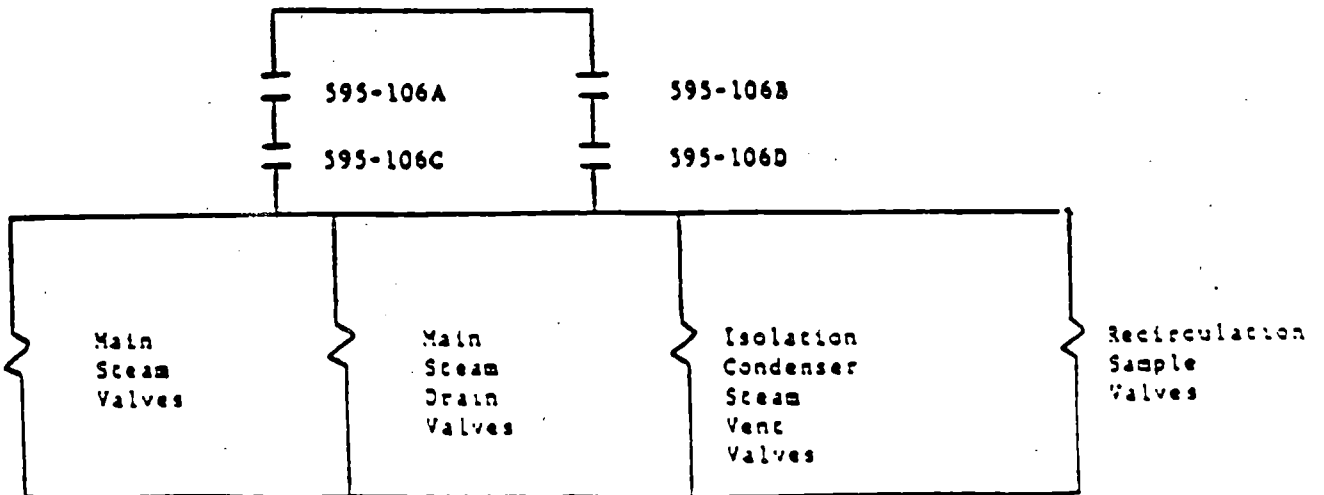
Figure 1

Simplified Group I Valve  
Actuation Relay Logic
