LICENSEE EVENT REPORT (LER)

Facility Name (1) Dresden Nuclear Power Station, Unit 2
 Docket Number (2) 0 5 10 10 10 2 3 7
 Page (3) 1 of 0 4

Title (4) Unanticipated Valve Movement During 125 VDC Ground Checking Due to Management Deficiency

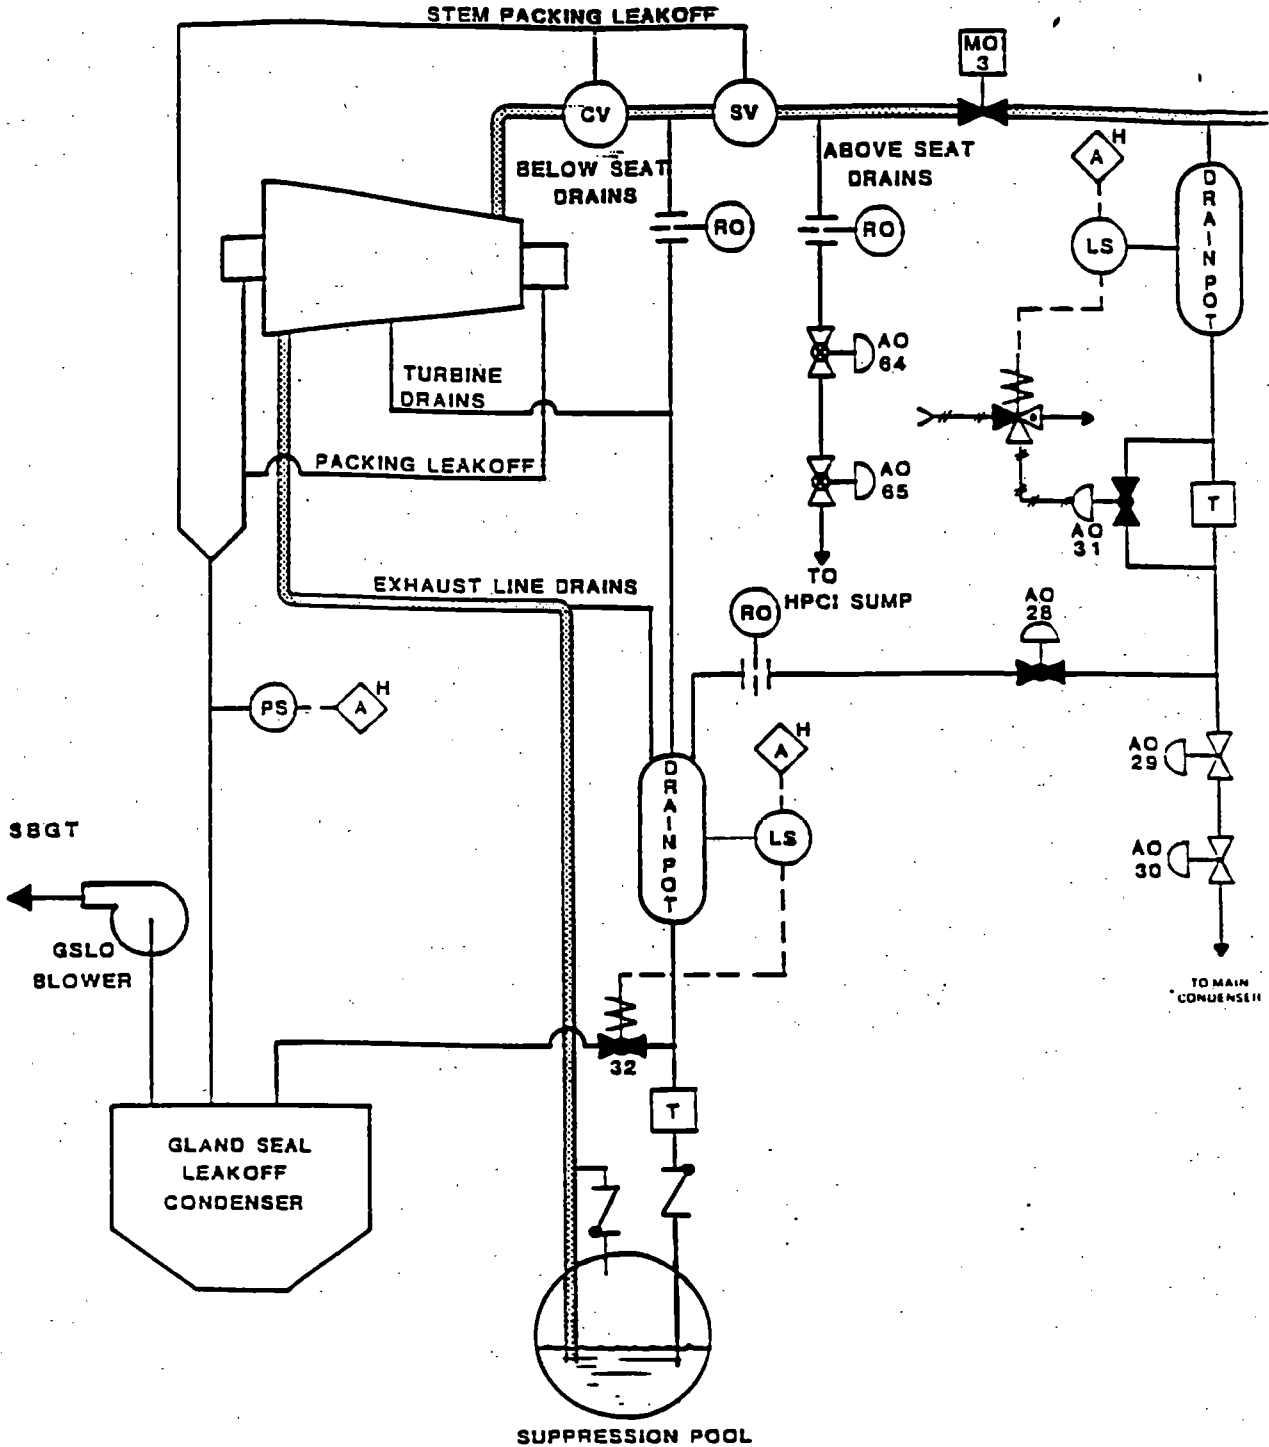
Figure 1

During standby conditions, the HPCI system inlet drain pot removes condensate from the HPCI steam inlet piping upstream of normally closed valve M02-2301-3 and routes it to the main condenser. Valves A02-2301-64 and A02-2301-65 remove any entrapped condensate between M02-2301-3 and the HPCI Turbine Stop Valve, and the condensate is routed to the HPCI sump. Upon HPCI initiation, the inlet drain pot is isolated from the main condenser by the closure of A02-2302-29 and A02-2301-30. A02-2301-64 and A02-2301-65 close to prevent steam from entering the HPCI room through the sump. Valve A02-2301-28 opens to align the inlet drain pot to the suppression pool. In this event all valves were repositioned except for A02-2301-28 which was stuck closed.

HPCI Drain System (Simplified)
