**Commonwealth Edison**  
Dresden Nuclear Power Station  
R.R. #1  
Morris, Illinois 60450  
Telephone 815/942-2920

LICENSEE EVENT REPORT (LER)

Facility Name (1) Dresden Nuclear Power Station, Unit 2  
 Docket Number (2) 0 5 10 10 10 2 3 7  
 Page (3) 1 of 0 4

Title (4) Unanticipated Valve Movement During 125 VDC Ground Checking Due to Management Deficiency

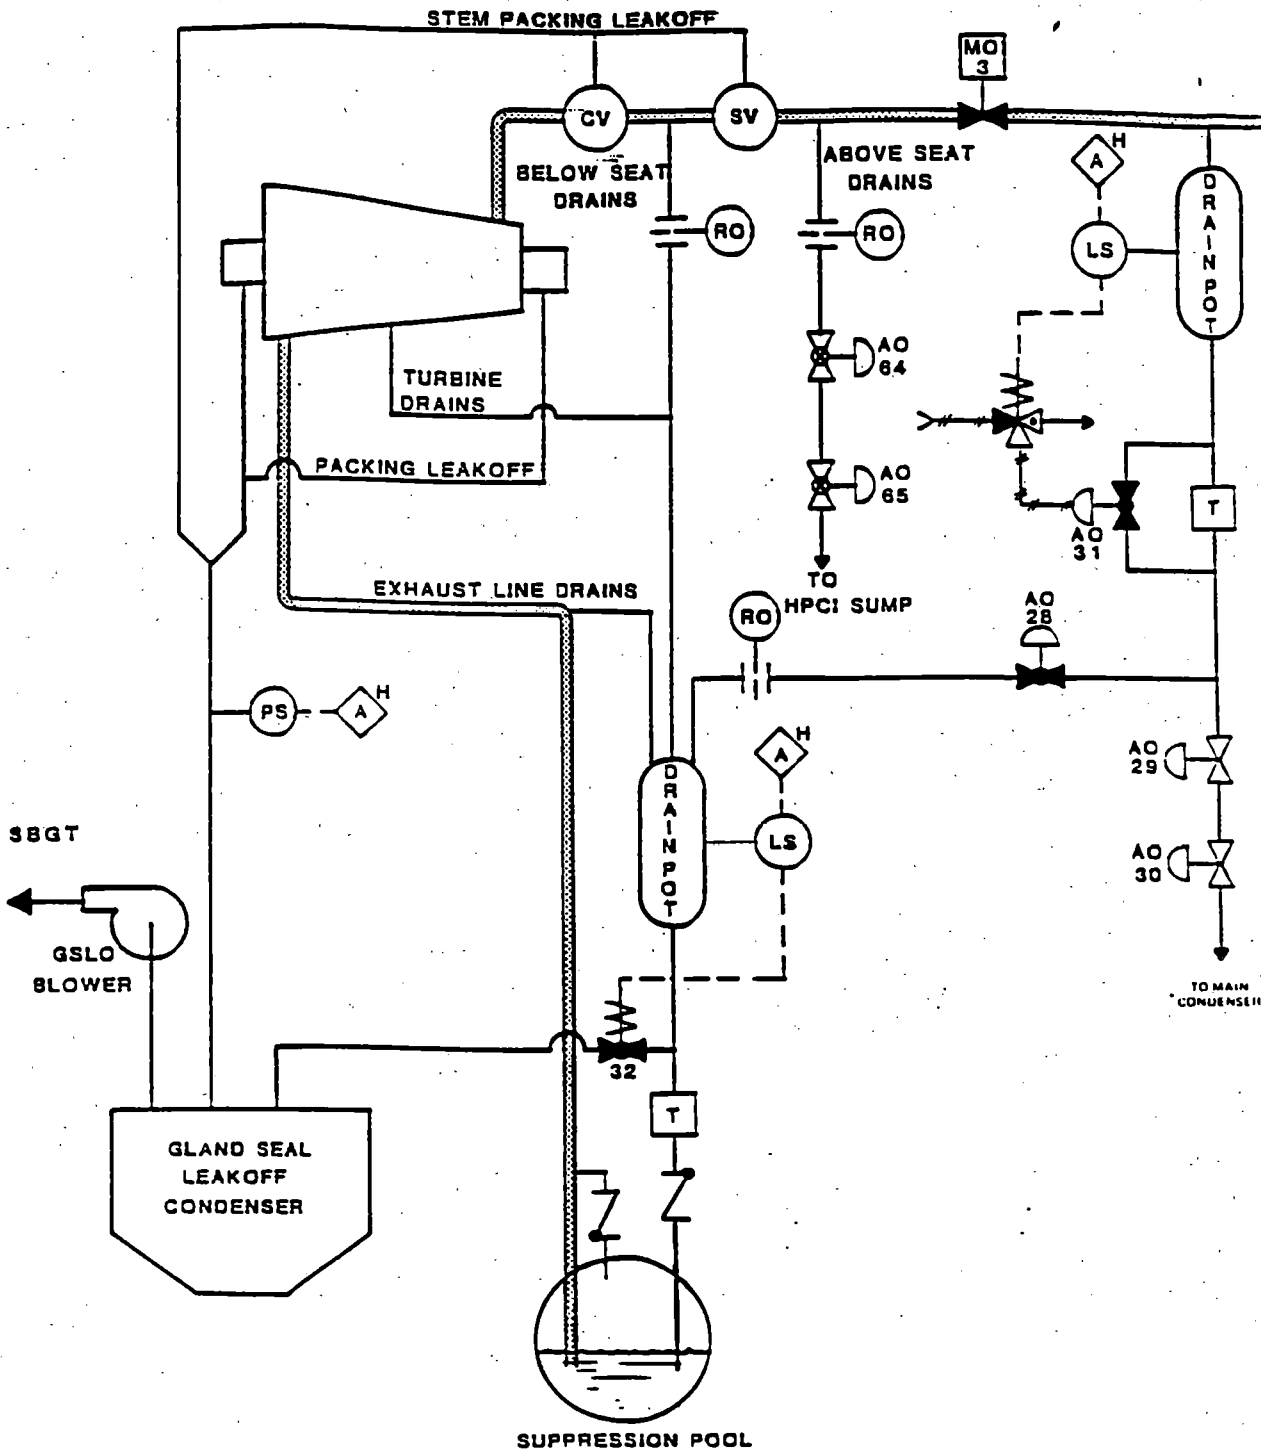
Figure 1

During standby conditions, the HPCI system inlet drain pot removes condensate from the HPCI steam inlet piping upstream of normally closed valve M02-2301-3 and routes it to the main condenser. Valves A02-2301-64 and A02-2301-65 remove any entrapped condensate between M02-2301-3 and the HPCI Turbine Stop Valve, and the condensate is routed to the HPCI sump. Upon HPCI initiation, the inlet drain pot is isolated from the main condenser by the closure of A02-2302-29 and A02-2301-30. A02-2301-64 and A02-2301-65 close to prevent steam from entering the HPCI room through the sump. Valve A02-2301-28 opens to align the inlet drain pot to the suppression pool. In this event all valves were repositioned except for A02-2301-28 which was stuck closed.

If HPCI were to initiate with A02-2301-28 closed, the inlet drain pot would be prevented from draining. During HPCI operation, however, the condensate level inside the drain pot would remain approximately the same since a lower drain path is provided in the inlet piping with M02-2301-3 open. However, if the system was shutdown with M02-2301-3 closed, condensate would begin to collect upstream of M02-2301-3 at a condensing rate of approximately 200 lb/hr. As the condensate level increased, the level alarms in the drain pot would notify the operator of a drain problem, at which time the operator would cycle A02-2301-28 to open the valve.

HPCI Drain System (Simplified)
