LICENSEE EVENT REPORT (LER)

Facility Name (1) Dresden Nuclear Power Station, Unit 2	Docket Number (2) 0 5 0 0 0 2 3 7	Page (3) 1 of 0 4
--	--	----------------------------

Title (4) Unanticipated Valve Movement During 125 VDC Ground Checking Due to Management Deficiency

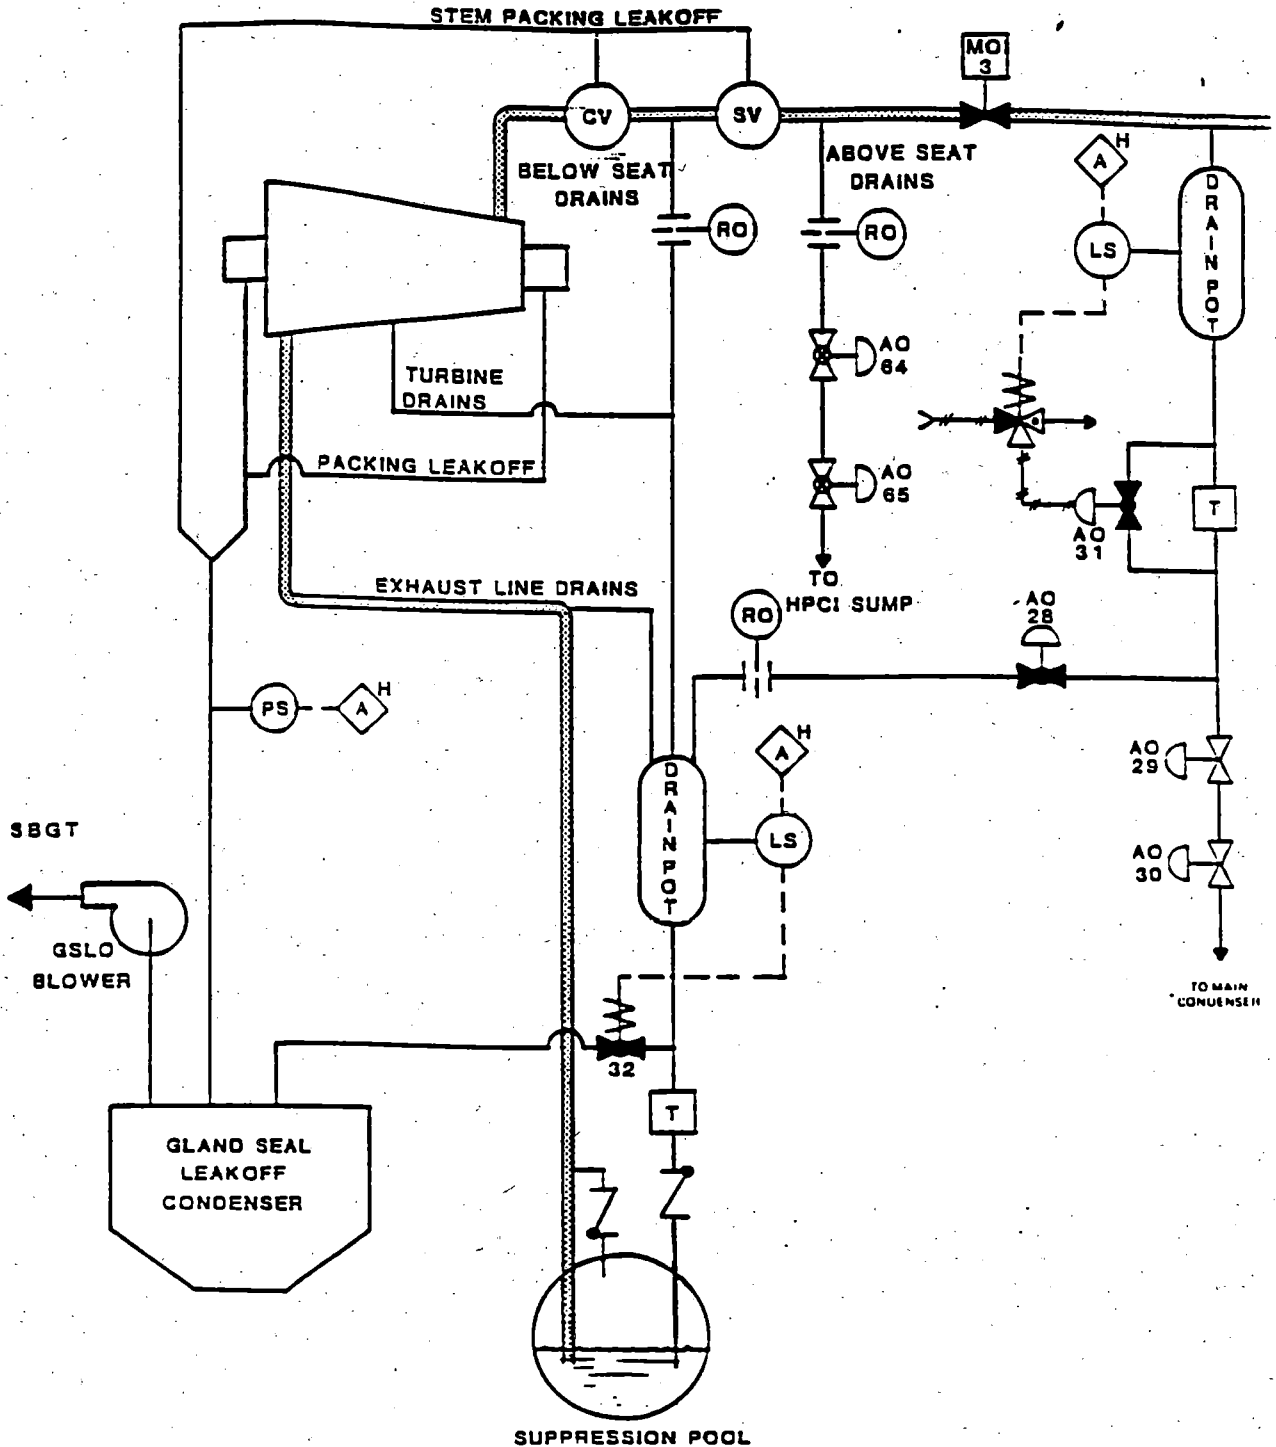
During standby conditions, the HPCI system inlet drain pot removes condensate from the HPCI steam inlet piping upstream of normally closed M02-2301-3 and routes it to the main condenser. (Refer to Figure 1 for a HPCI drain system diagram.) Valves A02-2301-64 and A02-2301-65 remove entrapped condensate between M02-2301-3 and the HPCI Turbine Stop Valve, and the condensate is routed to the HPCI sump. Upon HPCI initiation, the inlet drain pot is isolated from the main condenser by the closure of valves A02-2302-29 and A02-2301-30. Valves A02-2301-64 and A02-2301-65 close to prevent steam from entering the HPCI room through the sump. The inlet drain pot is then aligned to the suppression pool (normally closed valve A02-2301-28 opens).

It was determined that the solenoid for valve A02-2301-28 had been de-energized during the afternoon shift on May 7, when a portion of the HPCI control logic was temporarily de-energized per Dresden Operating Procedure (DOP) 6900-7, 125 Volt Ground Detection. The solenoids for valves A02-2301-29,30,64, and 65 were also de-energized at this time. DOP 6900-07 requires circuit #14 of 125 VDC Turbine Building Reserve Bus 2B-1 to be de-energized and isolated from the battery in order to determine if the ground is located in that circuit. The procedure identified the de-energization of valves A02-2301-64 and A02-2301-65, but did not identify the de-energization of valves A02-2301-28, A02-2301-29, and A02-2301-30. The solenoids for these valves are normally energized, with valve A02-2301-28 being designed to fail open upon loss of DC power or instrument air. De-energization of the solenoids for these valves requires manual resetting of each valve to return them to the normal position. Valves A02-2301-29,30,64, and 65 responded correctly to the de-energization, and were restored to their normal position. The solenoid for A02-2301-28 was de-energized; however, the main valve did not initially open. A02-2301-28 remained closed until about 0400 hours on May 8. A review of suppression pool temperature and level revealed that both parameters were constant until 0400, when both began increasing. Even with valve A02-2301-28 being open, the increase in pool temperature and level was greater than expected. A review of the HPCI system revealed that the HPCI steam inlet drain pot steam trap bypass valve, A02-2301-31, was leaking through. This resulted in reactor steam pressure being applied to a restricting orifice upstream of A02-2301-28, and providing the increased steam load to the suppression pool.

Contributing to this event was the A02-2301-28 solenoid being de-energized, but not initially opening. The cause has been attributed to binding of the valve stem, thereby preventing this valve from going fully open. A maintenance history review revealed that this valve had previously exhibited binding problems. The entire valve was replaced in December 1990. WR 08593 had previously been written on April 16, 1992 to investigate a failure of the valve to cycle from the Control Room. The valve stem was lubricated and the valve was stroked 3 times to verify operability.

During standby conditions, the HPCI system inlet drain pot removes condensate from the HPCI steam inlet piping upstream of normally closed valve M02-2301-3 and routes it to the main condenser. Valves A02-2301-64 and A02-2301-65 remove any entrapped condensate between M02-2301-3 and the HPCI Turbine Stop Valve, and the condensate is routed to the HPCI sump. Upon HPCI initiation, the inlet drain pot is isolated from the main condenser by the closure of A02-2302-29 and A02-2301-30. A02-2301-64 and A02-2301-65 close to prevent steam from entering the HPCI room through the sump. Valve A02-2301-28 opens to align the inlet drain pot to the suppression pool. In this event all valves were repositioned except for A02-2301-28 which was stuck closed.

Mechanical Maintenance Department (MMD) personnel investigated the cause of valve A02-2301-28 failure to open. Lack of lubrication on the valve stem contributed to this valve's failure to cycle. The valve stem was lubricated and verified operable by cycling the valve three times. This valve is included in a preventive maintenance program to lubricate once every refuel outage.
