LICENSEE EVENT REPORT (LER)

Facility Name (1) Dresden Nuclear Power Station, Unit 2						Docket Number (2) 0 5 0 0 0 2 3 7			Page (3) 1 of 0 5		
Title (4) Primary System Isolation Valve Closure Due To Reactor Water Cleanup System Isolation During Pump Change-over

Reactor Water Cleanup [CE] System Primary Containment Isolation [JM] Valve Closure During Pump Change-over

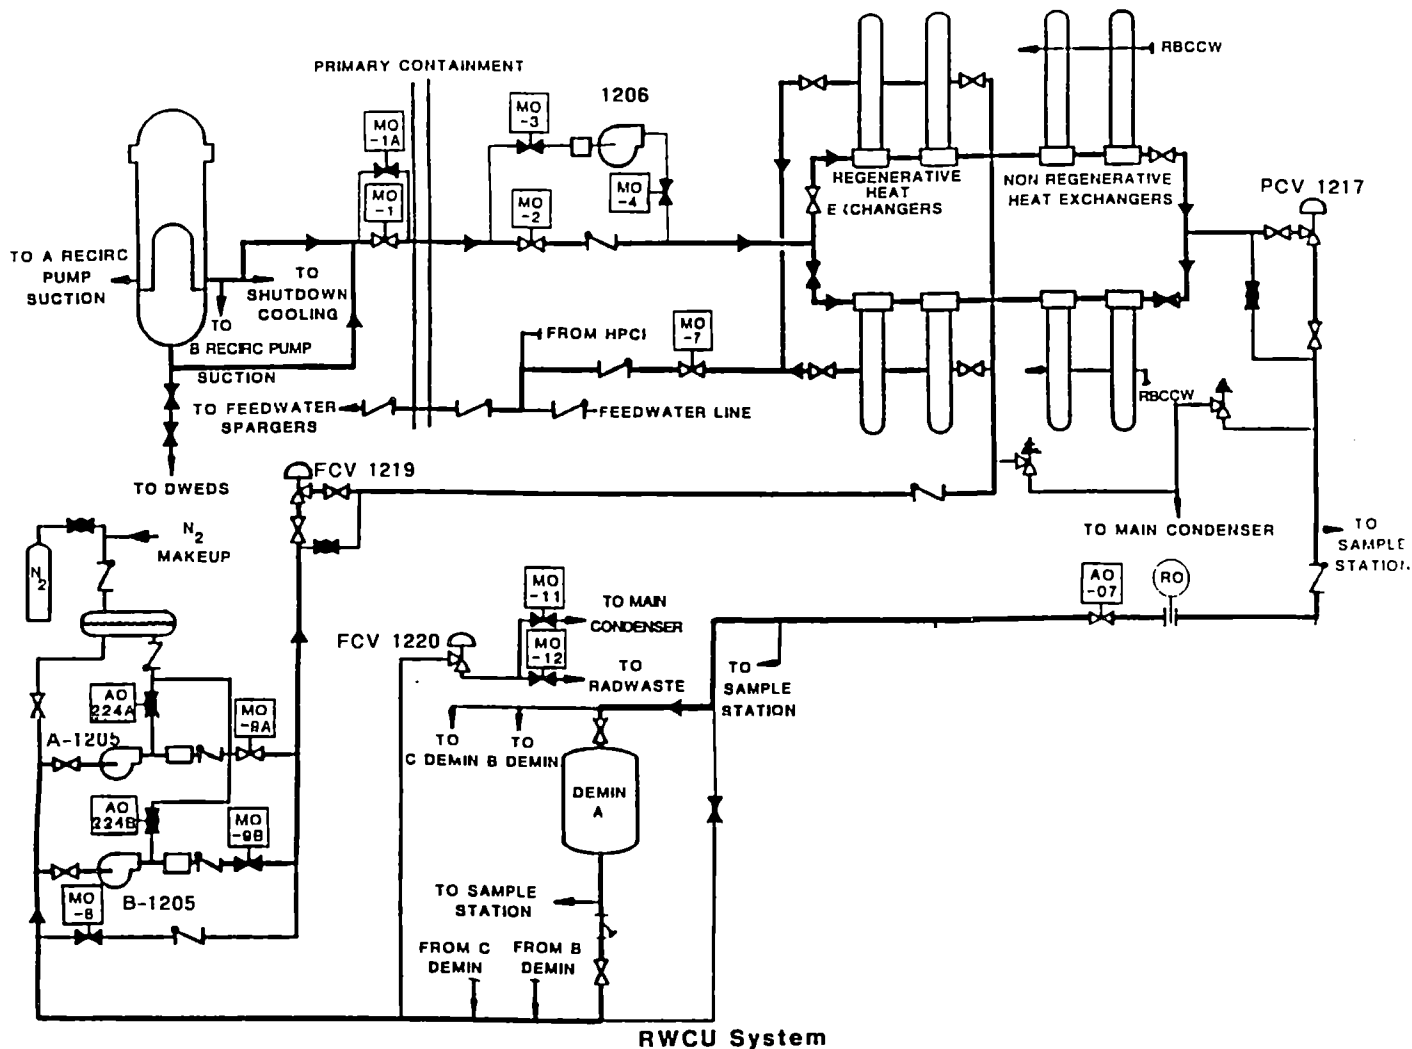
ATTACHMENT 1

The RWC system takes water from the reactor vessel through the Reactor Recirculation [AD] system suction line (see attachment 1). During power operation, normal reactor pressure provides the driving force for the water to the RWC system. The water then passes through heat exchangers and a pressure control valve (PCV 2-1217) which reduces the water temperature and pressure prior to entering the demineralizers. After the water exits the demineralizers, the water is returned to the Feedwater [SJ] system through a recirculation pump and a flow control valve (FCV 2-1219).
