Commonwealth Edison
Dresden Nuclear Power Station
R.R. #1
Morris, Illinois 60450
Telephone 815/942-2920

LICENSEE EVENT REPORT (LER)

Facility Name (1) Dresden Nuclear Power Station, Unit 3	Docket Number (2) 0 5 0 0 0 2 4 9	Page (3) 1 of 0 7
------------------------------------------------------------	--------------------------------------	----------------------

Title (4) Bus 38 Undervoltage Relay Actuation Due to Inadvertent Shorting of Relay Terminals

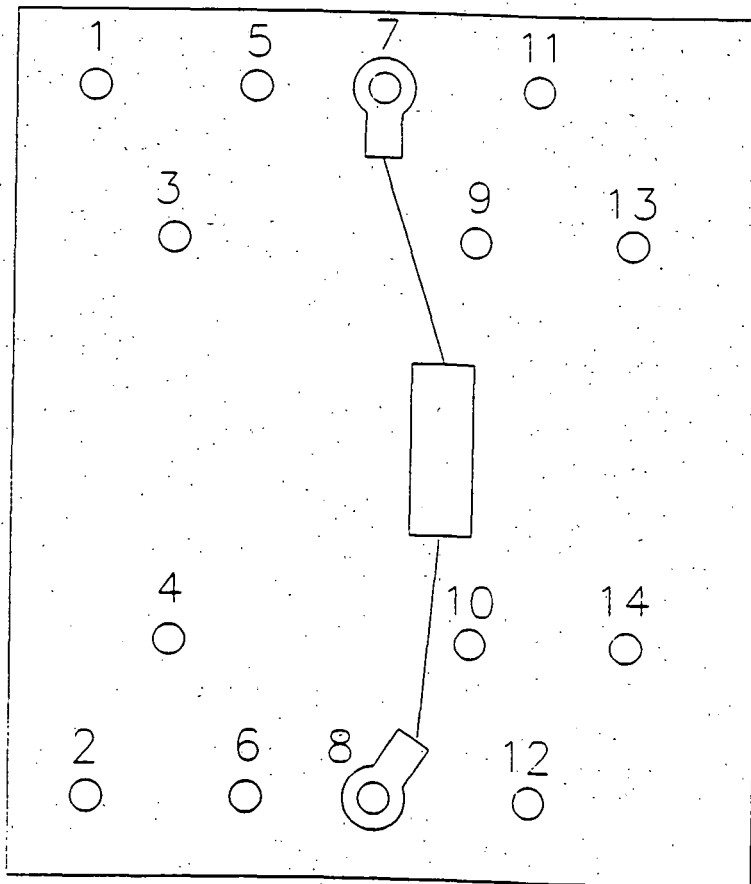
Figure 1.

The cause of this event is attributed to the Electrician's tool coming in contact with two terminals on the undervoltage relay (Refer to Figure 1). During a tightness check of a wire termination nut at the rear of relay #227-B38-X1, the Electrician had put a taped nut driver on terminal #10. When the exposed lower face of the nut driver contacted a non-insulated lug of a resistor installed on terminal #8. The resistor lug on terminal #8 was in close proximity to terminal #10. The momentary contact between the two terminals caused relay #227-B38-X1 to actuate, shedding all active equipment off of Bus 38 (Refer to Figure 2). In order for the relay to have actuated, terminal #10 would have to be at a positive DC potential, as the coil is normally at a negative DC potential. Initially it was believed that the wiring to contacts #9 and #10 were reversed. Work Request (WR) 04274 was written to investigate the wiring to relay #227-B38-X1.

Back View of Relay 227-B38-X1 Terminals

The immediate corrective actions were to terminate the surveillance and restore all affected equipment to normal operation. The event was reviewed with the personnel involved; it should be noted that the Electrician had taped the nut driver shaft and was using caution against accidental shorts. WR 04274 was written to further investigate the wiring. Under WR 04274 the wiring leading to terminals #9 and #10 was confirmed to be correct. The Electrical Maintenance Department (EMD) purchased sets of nut drivers insulated with a rubber sheath for use in this type of activity. WR 09999 was written to adjust the position of the resistor to prevent this event from recurring. EMD will perform this during refueling outage D3R13. (249-200-91-07504)

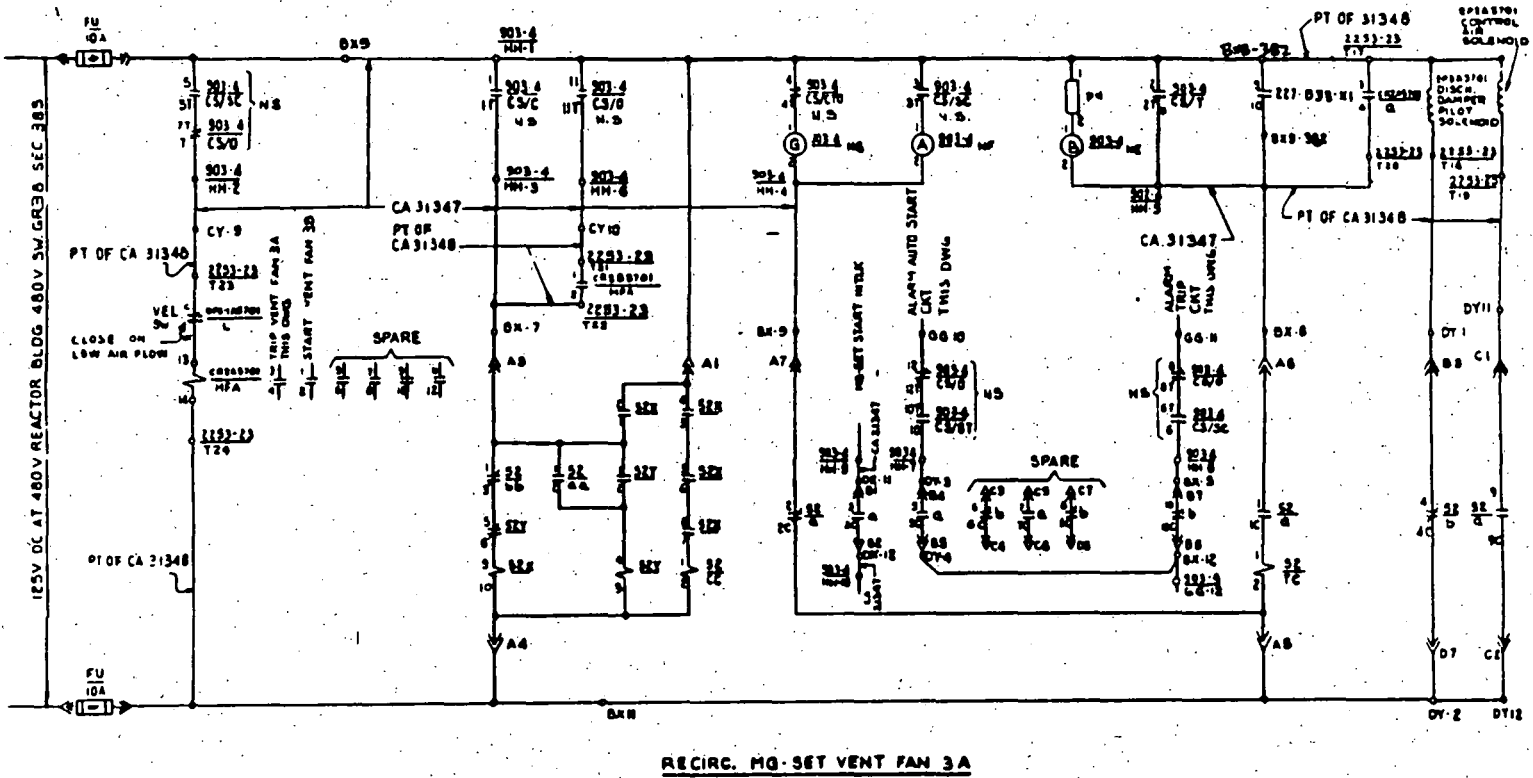
Figure 3.

A check for circuit continuity utilizing approved drawings, with the fuses pulled and the Recirculation [AD] Motor Generator Set (MG-Set) Vent Fan 3A Out-Of-Service (OOS), confirmed a properly wired circuit for the 9-10 contact of relay #227-B38-X1 (Refer to Figure 3). A review of Unit 3 Operator Daily Surveillance Log was performed, and it was determined that at time of the event the MG-Set 3B Vent Fan was in the pull-to-lock (PTL) position. With the MG-Set 3B Vent Fan control switch in its PTL position, contact 2-2T which is in parallel with contact 9-10 of relay #227-B38-X1, is closed. Terminal #10 in this condition would be at a positive DC potential. Also, relay #227-B38-X1 has a coil with a DC rating of 62.5 Volts. Therefore, when the terminals were shorted the voltage across the coil was sufficient to pick up relay #227-B38-X1, which sealed in the undervoltage scheme of the circuit actuating relay #227-B38-X2 and shedding the active equipment off of Bus 38.
