Commonwealth Edison
Dresden Nuclear Power Station
R.R. #1
Morris, Illinois 60450
Telephone 815/942-2920

LICENSEE EVENT REPORT (LER)

Facility Name (1) Dresden Nuclear Power Station, Unit 3 Docket Number (2) 0 15 10 10 10 12 14 19 Page (3) 1 of 0 4

Title (4) Primary Containment Isolation Valve Closure Due To RWCU System Isolation

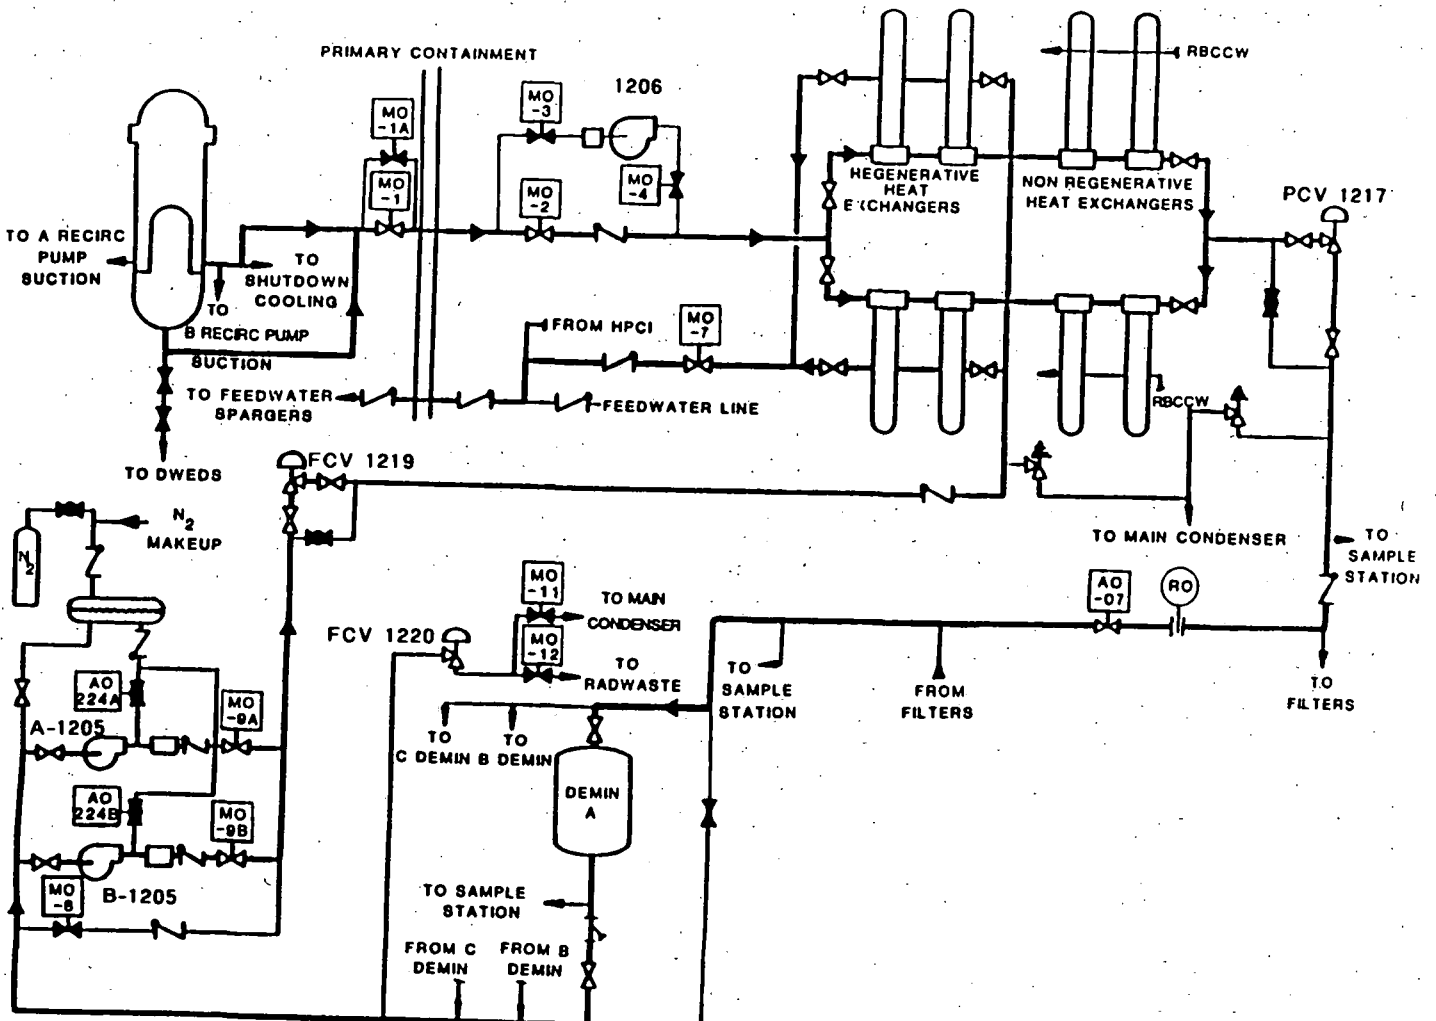
ATTACHMENT 1

The RWCU system takes water from the Reactor Recirculation [AD] System Suction Line (see Attachment 1). During normal power operation, reactor pressure provides the driving force to circulate water through the RWCU system. Auxiliary pumps are provided to transfer water when the reactor is not at pressure. The RWCU recirculation pumps are not utilized during this mode of operation. The water passes through heat exchangers and Pressure Control Valve (PCV) 3-1217, to reduce temperature and pressure. Temperature and pressure must be reduced to less than 150 lbs and 150 degrees F to avoid damaging the bead resin in the demineralizers. After flowing through the demineralizers, the water is returned to the Feedwater [SJ] system through the RWCU Recirculation pump and Flow Control Valve (FCV) 3-1219.

The root cause of this system isolation was due to a momentary system pressure surge created by the inability of the PCV 3-1217 to control startup flow rates and pressures. The PCV 3-1217 was designed for 1300 GPM (two demineralizers in service) flow and is currently operating at 650 GPM (one demineralizer in service). This results in the valve being severely throttled which leads to wear and cavitation. A PCV more suitably sized for use in the Unit 2 RWCU system has been ordered. The same valve design is also being considered for Unit 3 RWCU PCV 3-1217.

Normal RWCU System Flow

The Nuclear Engineering Department (NED), the Site General Electric Company Engineer, and the System Engineer have reviewed the design of a new pressure control valve. This valve is scheduled to be replaced during the next Unit 2 refuel outage (237-200-92-07104).
