Commonwealth Edison
Dresden Nuclear Power Station
R.R. #1
Morris, Illinois 60450
Telephone 815/942-2920

Attached please find Licensee Event Report #91-031-01, Docket #050237.
This revised report is being submitted to provide the result of the
disassembly and inspection of Unit 2 Control Rod Drive R-10, as committed
in the original report.

Title (4) Control Rod Drive R-10 Failure to Latch Due to Collet Piston Binding

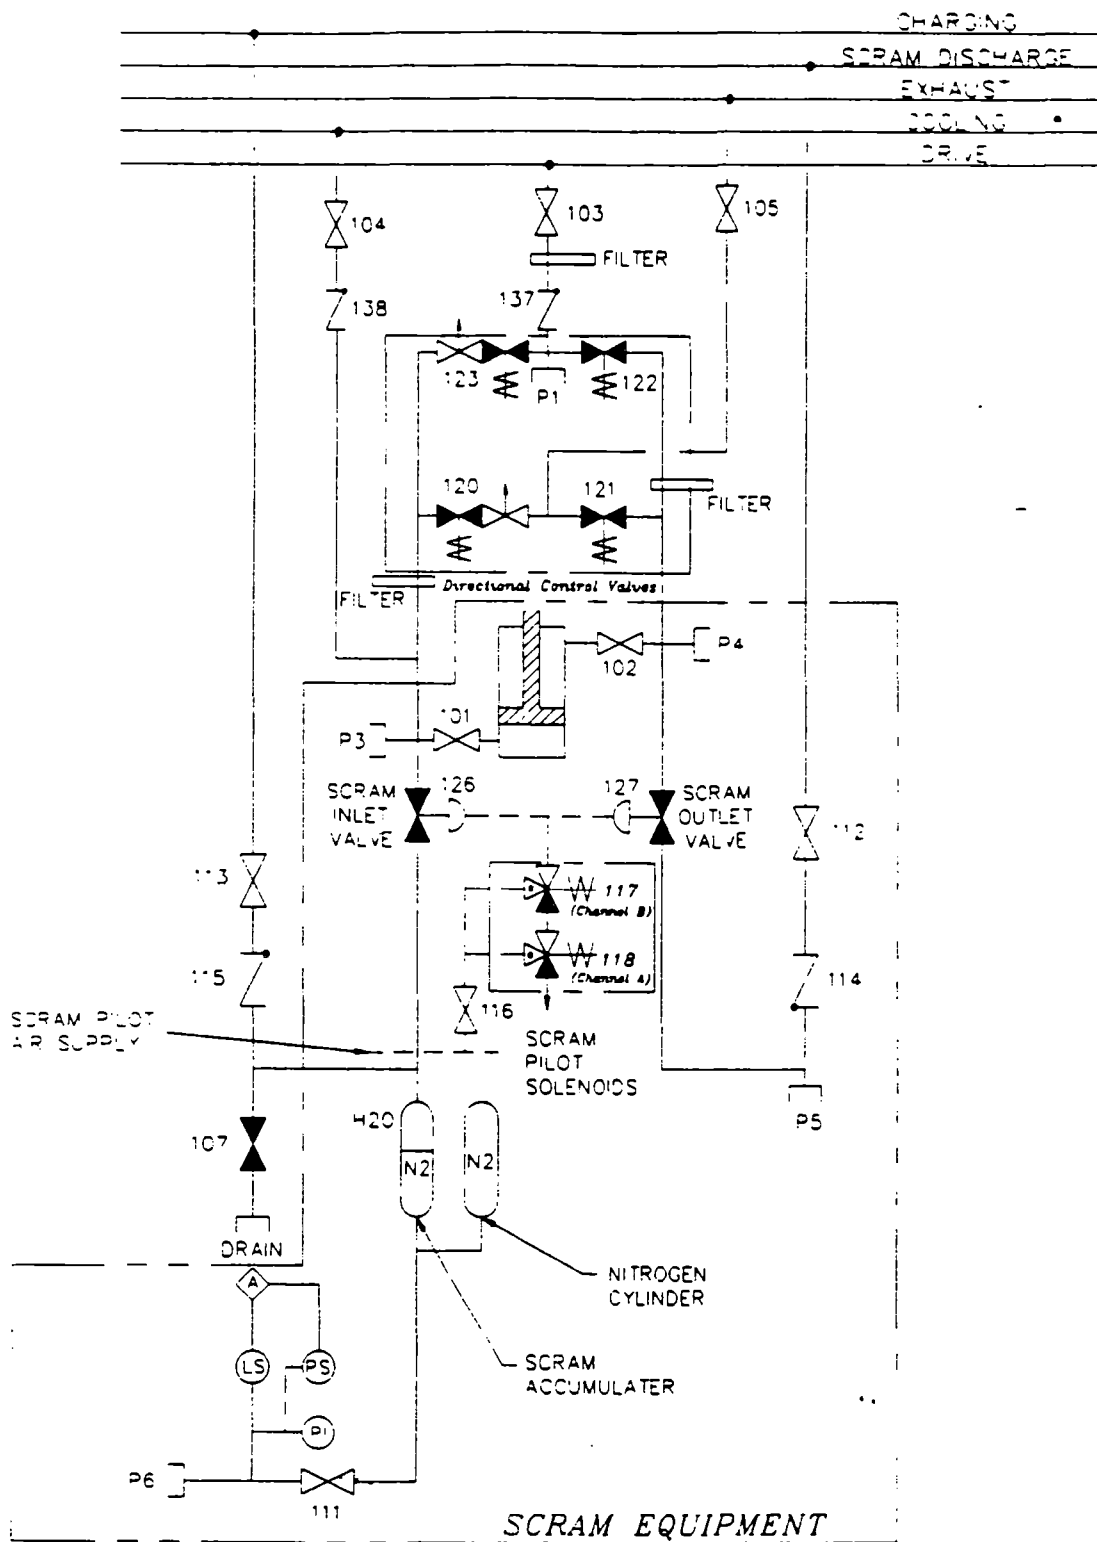
STABLE
 CRD Hydraulic Control Unit (piping diagram)
 Figure 1

While troubleshooting CRD R-10, valve 2-305-102, Withdraw Riser Isolation Valve, was isolated to eliminate potential drive pressure to the CRD overpiston area or CRD collet piston (see Figure 1 attached). The insert signal was then removed and CRD R-10 again failed to latch at position "00". The CRD was returned to position "00" using the Emergency-In/Notch Override Switch and valve 2-305-102 was opened.

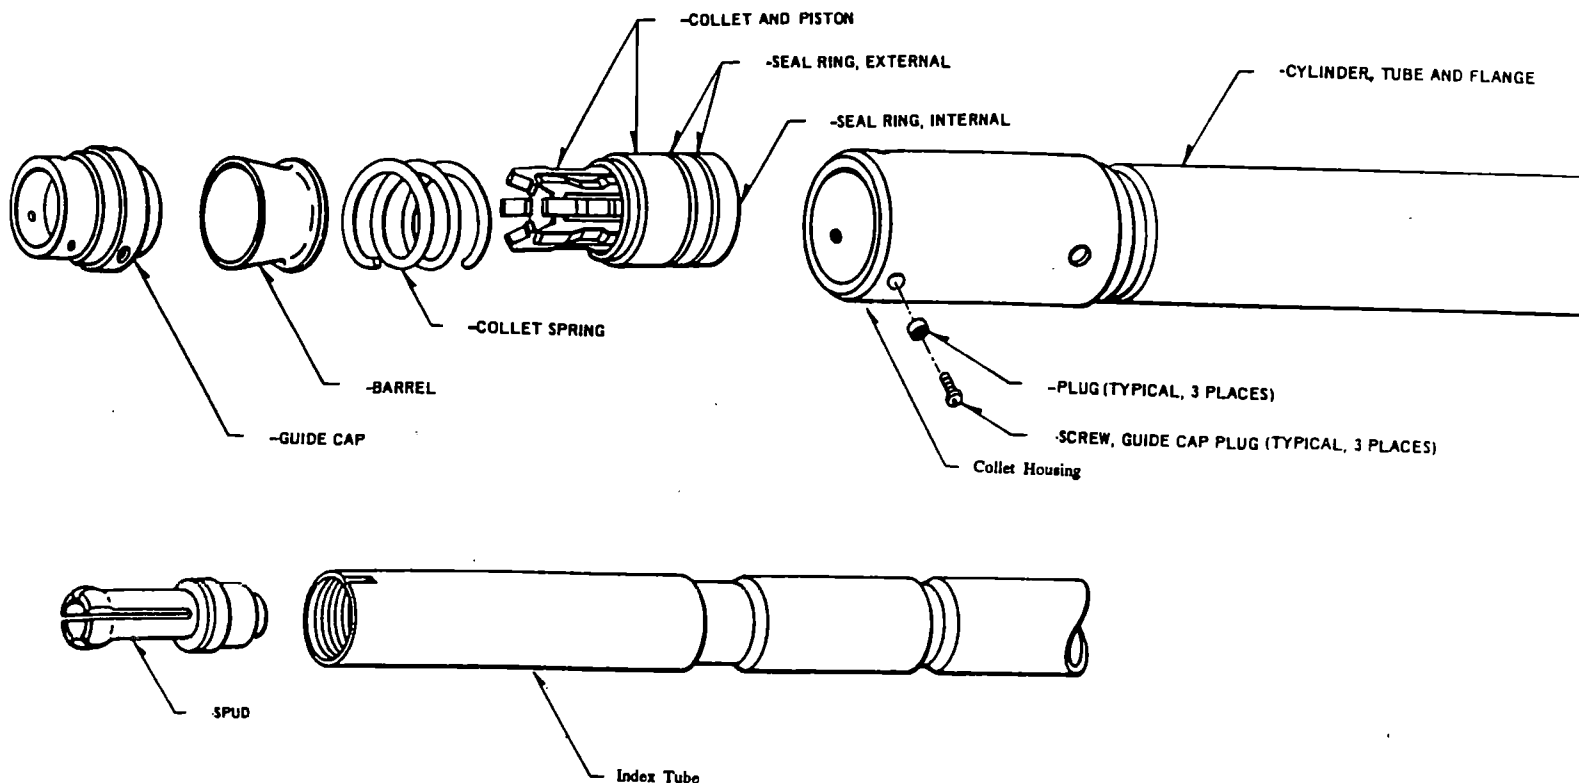
Figure 2

On July 11, 1992, the CRD was disassembled and inspected by the Technical Staff System Engineer. The Collet Piston and Collet Housing area of the Cylinder Tube were inspected for damage (see figure 2). The inspection found that the contacting surfaces between the two parts were covered with a significant film of corrosion. The corrosion resulted in the collet piston binding in the unlatched position. In this position, the collet fingers are spread by the guide cap preventing them from latching to the index tube. The result is that the CRD is unable to latch at any position during normal drive movement.

During a scram, however, CRD R-10 was able to latch at position "00". This is due to the difference in methods for returning the collet piston to the latched position during each type of drive movement. During normal drive movement, pressure from the collet spring is used to return the collet piston to the latched position. During a scram signal, as the scram outlet valve opens (see figure 3) allowing flow to the scram discharge volume, the withdraw line goes to atmospheric pressure. This results in a differential pressure of approximately 1000 psi (reactor pressure) across the collet piston. This differential pressure is able to overcome the piston binding and therefore latch the CRD at position "00". Inspections found the collet housing intact.

4. OSR 91-27 was written to address safety concerns and special actions that resulted from allowing CRD R-10 to remain in the core.
5. CRD R-10 was removed from Unit 2 in Decmeber, 1991. The CRD was then disassembled under work request 04125 to determine the cause of the collet piston binding.
