LICENSEE EVENT REPORT (LER)

Facility Name (1) <p style="text-align:center;">Dresden Nuclear Power Station, Unit 2</p>	Docket Number (2) <p style="text-align:center;">0 5 0 0 0 2 3 7</p>	Page (1) <p style="text-align:center;">1 of 0 5</p>
--	--	--

Title (4)
Isolation Condenser Vent Valves 2-1301-17 and 2-1301-20 Closure Due to Unknown Causes

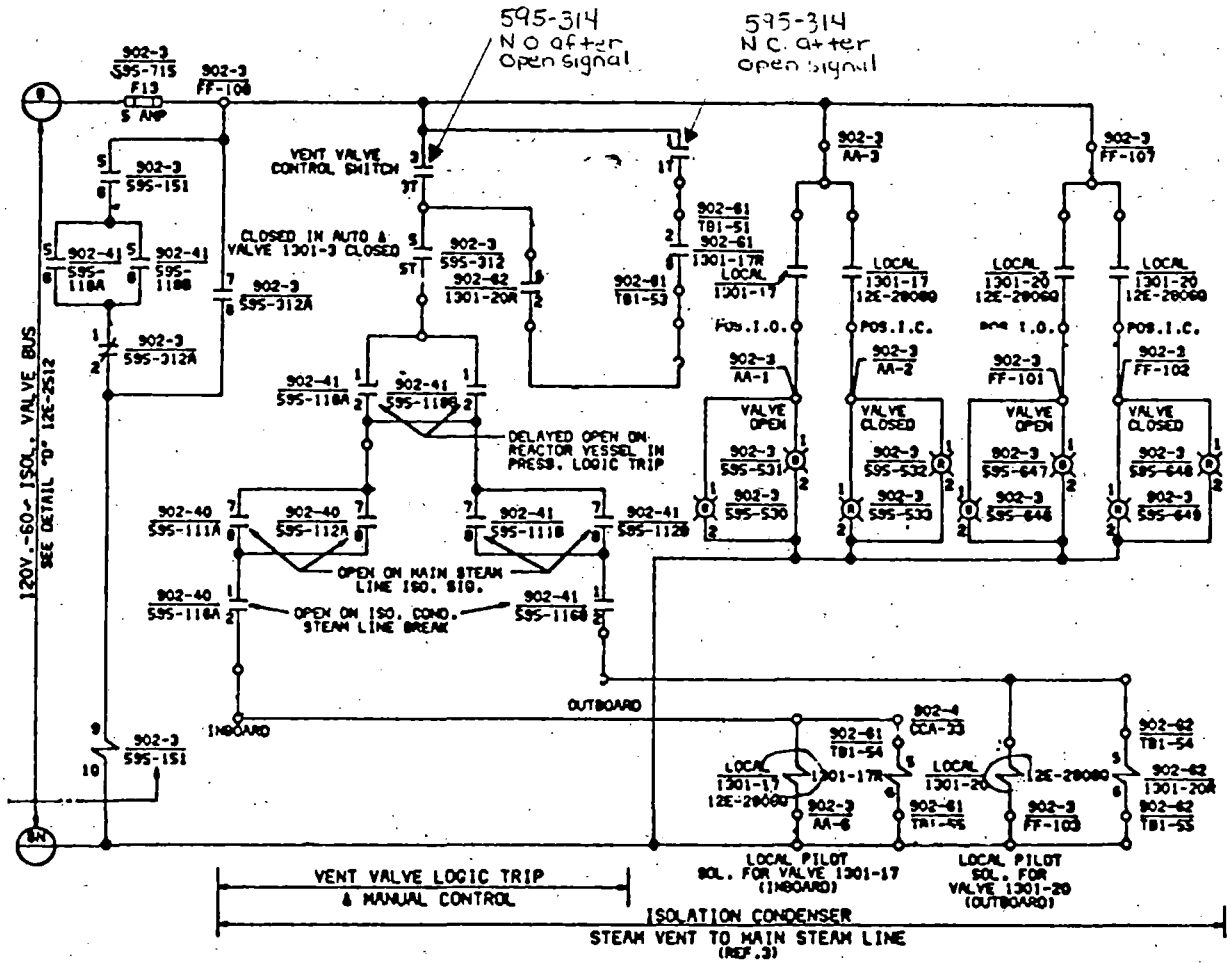
Figure 1

The investigation began with a review of the schematic diagram (See Figure 1) for the Isolation Condenser Vent Valves 2-1301-17 and 2-1301-20 to identify potential circuit locations that could cause both valves to close. The locations are:

- 1) Fuse (595-715) located in the 902-3 panel in the Control Room (CR).
- 2) Contacts from the control switch for valves 1301-17 and 20 on the 902-3 panel.
- 3) The 1301-17R relay contacts 2-8 located in the 902-61 panel in the Auxiliary Electric Equipment Room.

- 4) The 1301-20R relay contacts 2-8 located in the 902-62 panel in the Unit 2 Battery Room.
- 5) Contacts from the 1301-3 valve control switch also located in the 902-3 panel.
- 6) The 595-118A(B) relays located in the 902-41 panel.
- 7) The 595-111A(B) and the 595-112A(B) relays located in the 902-40 and 41 panels.
- 8) The 595-116A(B) relays located in the 902-40 and 41 panels.

Upon reviewing the possible circuit failures that could have caused the event, several can be eliminated because no associated alarms were received, because simultaneous opens on individual contacts from separate relays would be required, and because no known activities were in progress in any other locations but the Unit 2 Battery room. Based on the available evidence, the postulated cause of this event can be attributed to the activity in the Unit 2 Battery room which may have jarred the 902-62 panel, causing the 2-8 contacts on the 1301-20R relay to momentarily open and de-energize the circuit.

Although the evidence leads to an apparent cause due to jarring of the 1301-20R relay, no conclusive evidence is available to determine a definite root cause.

The immediate corrective action taken was to return the valves to their normally open position via their control switch. Because jarring of the 902-62 panel was determined to be the probable cause, the Electrical Maintenance department (EMD) performed a thermography inspection and verified that no loose connections were located in the 902-62 panel that could have made the 1301-20R relay more sensitive to vibrations. This work was completed under WR 11013 and no problems were identified. The Operations department will install signs on the 902(3)-61 and 902(3)-62 panels, to identify these relay cabinets as containing vibration sensitive equipment (237-200-92-13701).
