**Commonwealth Edison**  
Dresden Nuclear Power Station  
R.R. #1  
Morris, Illinois 60450  
Telephone 815/942-2920

LICENSEE EVENT REPORT (LER)

Title (4) **Orderly Unit Shutdown Due to Leakage Through Primary Containment Isolation Valves A0 2-220-44 and A0 2-220-45**

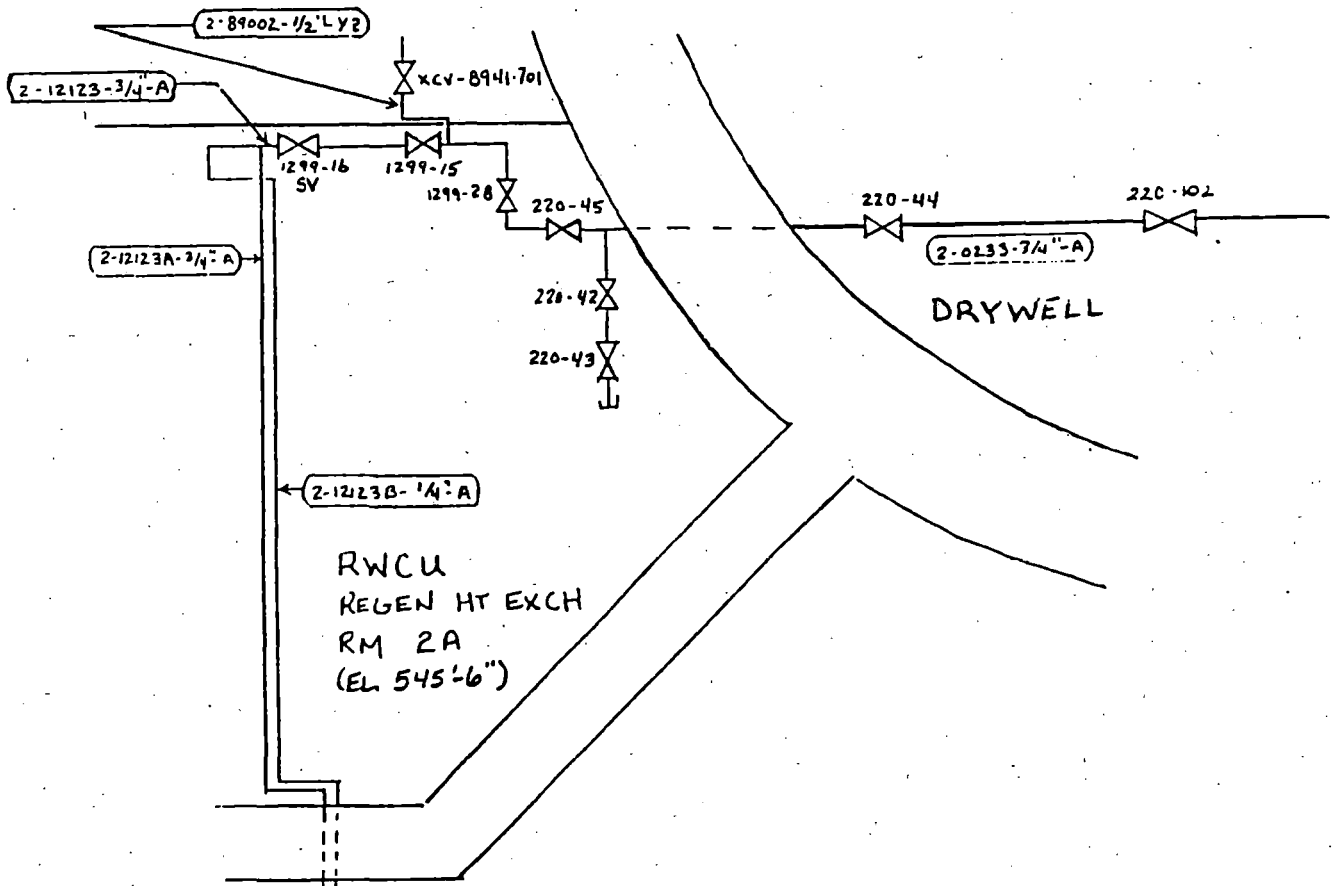
FIGURE 1

At 1740 hours on March 4, 1991, with Unit 2 at 73% power while performing a modification test for a Process Sampling Sample Panel [KN] modification, a small steam leak was found upstream of the 2-1299-16 valve (see Figure 1, attached). A call to the Control Room was then made for the Operator to isolate the leak. The air operated (A0) Reactor Recirculation [AD] sample line Primary Containment isolation valves A0 2-220-44 and A0 2-220-45 were then closed; however, the leak did not stop. A Shift Supervisor then closed the 2-1299-15 valve located in the "A" Reactor Water Clean-Up [CE] Heat Exchanger Room and the leak stopped, indicating that both containment isolation valves were leaking through. The A0 2-220-44 and A0 2-220-45 valves were then declared inoperable, resulting in entry into a 24 hour Limiting Condition for Operation (LCO) per Technical Specification 3.7.D.3, and an orderly Unit 2 shutdown was initiated to perform repairs. A primary containment drywell entry was also performed to close the upstream valve 2-220-102. Cold shutdown conditions were achieved at 1728 hours on March 5, 1991.
