Commonwealth Edison
Dresden Nuclear Power Station
R.R. #1
Morris, Illinois 60450
Telephone 815/942-2920

LICENSEE EVENT REPORT (LER)

Facility Name (1) Dresden Nuclear Power Station, Unit 3 Docket Number (2) 0 5 10 10 10 2 4 9 Page (3) 1 of 0 7

Title (4) Failure to Perform Post-Maintenance Local Leak Rate Test Due to Management Deficiency

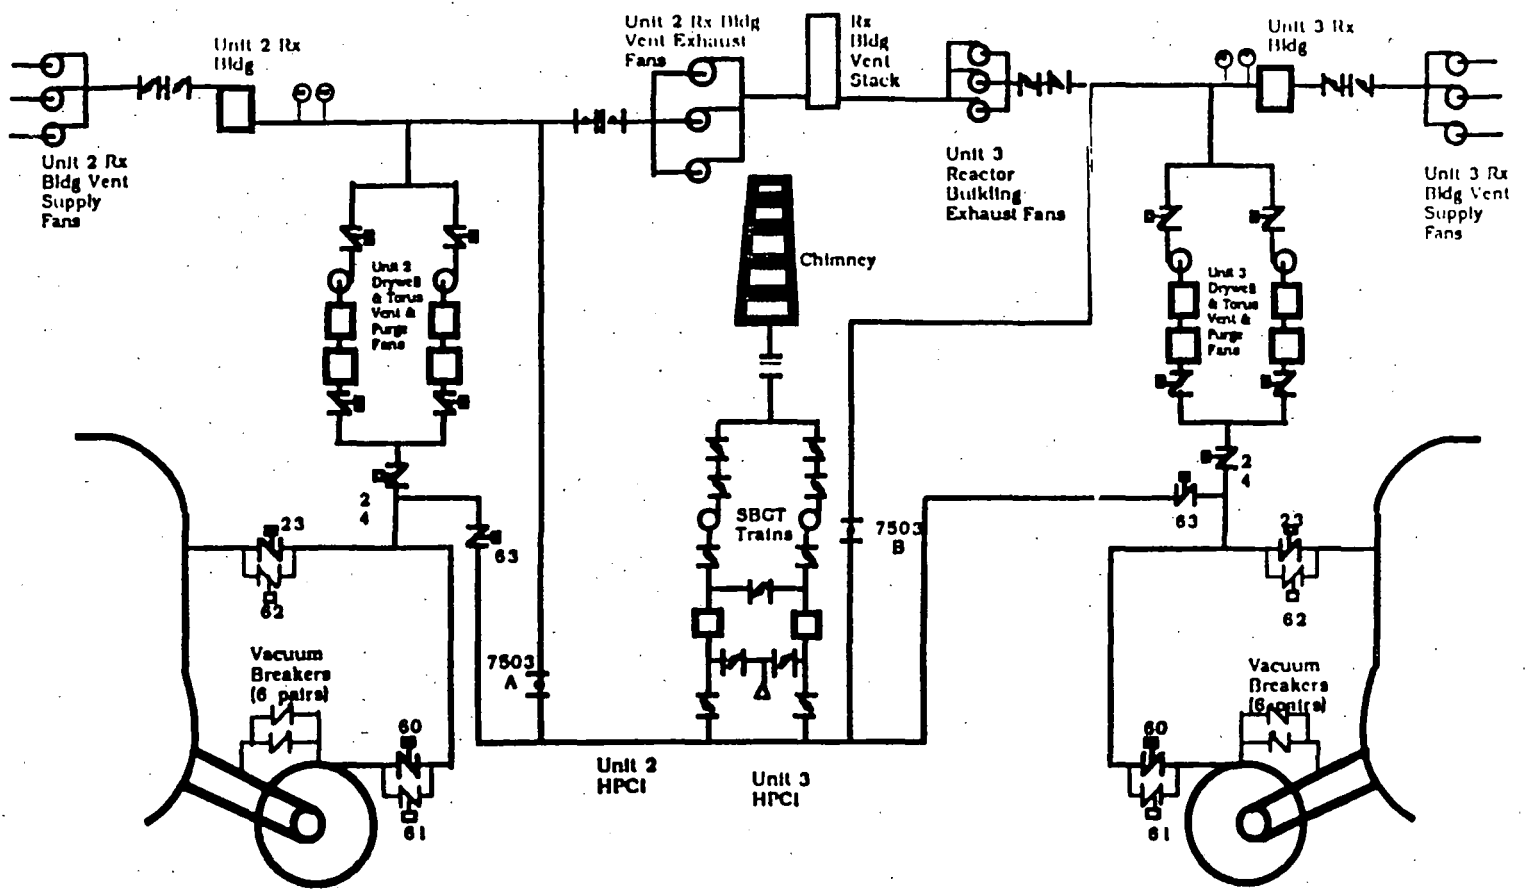
Figure 1 Drywell & Torus Vent Flowpaths

On September 16, 1991, with Unit 3 shutdown for refueling and maintenance, during performance of 10CFR50 Appendix J type C LLRT testing, the volume containing containment vent and purge system [BF] valves 3-1601-23, -24, -60, -61, -62 and -63 (see Figure 1) was identified to have excessive leakage. Further diagnostic testing concluded that valve 3-1601-24 was the leakage source. On September 20, 1991, at 1330 hours, while performing a maintenance history review, it was discovered that maintenance work had been performed on the 3-1601-24 valve during the previous refuel outage (D3R11) without completion of a proper post-maintenance LLRT as was required by 10CFR50 Appendix J. The valve operator cylinder was rebuilt on February 2, 1990, under Work Request (WR) 90166. The work package indicated that a new piston rod was installed and the cylinder was reassembled. The package required Post Maintenance Testing (PMT) as follows: (a) Dresden Technical Surveillance (DTS) 1600-29, Isolation valve Fail Safe Mode and Air Operator Accumulator System Integrity Test, (b) Dresden Operating Surveillance (DOS) 040-7, Remote Position Indication Verification, (c) DOS 1600-1, Quarterly Valve Timing. PMT did not require performance of DTS 1600-1, LLRT of Primary Containment Isolation Valves. An as found LLRT had been performed on this volume (12/5/89) and passed.

This corresponds to roughly 1/8 inch. This error was not caught because an LLRT was not performed on the valve following maintenance. The shaft and bonnet have punch marks to indicate the relative positioning required to achieve valve closure. These punch marks provide a reasonable approximation of valve closure; however, they are insufficient to ensure leak tight valve closure. When adjustments are performed which can affect valve closure, leak testing is required during the re-assembly to achieve the precise positioning required to achieve full closure. An LLRT is required as a Post Maintenance Test to ensure the valve does achieve proper closure. Dresden Maintenance Procedure (DMP) 1601-2, "Drywell and Torus Air Operated Butterfly Valve Maintenance," Revision 1 was not used as part of the work instructions because the work analyst believed that there were administrative restrictions on using only a portion of a procedure. DMP 1601-2 does contain a Limitation and Action which specifically allows for the use of only a portion of the procedure. However, the applicable steps are part of a section on removing the valve assembly and referencing the appropriate sub-steps could have lead to confusion. DMP 1601-2, Revision 1, Step 10, "Concluding Maintenance Activities," sub-step "a" reads "Obtain a final LLRT for valve." Had the Work Analyst reviewed DMP 1601-2 during the writing of the work instructions this requirement may have been included in the work instructions. The work package for WR 90166 contained a completed copy of Dresden Administrative Procedure (DAP) 15-6, Checklist C, "Post Maintenance Checklist." The line item for "Were Primary Containment Isolation Valves disturbed?" was marked YES by the Maintenance Supervisor. The desired tests to be completed prior to declaring the system/equipment operable listed the four tests which were performed but omitted an LLRT. This section was completed by the Shift Engineer on Checklist C. DAP 15-01 Rev. 22 and DAP 15-6 Rev. 0 were Dresden On-Site Reviewed (DOSRd) on January 12, 1990. DAP 15-1, Revision 21, (DOSRd 01/25/89) required the Operating Engineer/Designee to define the testing required to return the component to service following maintenance. DAP 15-6, Revision 0, (DOSRd 01/12/90) requires the Work Analyst/ENC Engineer to review the WR for Post Maintenance Testing/Verification (PMT/V) requirements. The work instructions were written on January 27, 1990. No training on the implementation or the accomplishment of this change was provided to the Work Analyst. When the Work Analyst wrote the work instructions on January 27, 1990, he used the Operating Engineer's recommended testing as specified on the Work Request. The PMT was later modified to incorporate the Shift Engineer's PMT requirements per checklist C of DAP 15-6. A barrier which could have prevented this event was follow-through on the part of the Technical Staff System Engineer, the Maintenance Supervisor, or the Maintenance Work Analyst. Any of these personnel could have prevented this event by following through and ensuring that an LLRT was performed. The reason why the problem with the 3-1601-24 valve was not discovered during the ILRT was that the inboard isolation valves of that volume were closed during the Integrated Leak Rate Test (ILRT). 3-1601-24 was also closed during the Type A Primary Containment Integrated Leak Rate Test (ILRT).
