**Commonwealth Edison**

LICENSEE EVENT REPORT (LER)

Facility Name (1) Dresden Nuclear Power Station, Unit 2 Docket Number (2) 0 5 10 10 10 2 13 17 Page (3) 1 of 0 6

Title (4) Failure of Standby Gas Treatment System Charcoal Adsorber Leak  
Test Due to Seal Leakage

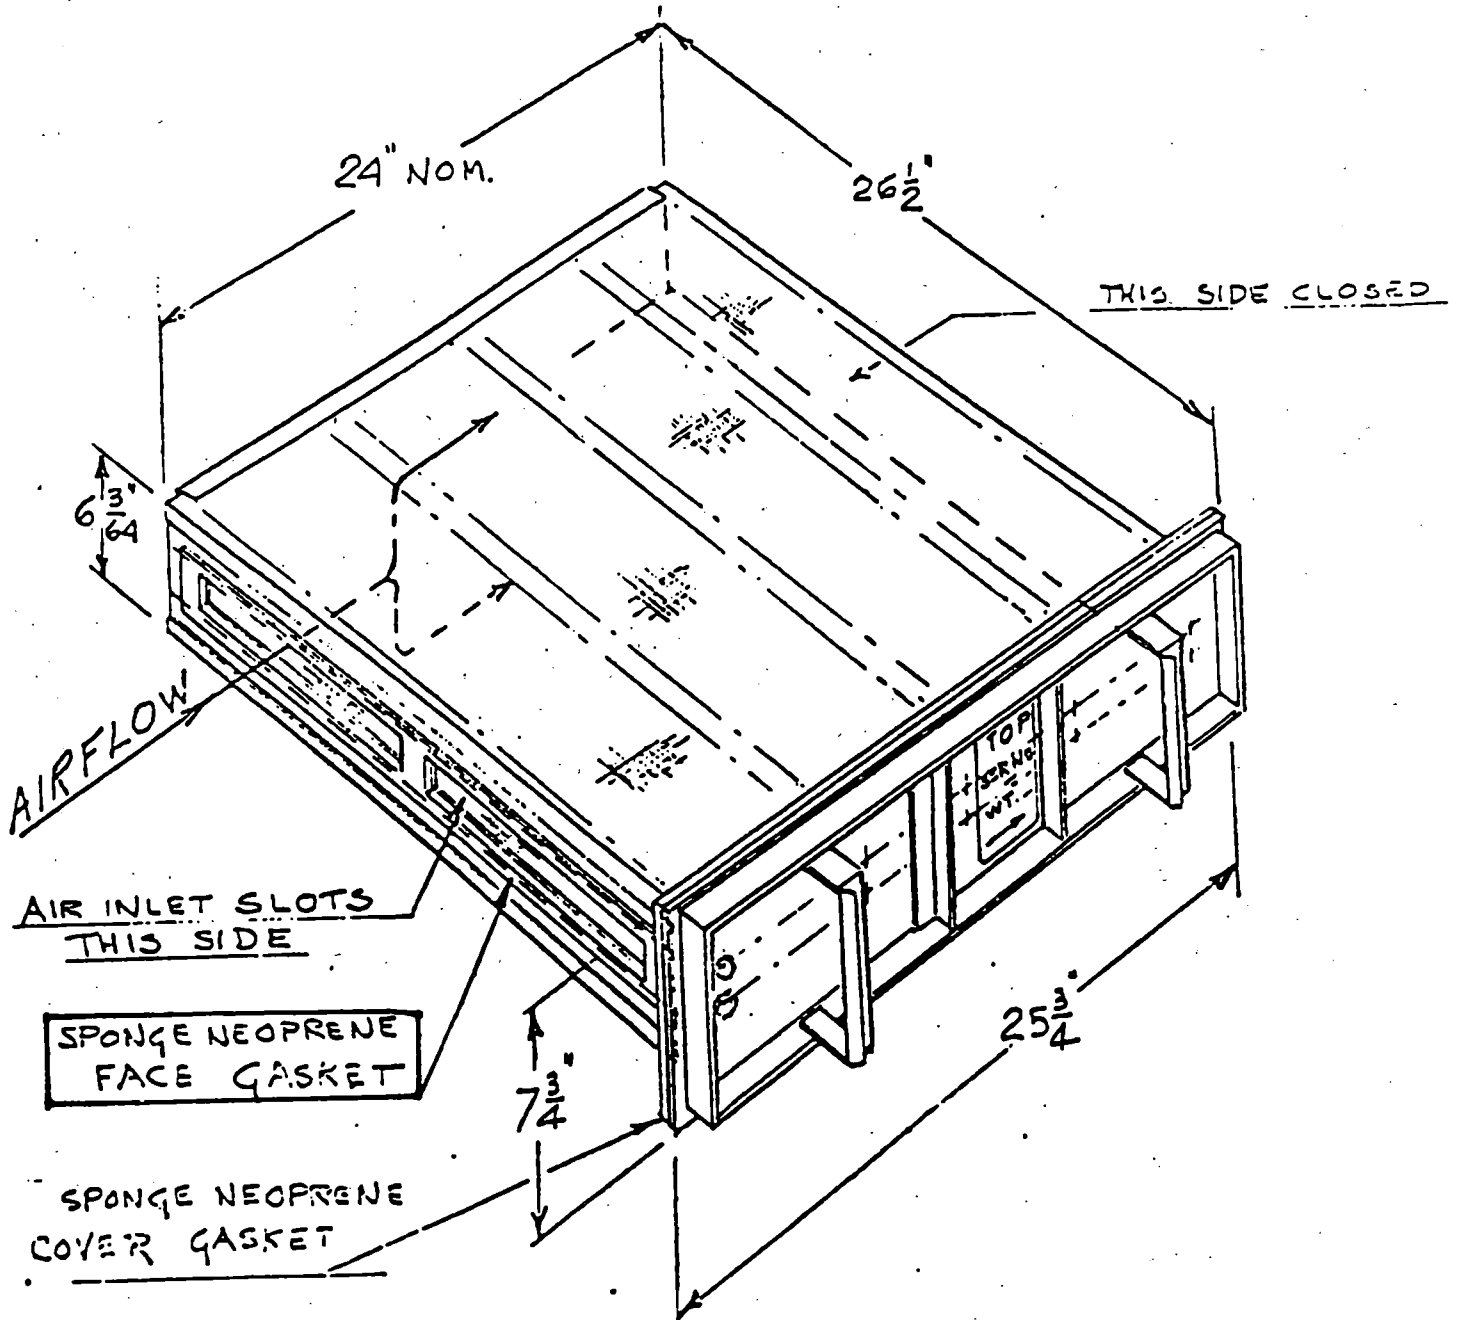
Figure 1

Since the test results improved dramatically when the sealing gaskets were replaced on each of the charcoal trays, the leakage was attributed primarily to uneven compression of the gaskets against the sealing surfaces (see Figure 1). The B Train exhibited only 0.12 percent leakage and the A Train exhibited .01 percent leakage in their most recent leakage tests on December 18, 1989. No significant change has occurred in the operating conditions of Standby Gas Treatment since the last test. Therefore, the root cause of the seal degradation could not be specifically identified.

Several contributing factors were identified during corrective maintenance on the system. The internal latching mechanisms on each train were found to be in disrepair. These mechanisms are responsible for maintaining pressure between the gaskets on each charcoal tray and their sealing surfaces. The primary cause of the damage to these mechanisms is improper operation of the latching lever due to a lack of a procedure. The latching lever is designed to be moved to a certain position for removal of the trays and a different position for operation. There is no labeling that indicates these positions.

The current design of the charcoal trays contributed to the leakage. Since the trays are designed with two sealing surfaces 90 degrees apart, it is difficult to achieve an adequate seal between the trays and the housing of the trays. The design currently does not require corrosion resistant materials to be used for the construction of the trays. Therefore, a design change has been initiated to replace the existing charcoal trays with an improved tray design.

Charcoal Adsorber Tray

The primary source of leakage was identified as the seal between the charcoal trays and the housing of of the trays. The gaskets were replaced on each tray and the sealing mechanisms were repaired. Much of the damage could have been avoided by improved installation and removal of the charcoal trays. A detailed illustration and instructions for the operation of the latching mechanism were added to Dresden Maintenance Procedure (DMP) 7500-01, Removal and Installation of Standby Gas Treatment Charcoal Filters by the Maintenance Department, and the open and closed positions of the latching lever were labeled at the Standby Gas Treatment trains along with a reference to DMP 7500-01.
