Commonwealth Edison
Dresden Nuclear Power Station
R.R. #1
Morris, Illinois 60450
Telephone 815/942-2920

September 18, 1992

LICENSEE EVENT REPORT (LER)

Title (4) Bellows at Primary Containment Penetration X-125 Found Outside FSAR Design Limits Due to Inaccurate Piping Analysis

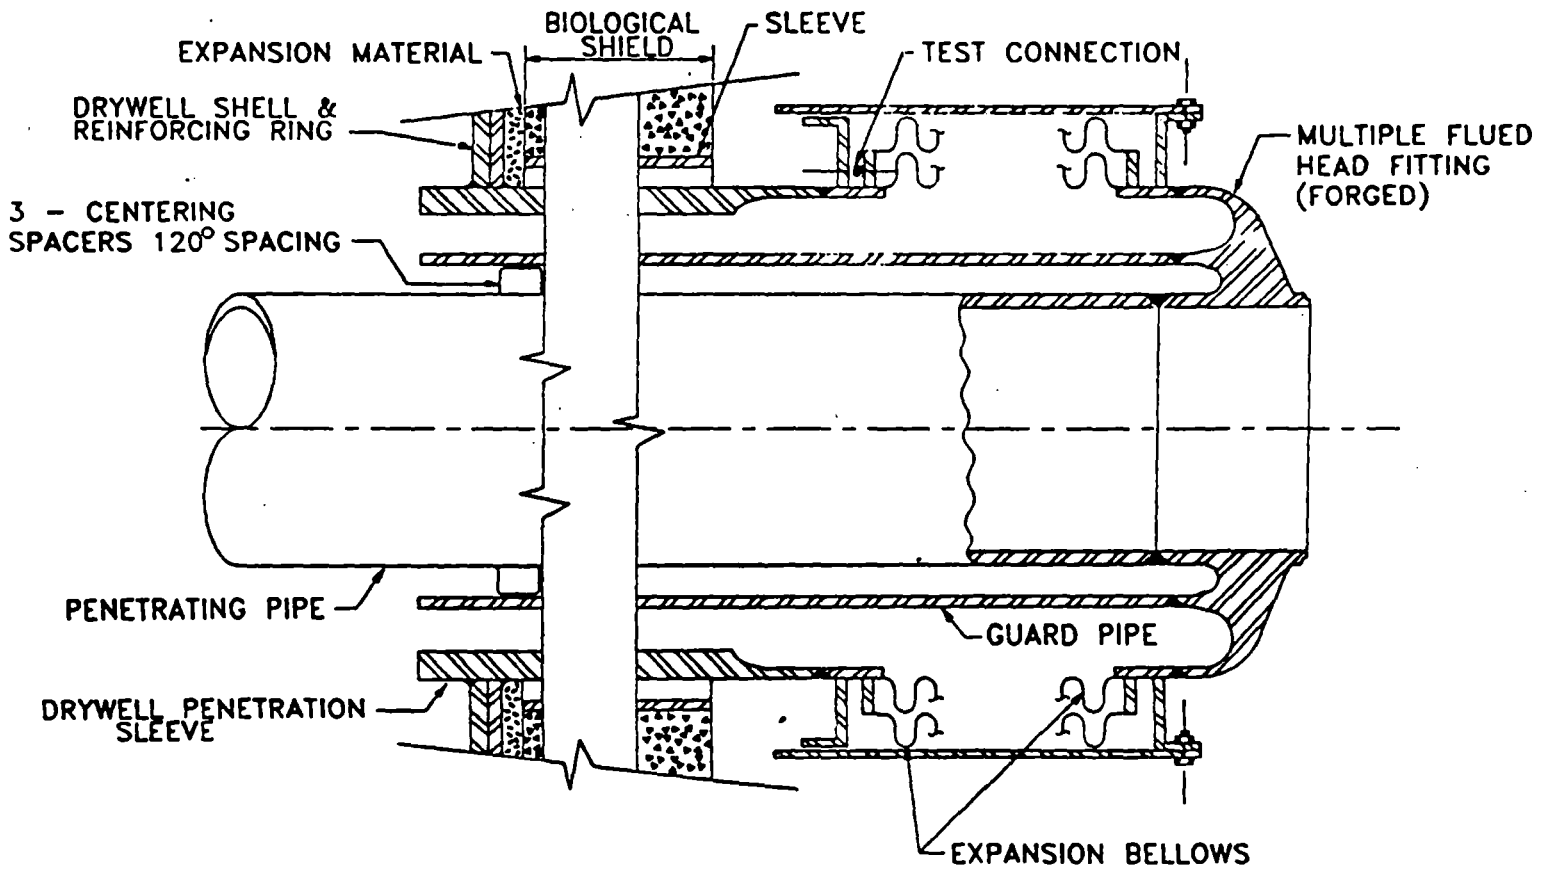
Figure 1

The primary containment penetrations and their bellows assemblies are part of the primary containment boundary. The purpose of the bellows assemblies is to allow for thermal expansion of the process pipe during heatup and system operation. Most penetrations consist of a penetration sleeve, guard pipe, process pipe, bellows assembly, and a flued head anchor (Figure 1). The X-125 penetration only consists of a process pipe and a bellows assembly with the bellows assembly as an integral part of the process pipe (Figure 2). Even though the as-built configuration of the bellows is outside the FSAR design limits, the bellows has been determined to be operable. Therefore, the safety significance of this event is minimal.

Configuration of Most Penetrations

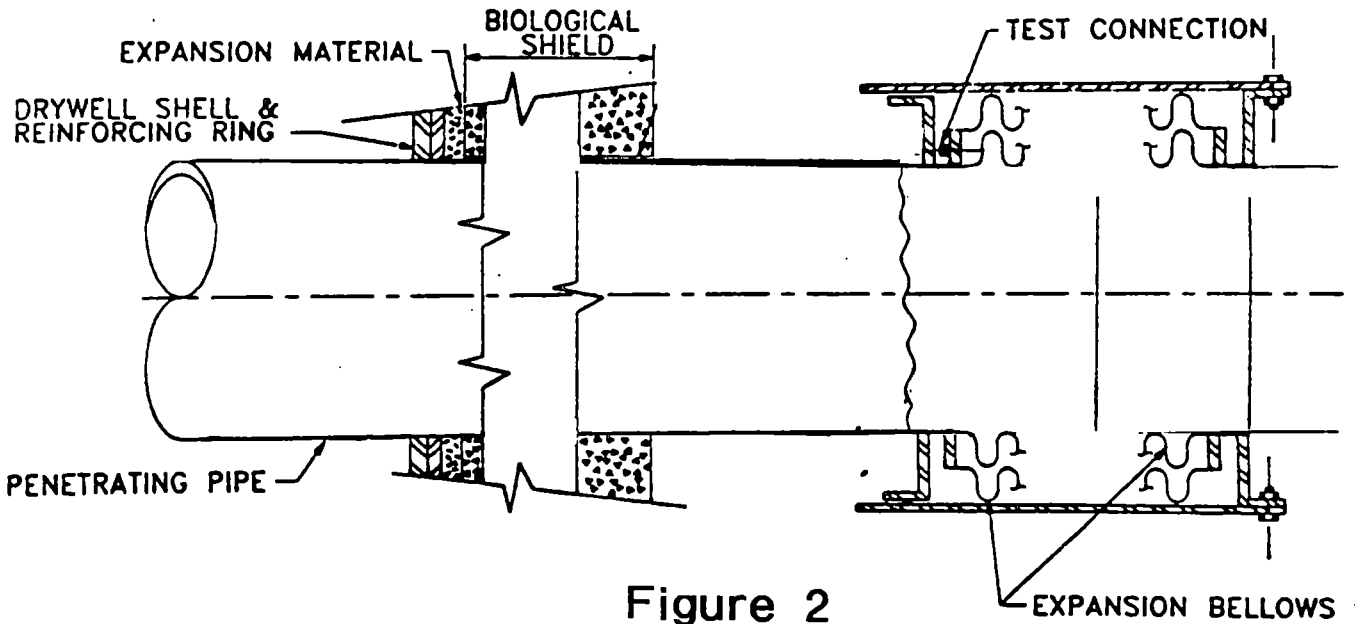
Figure 2

The inaccurate analysis was then incorporated to become part of the FSAR design limits. NED has determined that the improper piping analysis does not meet 10 CFR Part 21 criteria since it has been determined that the analysis was an isolated case and an operability concern or safety hazard is not present. Maintenance histories were reviewed for the X-125 bellows assemblies but were not very useful since the bellows assemblies require no maintenance. The local leak rate test (LLRT) data was also reviewed. The X-125 bellows on Unit 3 are currently scheduled for replacement under Dresden's Technical Specification exemption for 10 CFR 50 Appendix J bellows testing. The Unit 2 penetration has shown small amounts of leakage during testing.

Configuration of X-125

The immediate corrective actions taken were for NED to evaluate the X-125 bellows for operability and determine if the unanalyzed as-built configuration fell within the FSAR design limits. When the existing bellows were found outside of the FSAR design limits, additional corrective actions became necessary. Engineering is having a root cause analysis performed for this event in order to identify contributing factors that led to the inaccurate piping analysis. This root cause analysis will be completed by September 30, 1992 (2372009219001). After the root cause analysis is performed, the Technical Staff will review the documentation and pursue necessary corrective action, which will include a LER supplemental report, by November 15, 1992 (2372009219002). In addition the Technical Staff will be responsible for replacing the bellows assemblies for penetration X-125 with ones that meet the design limits of the FSAR. These replacements are currently scheduled for D2R13 and D3R13 (2372009219003).
