Commonwealth Edison
Dresden Nuclear Power Station
R.R. #1
Morris, Illinois 60450
Telephone 815/942-2920

Attached please find Licensee Event Report #91-013-01, Docket #050249.
This report is submitted to provide further information clarifying the
nature of the root cause of the event.

LICENSEE EVENT REPORT (LER)

Title (4) 250 Volt DC Battery Discharge Voltage Decreased Below Design Basis Limit
Due to Inaccurate Vendor Data

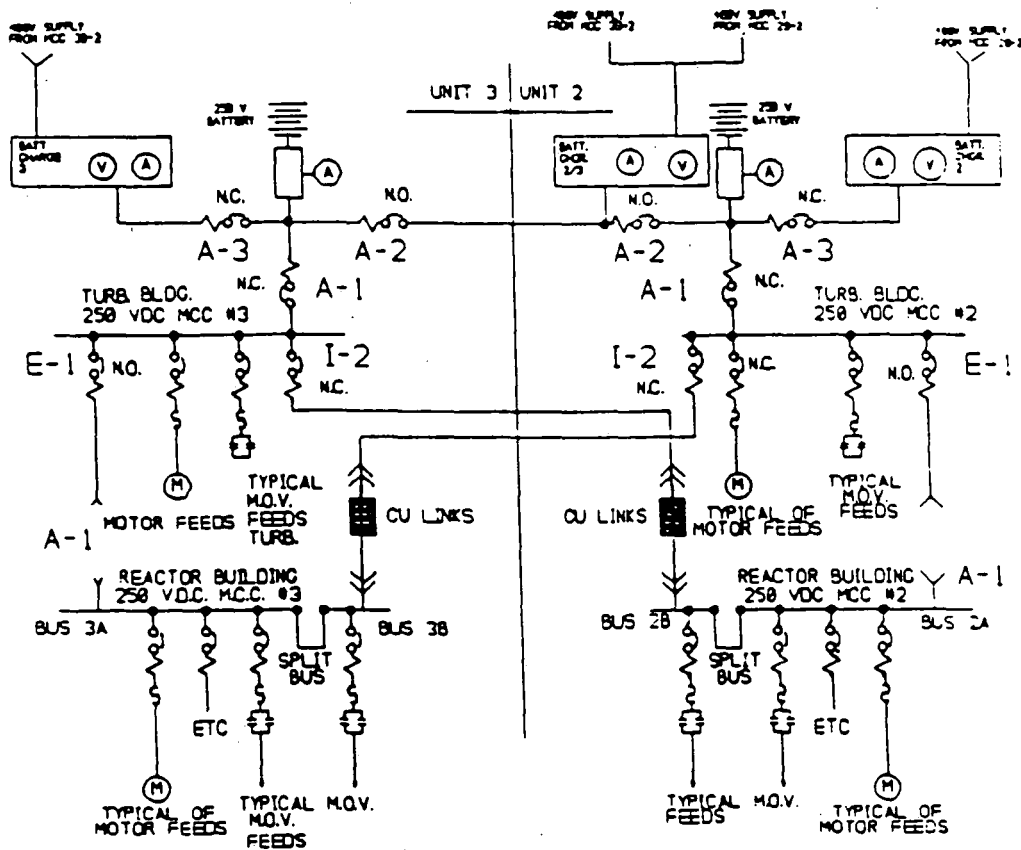
FIGURE 1
250 VDC SYSTEM KEY DIAGRAM

Dresden Station utilizes two 250 volt batteries, each with an associated charger. Additionally, there is a third battery charger which has the capability to be connected to either battery bus (Refer to Figure 1). Under the normal 250 volt DC distribution system configuration, the Unit 2 battery (and associated charger) supplies power to the Unit 2 Turbine Building 250 volt DC loads and the Unit 3 Reactor Building 250 volt DC loads, while the Unit 3 battery (and associated charger) supplies the Unit 3 Turbine Building 250 volt DC loads and the Unit 2 Reactor Building 250 volt DC loads.
