Commonwealth Edison
Dresden Nuclear Power Station
R.R. #1
Morris, Illinois 60450
Telephone 815/942-2920

LICENSEE EVENT REPORT (LER)

Facility Name (1) Dresden Nuclear Power Station, Unit 3						Docket Number (2) 0 5 10 10 10 2 4 9			Page (3) 1 of 0 5		
Title (4) HPCI System Declared Inoperable Due to Signal Converter Failure

HPCI [BJ] Declared Inoperable Due to Signal Converter Failure

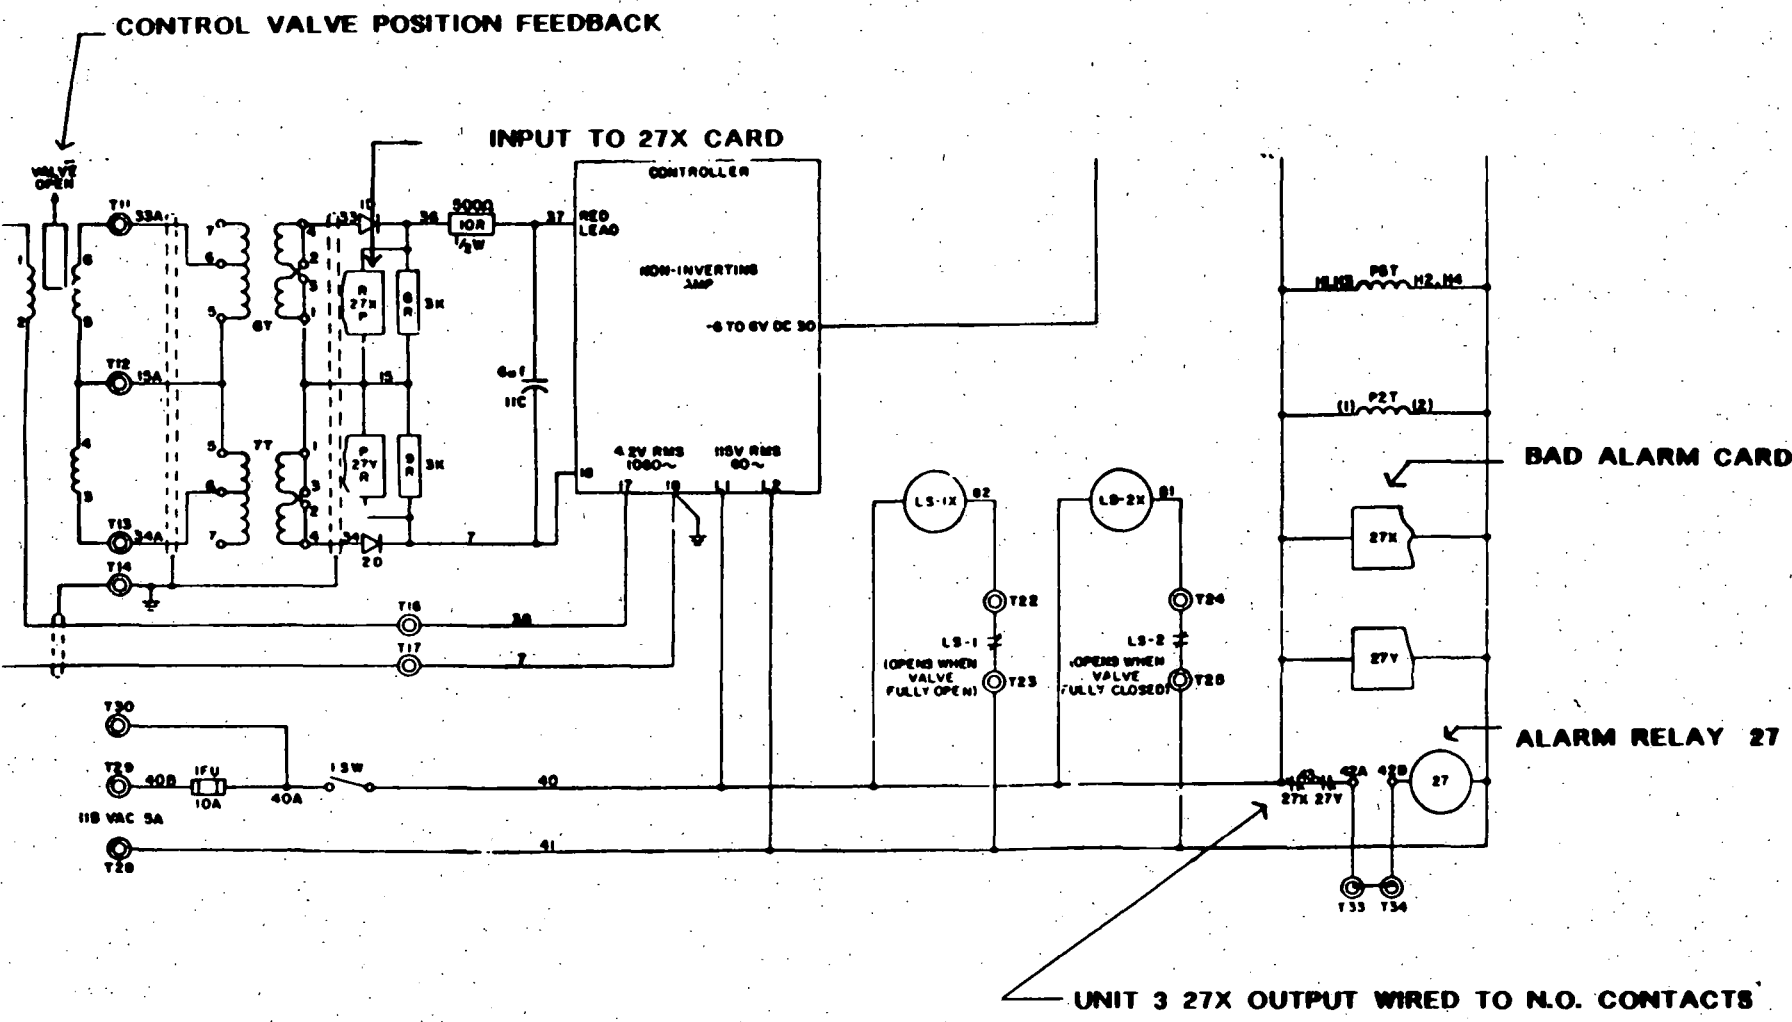
FIGURE 1

The HPCI Signal Converter is provided with three alarm functions to alert the NSO of a problem. The alarm occurs if there is a loss of supply voltage to the signal converter or a failure of the feedback circuit. The loss of supply voltage to the circuit will cause alarm relay 27 (Refer to Figure 1) to de-energize and cause the failure alarm. The feedback circuit has two cards, 27X and 27Y, which monitor voltage on the LVDT. A loss of voltage in the feedback circuit causes the 27X or 27Y card to energize a relay on the 27X or 27Y card. The relays on the cards have Normally Closed (NC) contacts in series with the Normally energized alarm relay 27. If either of the alarm card relays energize, the alarm relay de-energizes and causes the HPCI Signal Converter Failure alarm to occur.

Investigation into the HPCI Signal failure alarm could not identify the cause of the signal converter alarm encountered on October 5, 1992. However, a wiring discrepancy was discovered on the output of the 27X alarm card. The alarm card output had been wired to the Normally Open (NO) contacts instead of the NC contacts. Voltages measured on the card indicated that the relay on the 27X card never de-energized causing the NO contacts to remain closed. Voltages measured on the 27Y card indicated that card to be operating properly. Apparently, the 27X alarm card had failed sometime previously, causing the relay on the card to remain energized. The failure of the card would cause the Signal Converter Failure Alarm to annunciate. In order to clear the alarm without replacing the degraded card, the output contacts for the 27X card relay would have to be wired to the NO contacts which are closed due to the card failure. The wiring to the output contacts on the 27X card showed that it had been originally trained to the NC contacts.

Therefore, the original alarm encountered on October 5, 1992, is believed to have been spurious based on the alarm clearing and that no problems which would have caused the condition were identified during troubleshooting. The wiring discrepancy discovered during troubleshooting was caused by inadequate management control of work activities in the plant. It is believed that the wiring change was performed several years ago, before the enhanced management controls now in place existed which would prevent such an occurrence.

POSITION FEEDBACK AND ALARM CIRCUIT

The 27X board was replaced and tested satisfactorily on October 9, 1992.
