Commonwealth Edison
Dresden Nuclear Power Station
R.R. #1
Morris, Illinois 60450
Telephone 815/942-2920

November 4, 1992

LICENSEE EVENT REPORT (LER)

Title (4) Bellows at Primary Containment Penetration X-125 Found Outside FSAR Design Limits Due to Project Instruction Deficiencies

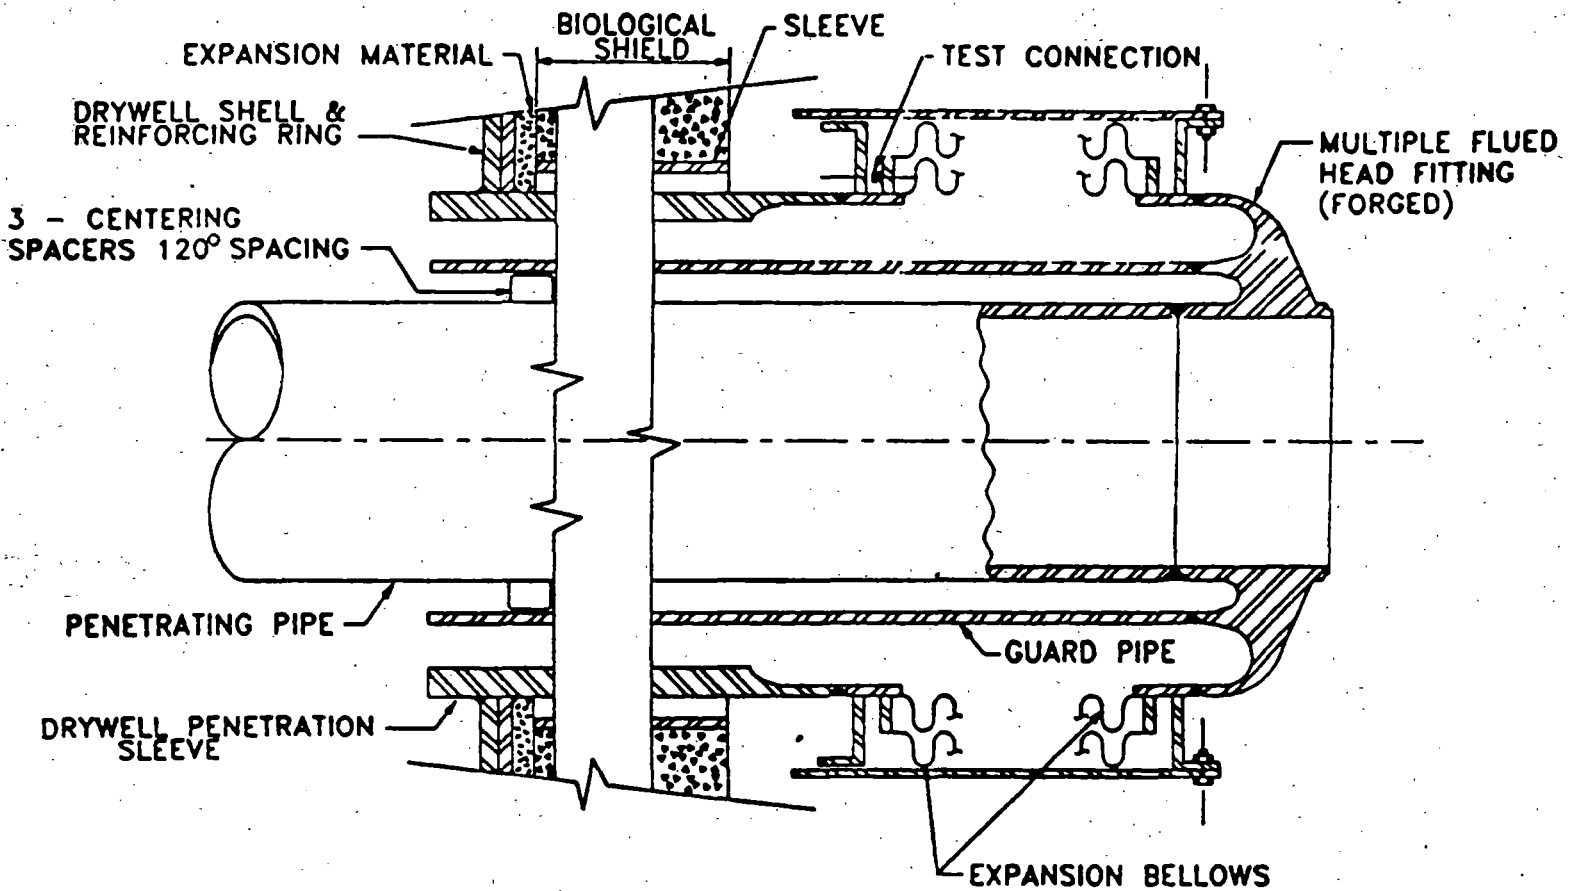
Figure 1

The primary containment penetrations and their bellows assemblies are part of the primary containment boundary. The purpose of the bellows assemblies is to allow for thermal expansion of the process pipe during heatup and system operation. Most penetrations consist of a penetration sleeve, guard pipe, process pipe, bellows assembly, and a flued head anchor (Figure 1). The X-125 penetration only consists of a process pipe and a bellows assembly with the bellows assembly as an integral part of the process pipe (Figure 2). Even though the as-built configuration of the bellows is outside the FSAR design limits, the bellows has been determined to be operable. Therefore, the safety significance of this event is minimal.

Configuration of Most Penetrations

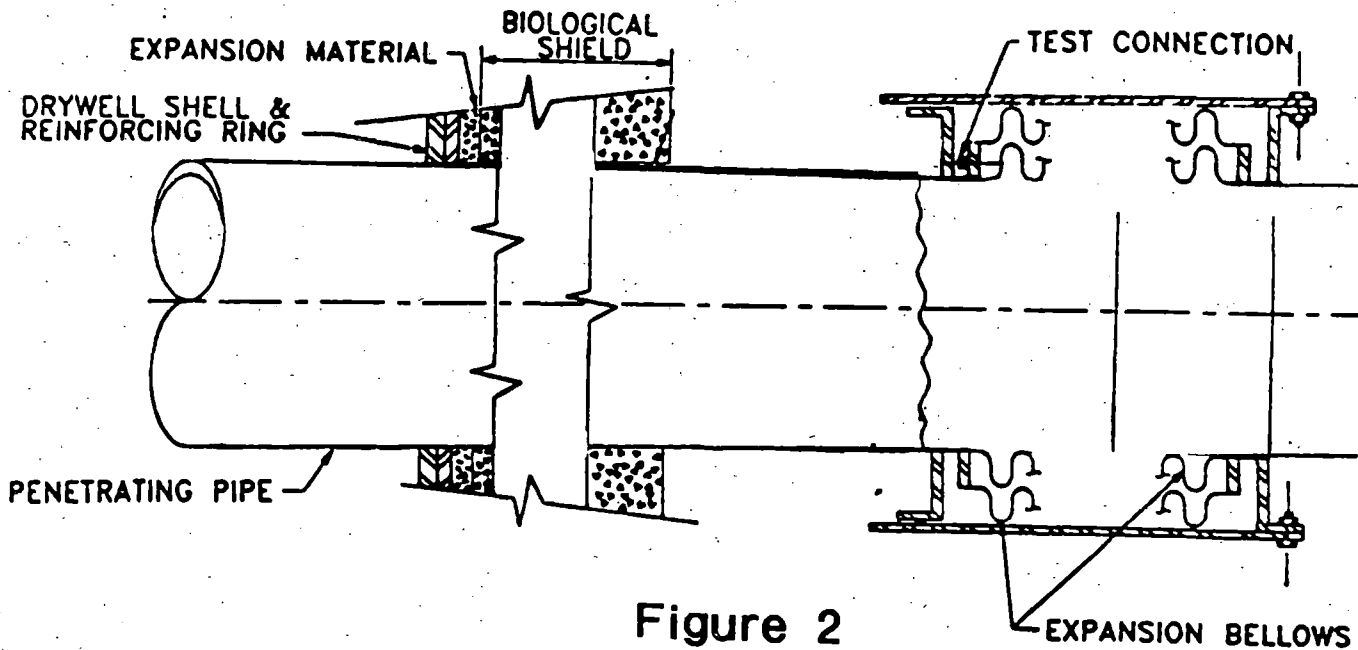
Figure 2

The root cause of the X-125 bellows being found outside FSAR design limits has been determined to be deficiencies in the Project Instruction that were used to perform the original piping calculations. An incorrect modeling assumption was used for the configuration of the in-line expansion bellows in the piping system at Primary Containment penetration X-125. The bellows were modeled as tied single bellows instead of the as-built conditions which are untied tandem bellows.

The single vs tandem error in the bellows modeling is a result of a misunderstanding by the piping analysts as to how bellows are modeled. As-built drawings were not available for Dresden's bellows and walkdown data at the time of the piping analysis showed that the as-built bellows were tandem bellows.

An assumption was made when modeling the bellows by the piping analyst to input the dimensions and stiffness of the tandem bellows but perform the rest of the model as if the bellows were a single bellows. This modeling assumption eliminated a degree of freedom from the analysis and significantly changed the stress loading on the piping. The tied vs untied error was a result of inadequate walkdown information. The piping analyst made an assumption while performing the piping calculation that the X-125 bellows are tied bellows. Both of these errors which led to the improper modeling of the X-125 bellows can be traced back to insufficient knowledge on the piping analysts part with respect to the analytical modeling of in-line bellows. Since the analysts rely on the Project Instructions for technical guidance, the root cause of both problems is the result of deficiencies in the original Project Instructions.

Configuration of X-125

The immediate corrective actions taken were for NED to evaluate the X-125 bellows for operability and determine if the unanalyzed as-built configuration fell within the FSAR design limits. When the existing bellows were found outside of the FSAR design limits, additional corrective actions became necessary. The Technical Staff will be responsible for replacing the bellows assemblies for X-125 with ones that meet the design limits of the FSAR. These replacements are currently scheduled for D2R13 and D3R13 (237-200-92-19003). In addition, NED should verify that the AE who performed the original piping analysis revises its generic piping analyses procedure to address the type of as-built information required and proper modeling techniques for in-line bellows by January 15, 1993 (237-200-92-19004). The analysis for penetrations with similar bellows assemblies were reviewed for their accuracy. No problems with any of these analyses were found.
