Commonwealth Edison
Dresden Nuclear Power Station
R.R. #1
Morris, Illinois 60450
Telephone 815/942-2920

LICENSEE EVENT REPORT (LER)

Title (4) Manual Isolation of the Isolation Condenser System Due to Steaming of the Isolation Condenser Shell Side Water During Normal Unit Startup

Manual Isolation of the Isolation Condenser [BL] System Due to Steaming of the Isolation Condenser Shell Side Water During Normal Unit Startup.

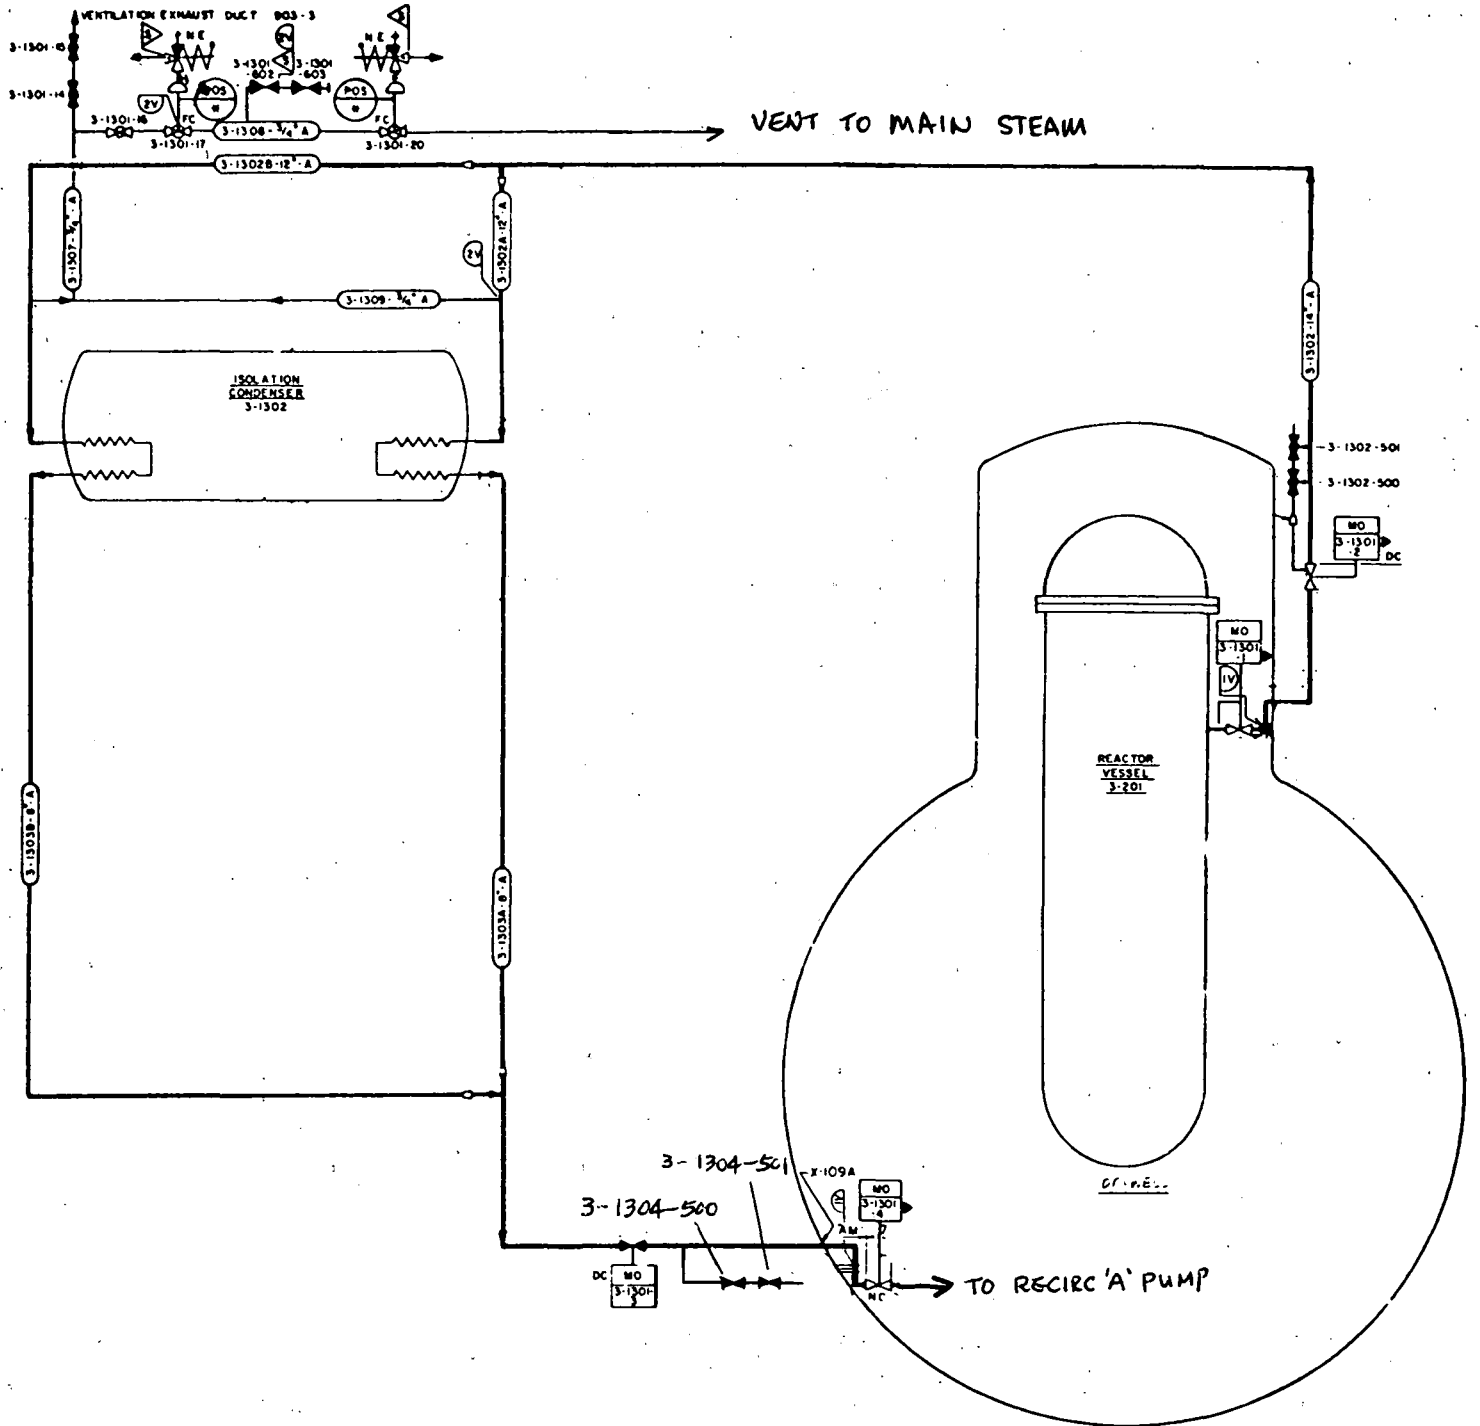
Figure 1. Isolation Condenser

The apparent cause of this event was attributed to low water level in the condensate return line of the Isolation Condenser system. The root causes of this event are as listed below:

1. During a Unit outage, the condensate return drain valve, 3-1304-500, was replaced due to a packing leak. To replace the drain valve, the water volume between the MO 3-1301-3 and MO 3-1301-4 condensate return valves was drained and the volume between MO 3-1301-3 and MO 3-1301-4 was not backfilled.
2. There is no existing procedure to verify condensate return line water level or to backfill the condensate return water line.

Following manual isolation of the Isolation Condenser system by closure of the MO 3-1301-1, 2, 4, AO 3-1301-17, and -20 valves, the Isolation Condenser system was declared inoperable and the Unit entered a 7 day LCO per Technical Specification 3.5.E.2. A shell-side water sample was obtained and analyzed by the Chemistry Department, and no detectable activity was present. The condensate return line up to the tube bundles was then backfilled. In order to prevent recurrence, Operations will revise Dresden Operating Procedure (DOP) 1300-1, Standby Operation of the Isolation Condenser System, to verify the condensate return line water level and to backfill the condensate return line by June 30, 1993 (249-200-92-02201). Operations will continue to check the Isolation Condenser shell side water level and temperature daily per the NSO round book, Appendix A.
