Licensee Event Report #90-006-01, Docket #050237 is being submitted to modify a corrective action that was provided in the original report.

LICENSEE EVENT REPORT

Facility Name (1) Dresden Nuclear Power Station, Unit 2 Docket Number (2) 0 5 10 10 10 12 13 17 Page (3) 1 of 1 0

Title (4) Target Rock Safety-Relief Valve Fails Open Due to a Steam Cut Pilot Valve Disc

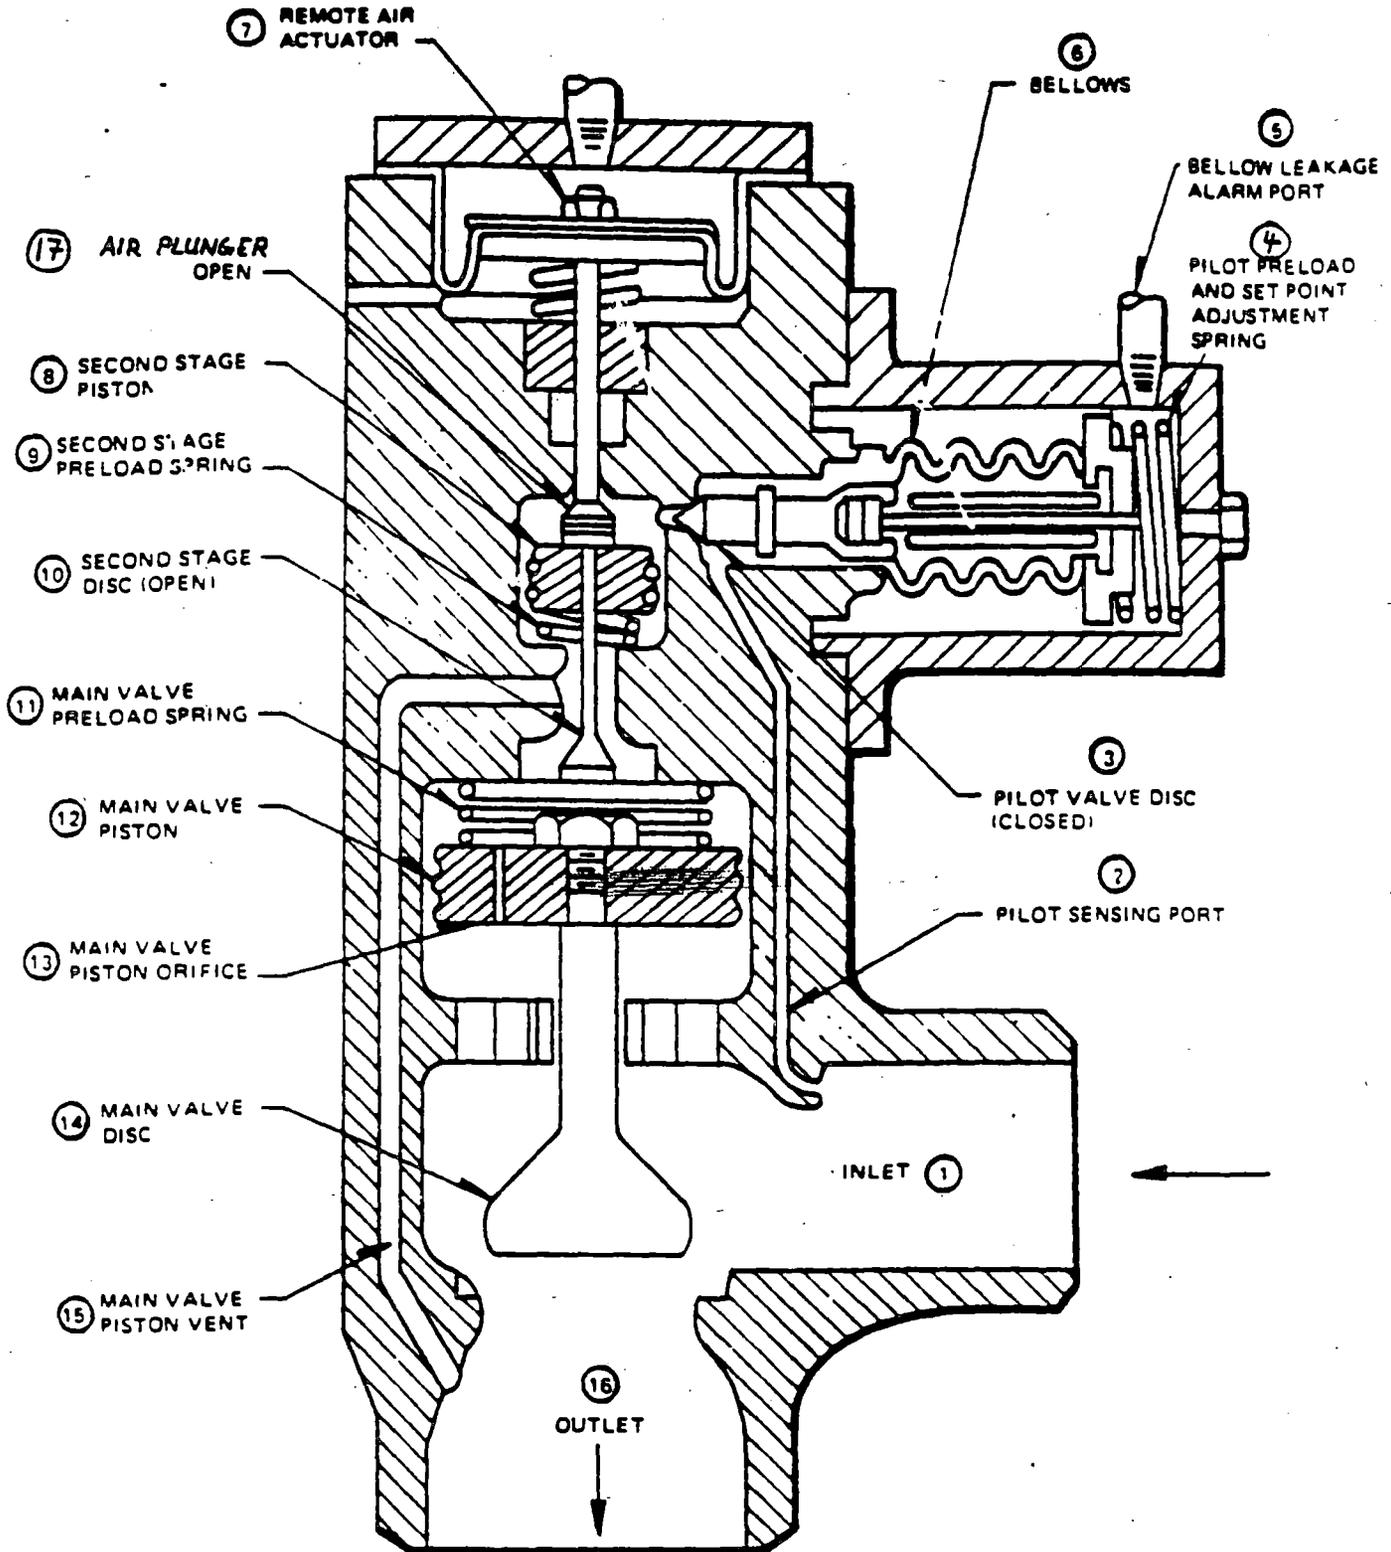
FIGURE 1

Self actuation occurs as follows (refer to Figure 1): Pressure is sensed at the pilot sensing port (2). The bellows (6) expands at a pressure setpoint of 1135 psig. This moves the pilot valve disc (3) allowing pressure to be transferred to the second stage piston (8). The second stage (8) is forced down moving the second stage disc (10) away from its seat. This permits the pressure from the top of the main valve piston (12) to be vented via the second stage disc (10) and out the main valve piston vent (15). A differential pressure is created across the main valve piston (12) due to the small size of the main valve piston orifice (13) as compared to the main valve piston vent (15). Reactor pressure then lifts the main valve piston (12) and the main valve disc (14). The final result is that reactor steam is directed through the discharge line to the suppression chamber. When steam pressure is approximately 50 psig below the setpoint pressure of 1135 psig, the pilot preload and setpoint adjustment spring (4) forces the pilot valve (3) closed. The second stage disc (10) then closes equalizing the pressure across the main valve piston (12). Spring force from the main valve preload spring (11) closes the main valve disc (14). If the bellows (6) ruptures, a pressure switch (5) results in an alarm in the Control Room on the 902-4 panel (annunciator D-23, TRSRV Inoperable) at 25 psig. This indicates that the self-actuation mode of the TRSRV is inoperable.

Remote actuation occurs as follows (refer to Figures 1 & 2): A DC solenoid admits nitrogen pressure of approximately 85 psig to the remote air actuator (7) resulting in the stroking of the air plunger (17) which in turn pushes down the second stage piston (8). This permits the pressure from the top of the main valve piston (12) to be vented via the second stage disc (10) and out the main valve piston vent (15). A differential pressure is created across the main valve piston (12) due to the small size of the main valve piston orifice (13) as compared to the main valve piston vent (15). Reactor pressure then lifts the main valve piston (12) and the main valve disc (14). The final result is that reactor steam flow is directed through the discharge pipe to the suppression chamber. When the solenoid is de-energized, pressure is vented from the remote air actuator (7). The second stage disc (10) then closes equalizing the pressure across the main valve piston (12). Spring force from the main valve preload spring (11) closes the main valve disc (14).

The apparent cause of the failure of the TRSRV was the severely steam cut pilot valve disc (refer to Figure 1). Excessive steam leakage through the pilot sensing port (2) and past the pilot valve (3) via the severe steam cuts allowed pressure to be transferred to the second stage piston (8). The second stage piston (8) was forced down, moving the second stage disc (10) away from its seat. This permitted pressure from the top of the main valve piston (12) to be vented via the second stage disc (10) and out the main valve piston vent (15). This created a differential pressure across the main valve piston (12). Reactor pressure then lifted the main valve piston (12) and main valve disc (14), thus, opening the valve. When reactor pressure reached approximately 100 psig, the main valve preload spring (11) force overcame the reactor pressure force and the main valve disc (14) subsequently closed. The root cause for the steam cuts on the pilot disc is an inherent design deficiency.

5. A satisfactorily leak tested, rebuilt TRSRV was installed per WR 90929.

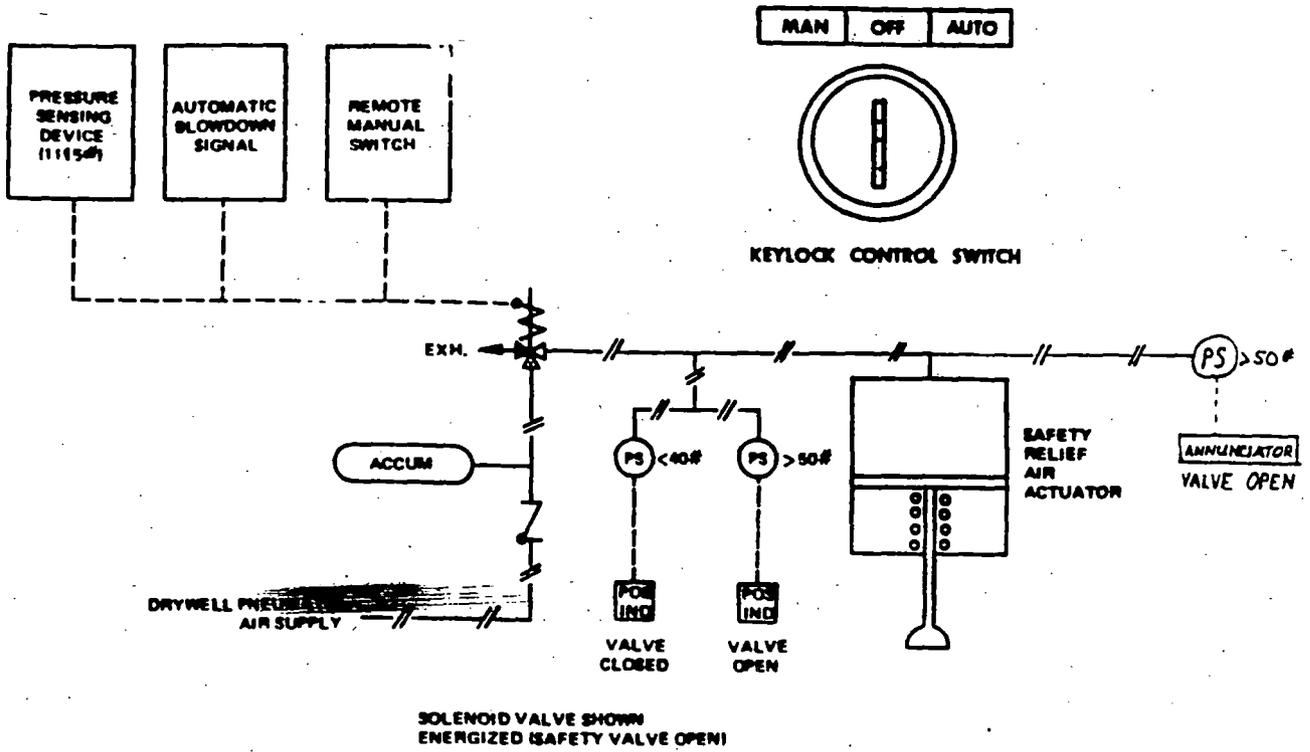
FIGURE 2

The TRSRV valve controls are shown in Figure 2. The control switch is a three-position, key operated switch. The three positions are "MANUAL", "OFF", and "AUTO". In the "MANUAL" position, the solenoid is always energized. In the "OFF" position, the solenoid only energizes from an automatic depressurization signal; it does not energize from a relief signal sent from the controller. In the "AUTO" position, the solenoid energizes from either an automatic depressurization signal or a relief signal sent from the Controller. The accumulator-check valve arrangement stores sufficient nitrogen to operate the TRSRV in the event of a loss of drywell pneumatic air (nitrogen). The pressure switches act as position indicators in the following manner: At less than 40 psig, the TRSRV indicates "Closed". At greater than 50 psig, the TRSRV indicates "Open". At greater than 50 psig, a Control Room annunciator also indicates valve actuation. Also, an acoustic monitor in the drywell monitors the TRSRV discharge piping and alarms in the Control Room when there is pipe vibration due to steam flow.
